Flex wire bonding

2022/10/27

Circular Electron Positron Collider

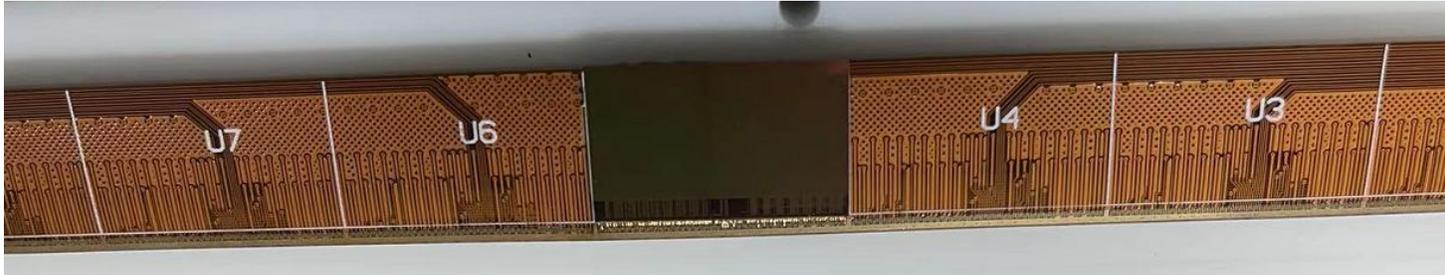
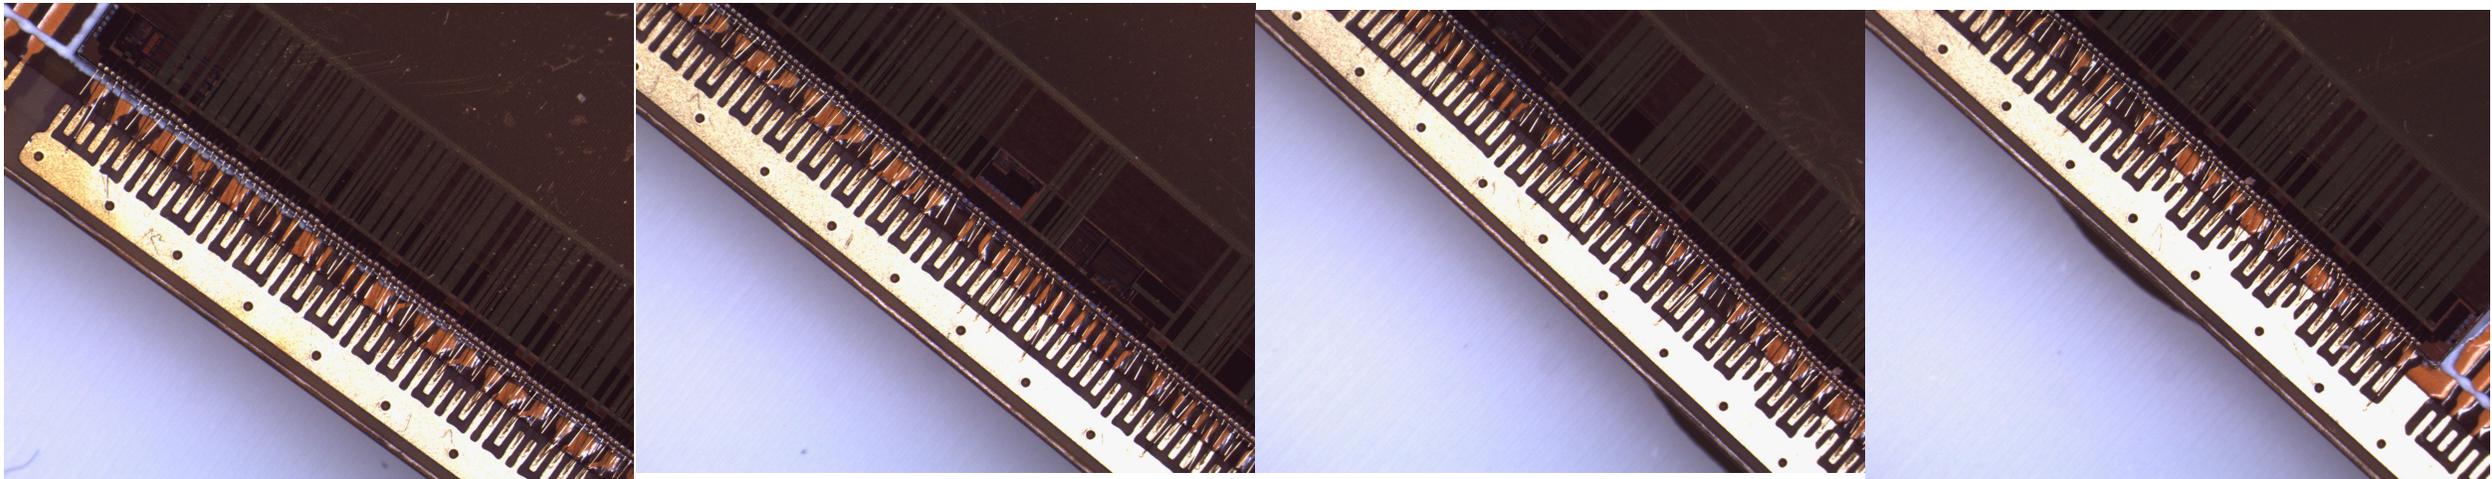
Flex short circuit after wire-bonding

- Flex was measured before wirebonding
- U5 was wirebonded
- A short circuit appeared (VDD to GND 1ohm and 24 ohm, GND to GND 0.1ohm)
- Schematic was checked without potential errors
- Wires were bonded as expected.

How to target the root of error? do more wirebonding? check everything again?

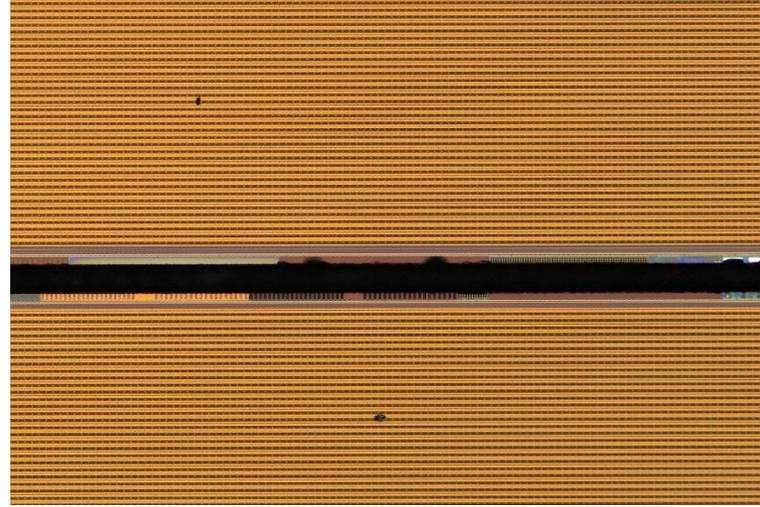
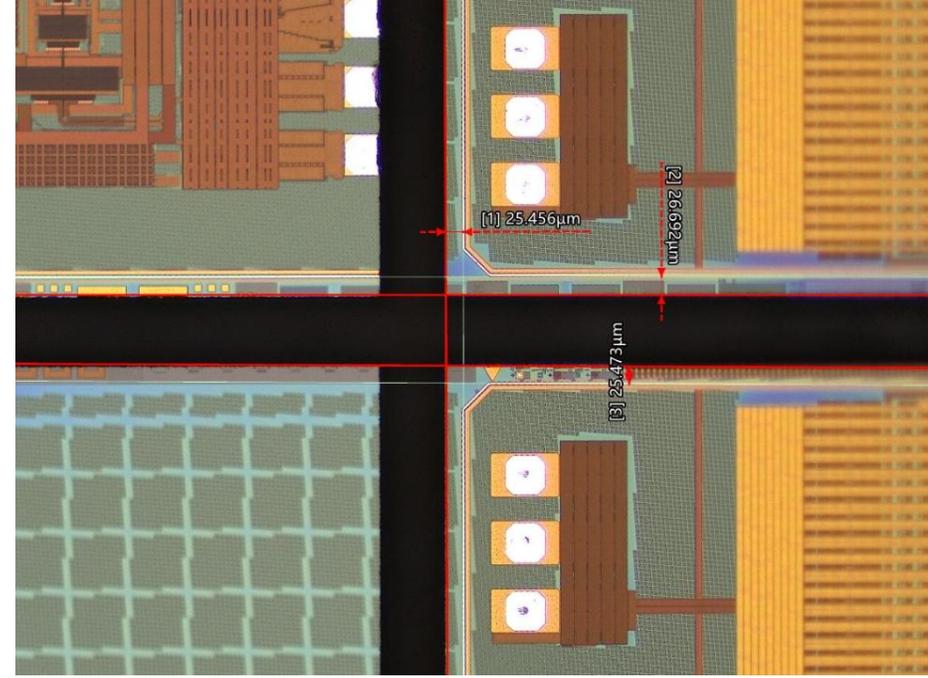
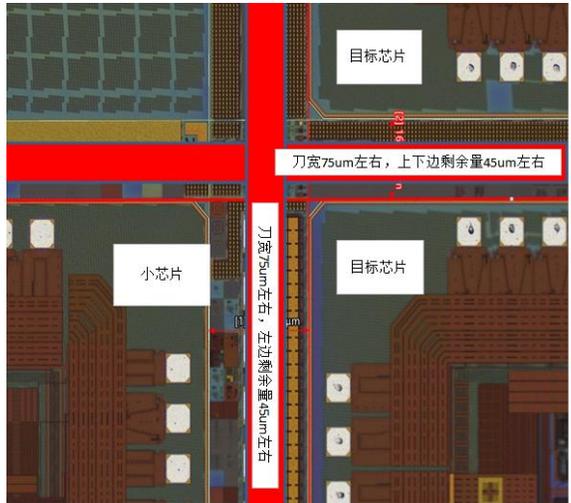
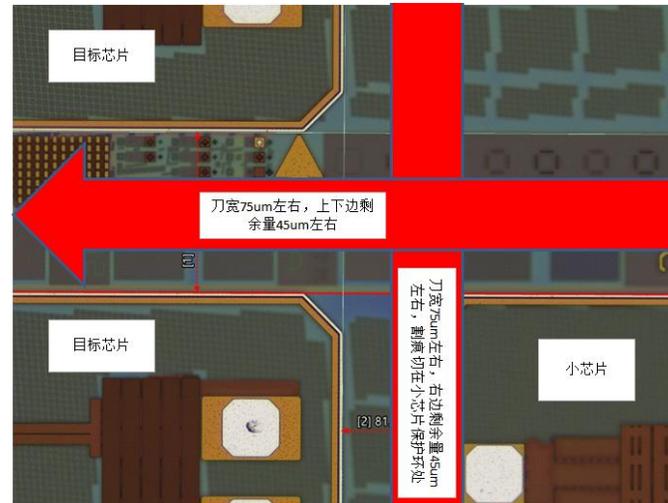
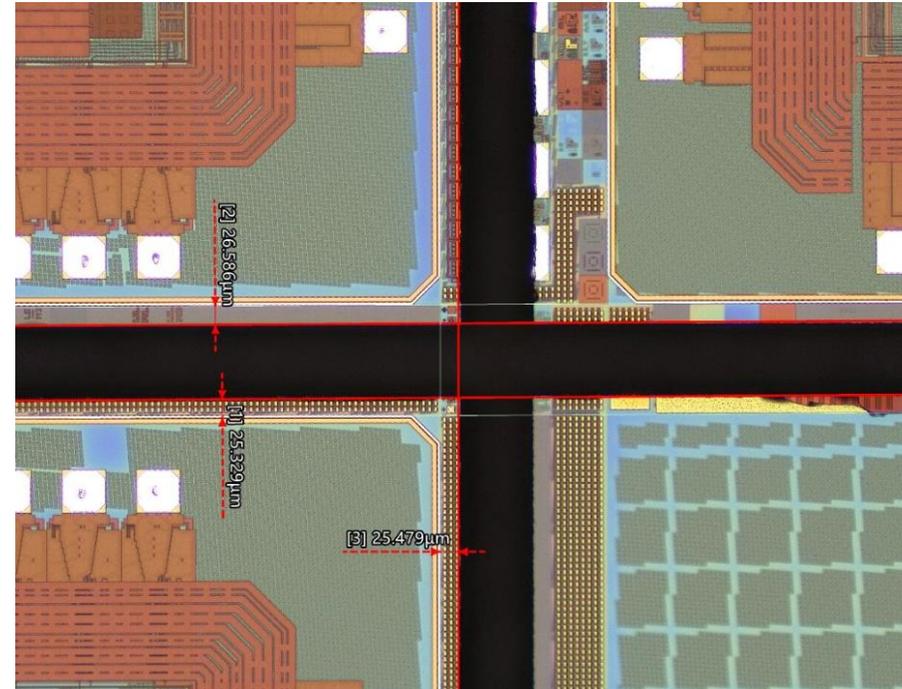
Chip dicing

- One wafer was diced(T212141-09A0,modified one)
- 105 um cutting knife
- 25~27 um was left on the edge of TaichuPix3
- The edge is uneven.
- We will test first wafer then diced the rest 4 wafers.

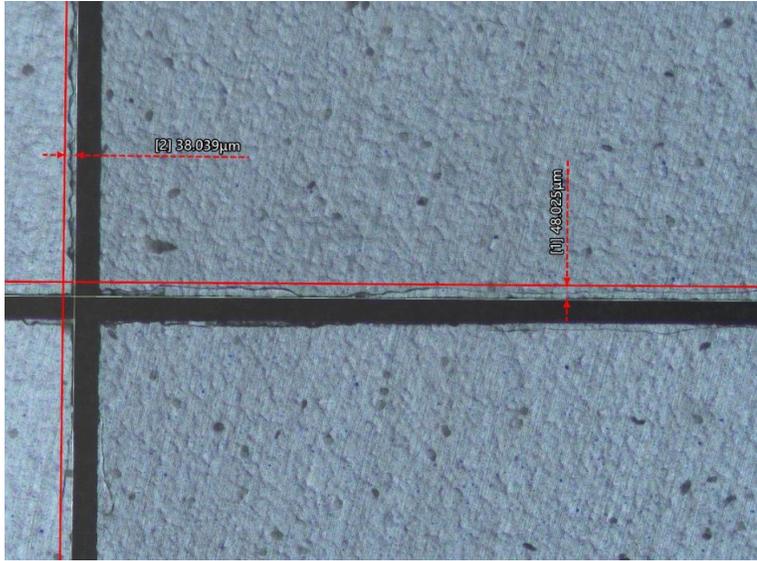
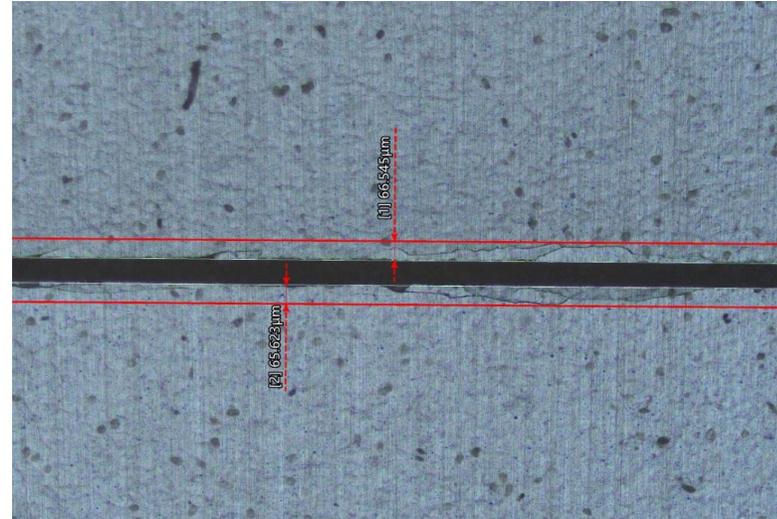
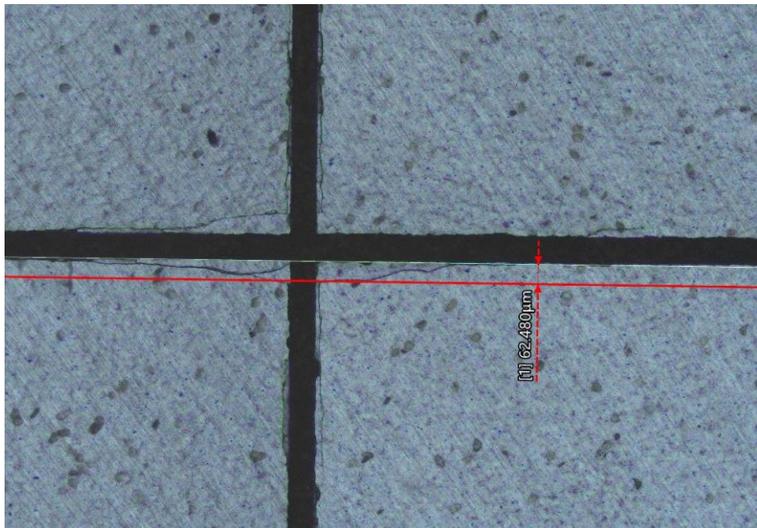
The uneven dicing edge backside

- Collapse the edge inward
- May hurt the chip itself
- This wafer in on the way to IHEP
- More testing to verify
