TaichuPix-3 test

2023-3-16

Investigation on issue of flex damage

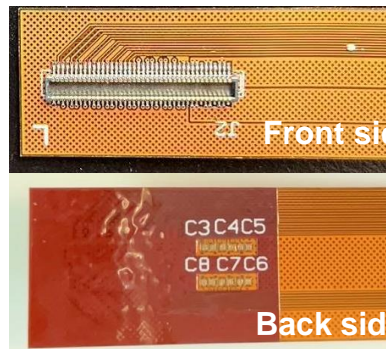
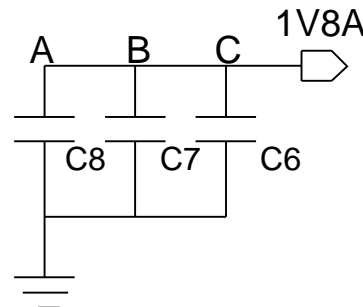
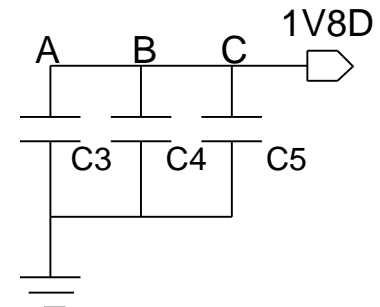
- 5 flex boards work normally at the beginning, while show no output during the test, three possibilities under suspicion
 - Damage of socket
 - Tried to replace the socket on two flex boards, no output after replacement → hard to be replaced
 - Further investigation indicates incomplete solder and damage to the flex under the socket
 - Different resistances of power 1V8A/D to GND observed at different capacitance terminals (A/B/C)
