# The operation status of neutron chopper system at CSNS

**Weiliang Cai**

Dongguan branch, Institute of High Energy Physics, Chinese Academy of Sciences (CAS)

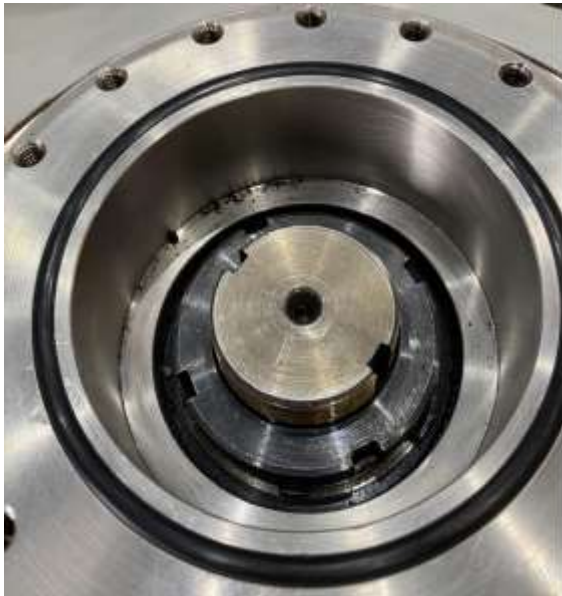
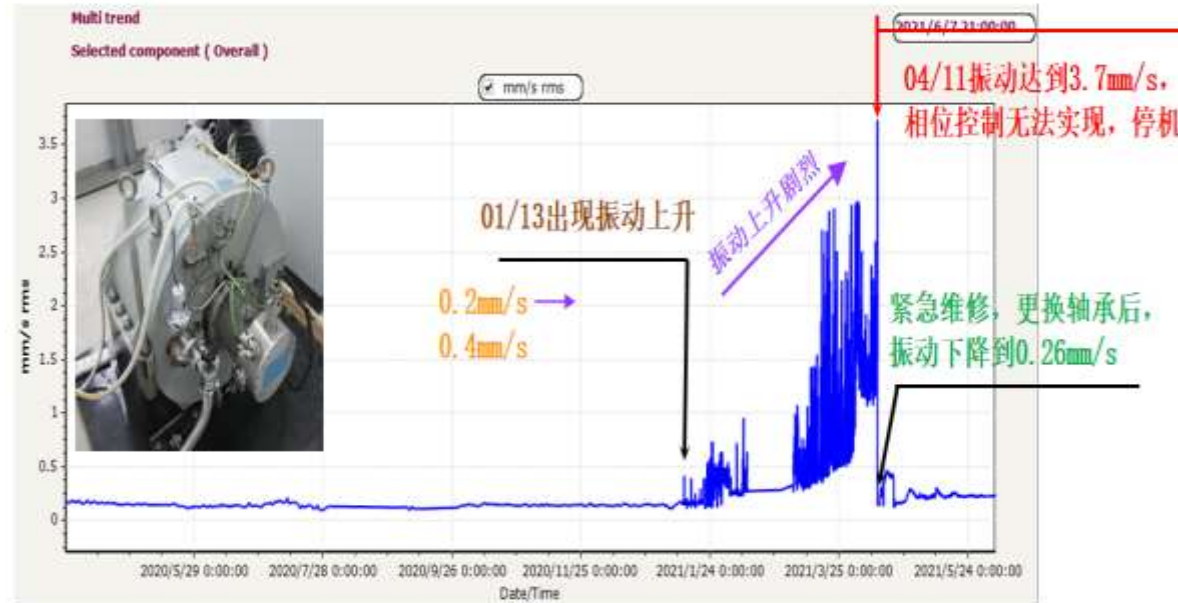
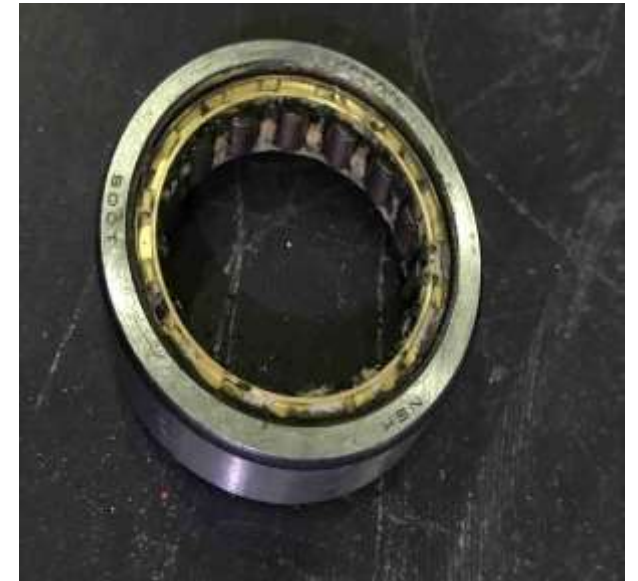
# Failure 1 - Bearings & Vibration

- T0 chopper - After 20000 hours running, T0 couldn't work caused by the bearing failure.
- Disk chopper - incorrect bearing selection(cylindrical roller bearings), resulting in shorter service life and a sharp increase in vibration
- 2 back to back ceramic ball angular contact bearings

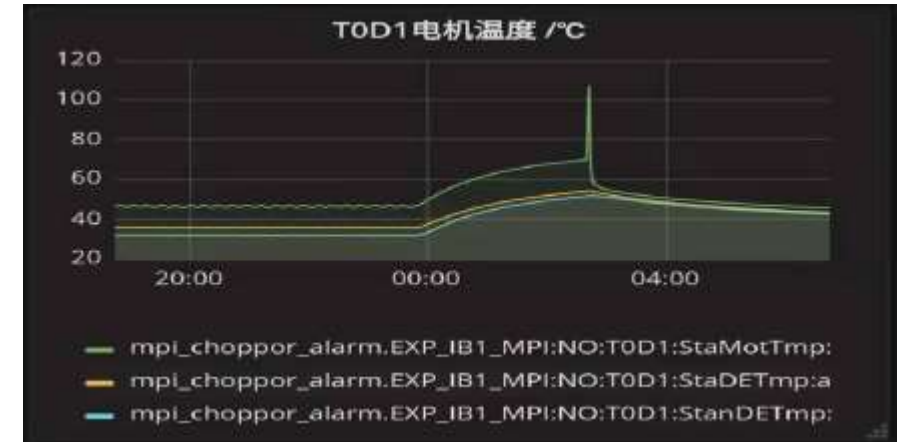
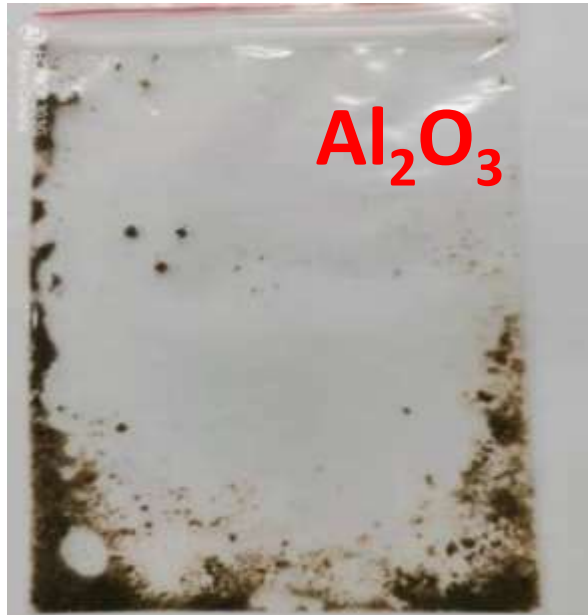
# Failure 2 - Cooling & Leakage

- Water-cooling pipe was plug by alumina particles which come from motor stator shell.
- Leakage of internal weld seam.

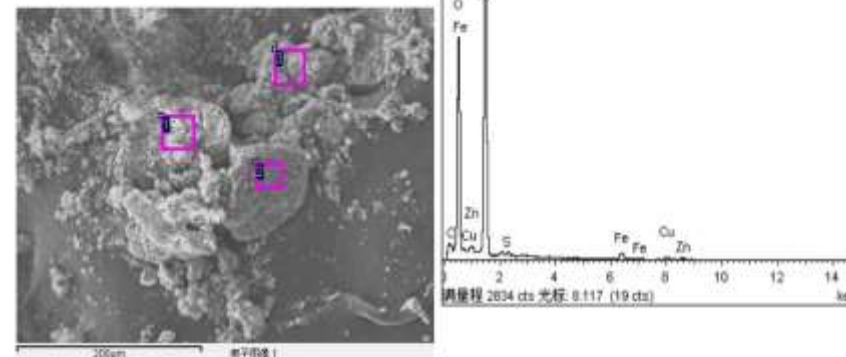
图1: 污染粉末样品的SEM图片及EDS点测试结果 ↓

谱图	C	O	Al	S	Fe	Cu	Zn	总的
1	0.24	53.29	35.52	0.71	5.80	2.13	2.31	100.00
2	4.34	46.73	41.58	0.59	3.44	1.59	1.74	100.00
3	3.71	56.19	33.90	0.45	2.31	1.68	1.77	100.00

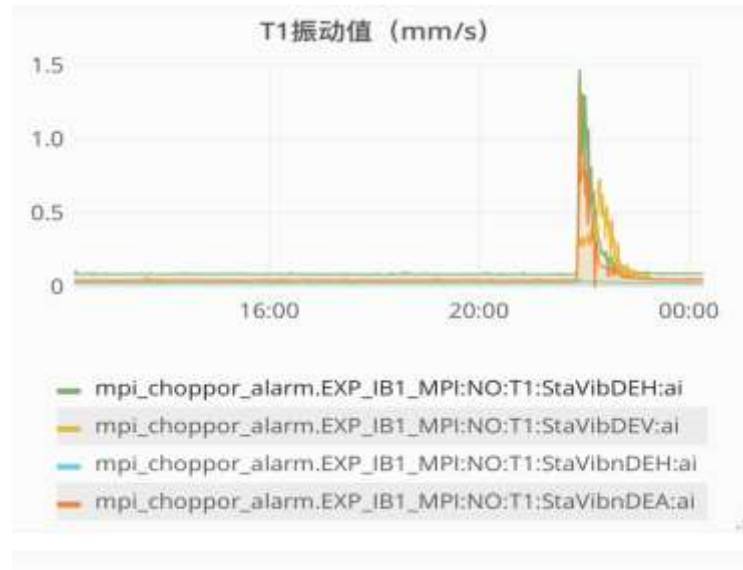
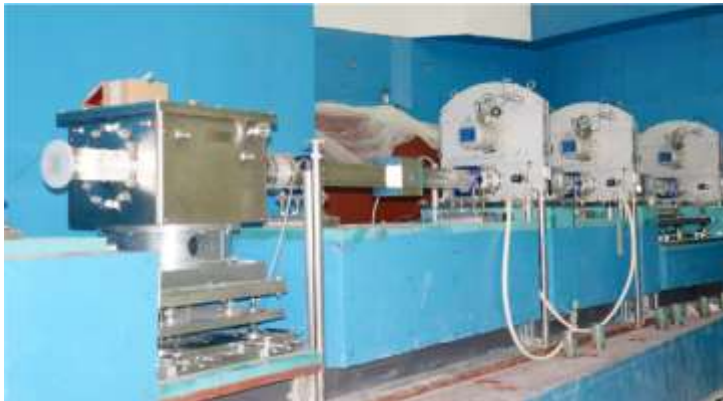
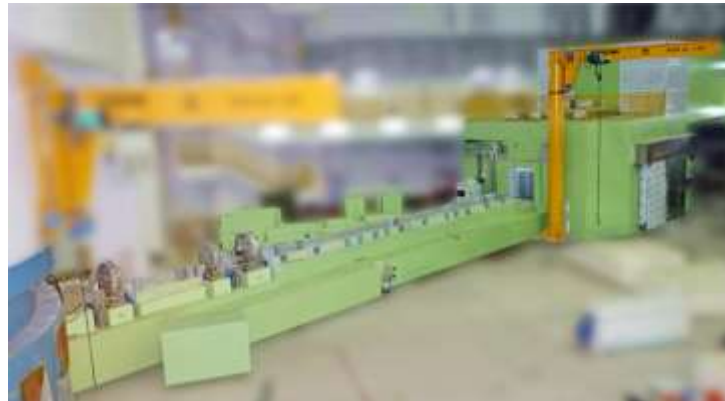
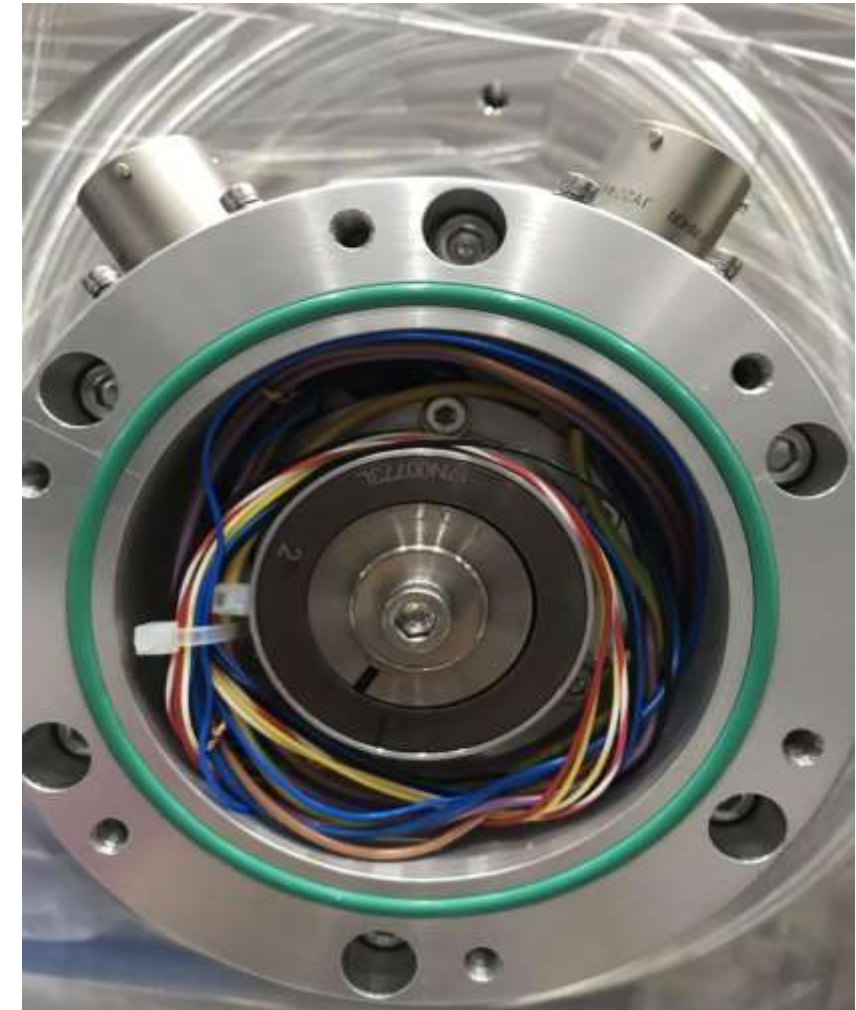
# Failure 3 - Electromagnetic Interference

- Unexplained interference
- Encoders, vibration sensors, and other electronic devices
- Trial solution: Add additional shielding

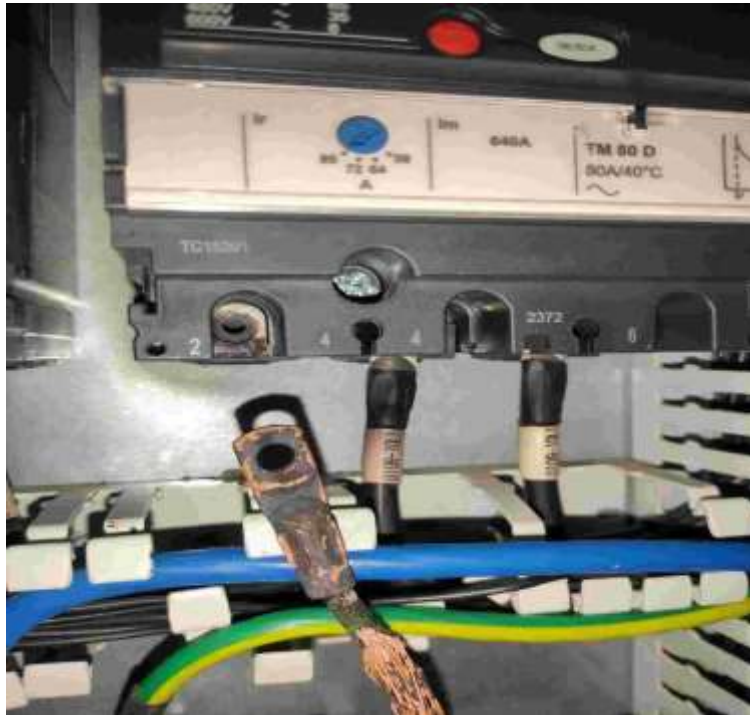
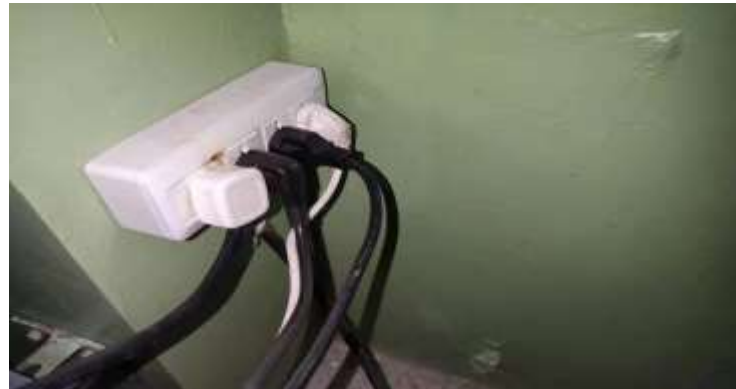
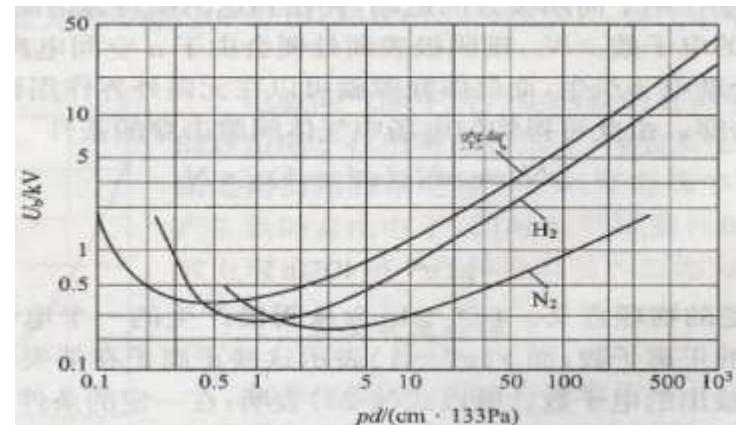
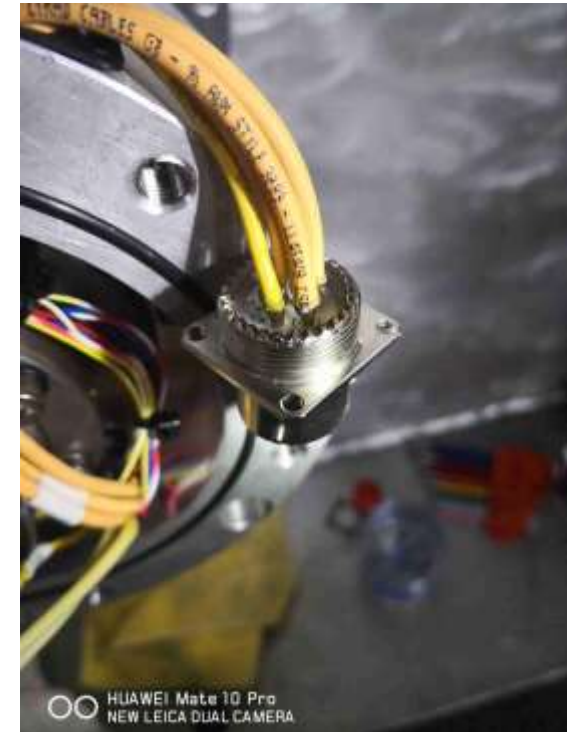
# Failure 4 - Connecting & Safety

- Loose connections, dust accumulation, vacuum discharge, etc
- Solution: Regular maintenance, cleaning, and tightening, epoxy enhances insulation
