Progress and Plan

Mingyi Dong

2024.9.23

Progress in the experimental hall last week

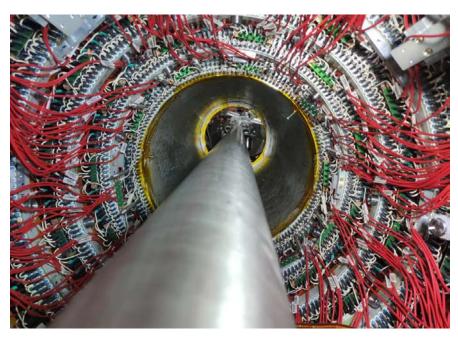
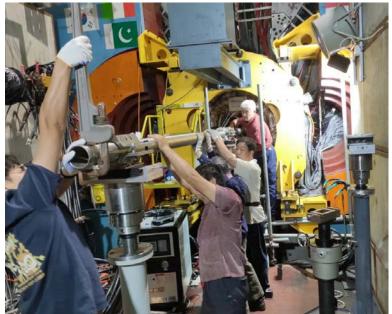
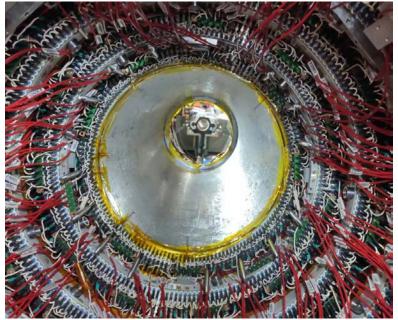
• September 18

- For the convenience of gas sealing operation and laser measurement, pulled out the long rail, and removed the small leg on the east side
- Removed the positioning targets on the west flange2
- Trial installation of the new east flange2. It is ok.
- Stopped gas flow, sealed CF cylinder and the screws/holes on the west flange2 with epoxy

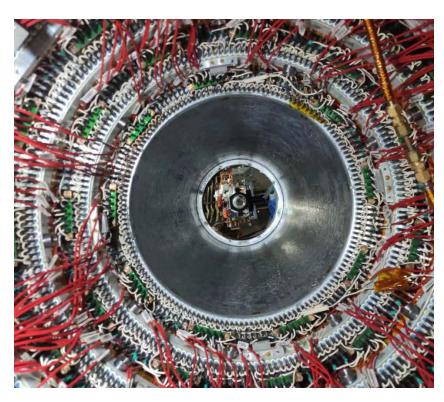
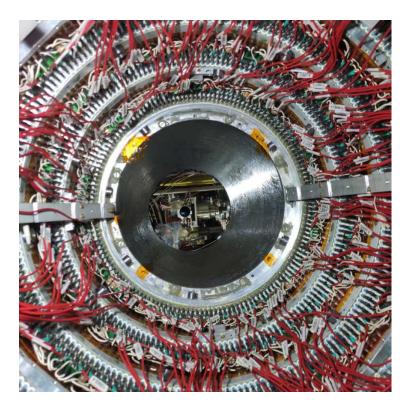
• September 19

- Check leakage with Ar in drift chamber. No big leakage was found
- Re-sealed the screws for fixing the CF cylinder on west side
- Trial installation of the new east flange2. The flange can not be installed after glued the CF cylinder. Need modification.
- Trial installation of the new shielding plates for step part
- Changed Ar with MDC operating gas (He/C3H8)

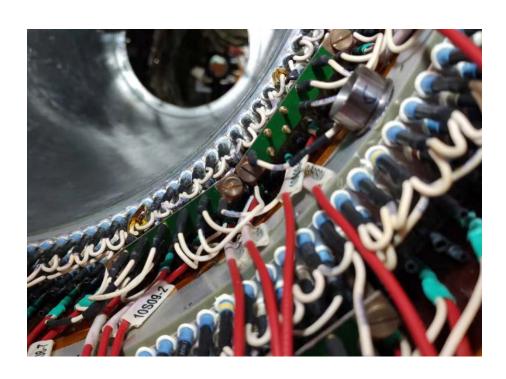
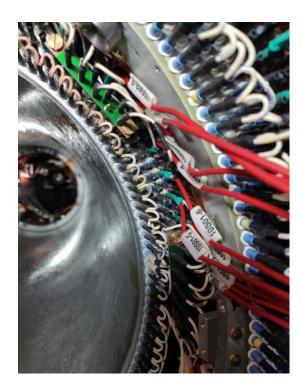
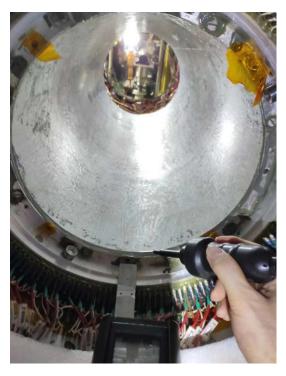
Restoration of the step part

- September 20
 - Installed the grounding boards of the first step of MDC on east side
 - Check leakage with gas mixture of He/C3H8 in drift chamber. Small leakage was found on the west fange2

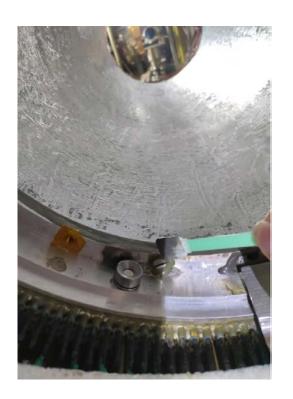
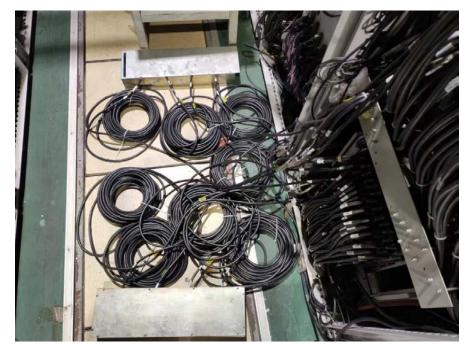
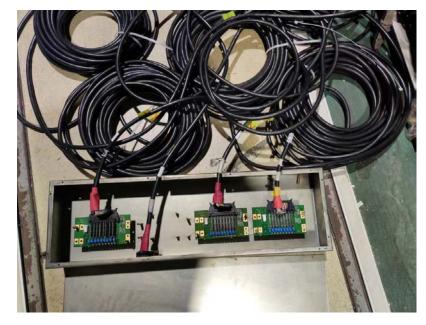
September 21

- Tested the wire tension again. After the wire tension test, restored the connection of the signal cables for the sense wires
- Re-sealed the positioning target holes on west flange2
- Completed the testing of the preamp boards to replace the dead preamps of the MDC

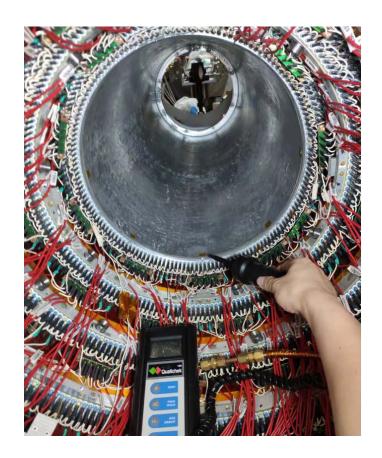
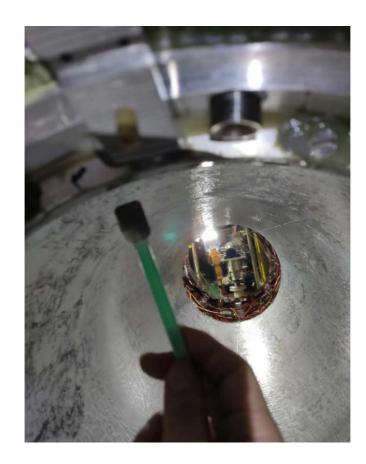
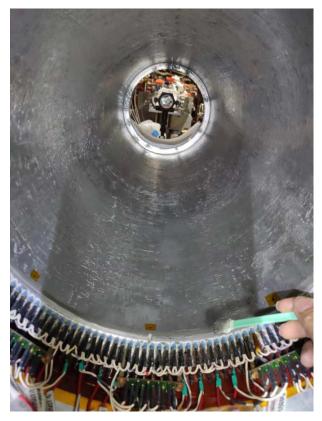
Gas sealing and leakage check

- September 22
 - Re-sealed the positioning target holes on west flange2
 - Re-sealed the CF cylinder on east side
