Progress and Plan

Mingyi Dong

2024.9.30

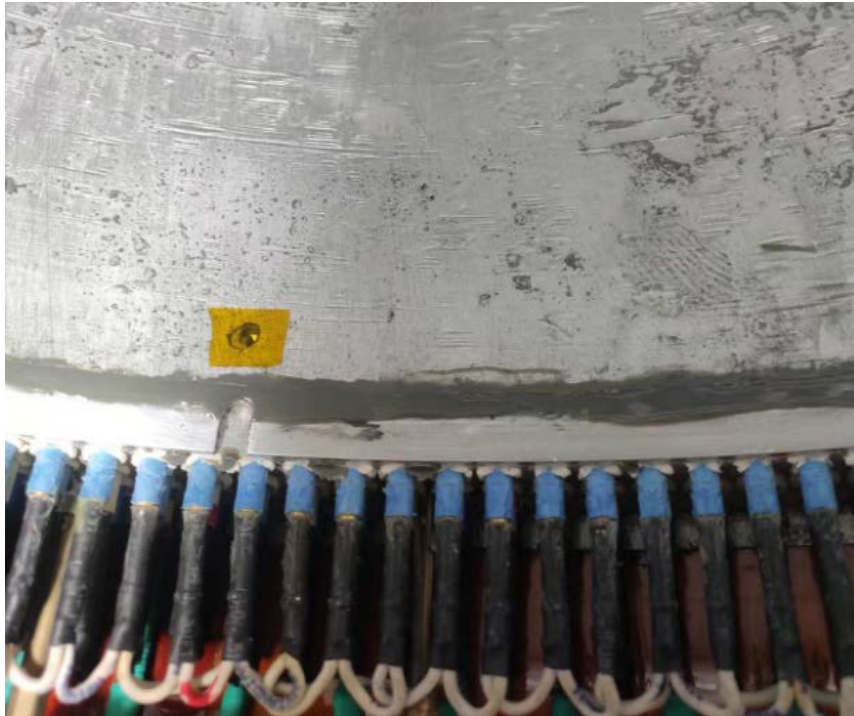
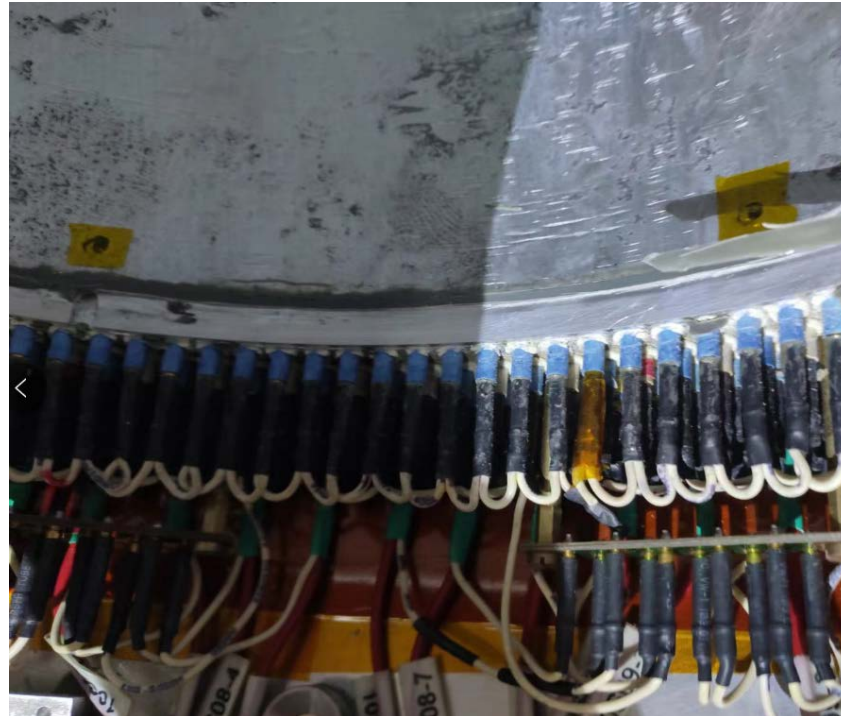
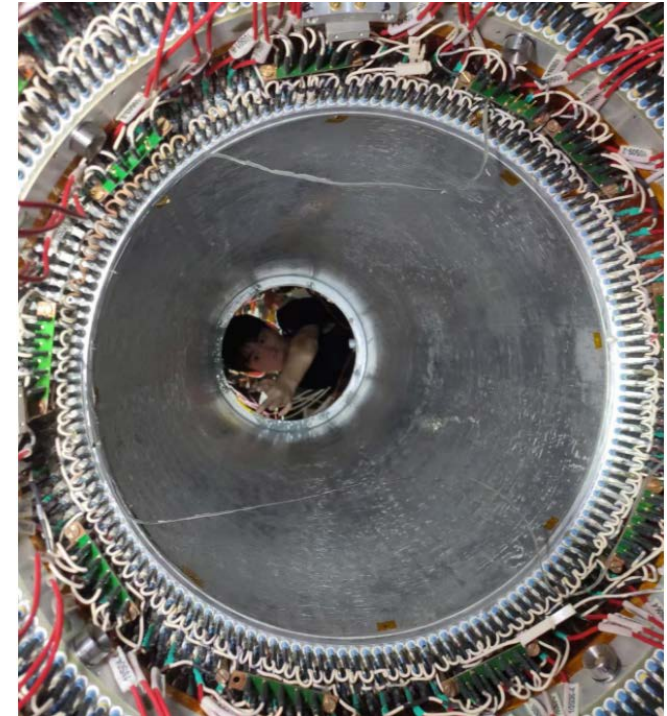
Scheme of installation of the east flange2

- September 23
 - Discussion with Stefano and Jinyu about the CGEM cable support on the EEMC during cabling
 - Discussion on the modification of east flange, z direction will not change. A portion of the glue on the Al ring will be removed, leaving only 2.5mm
 - Did the test of removing glue on the aluminum ring

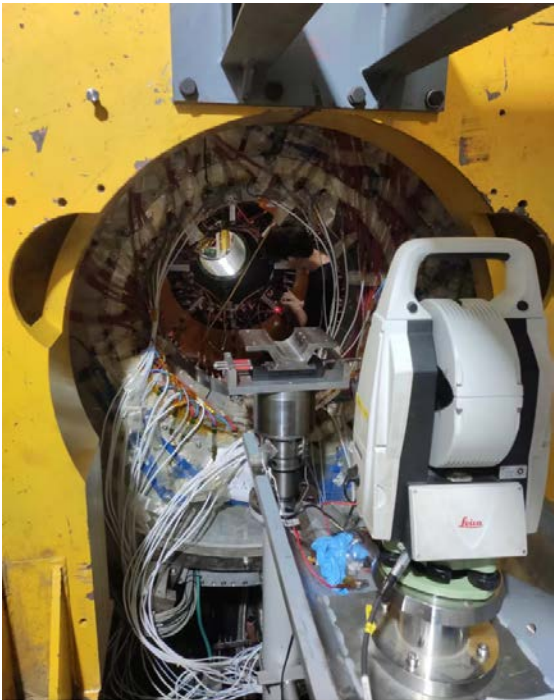
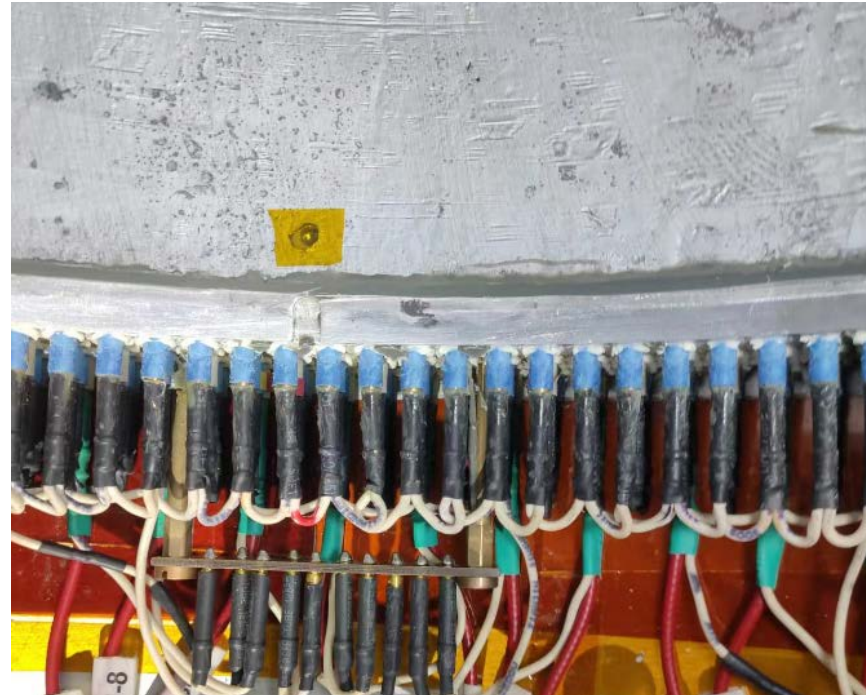
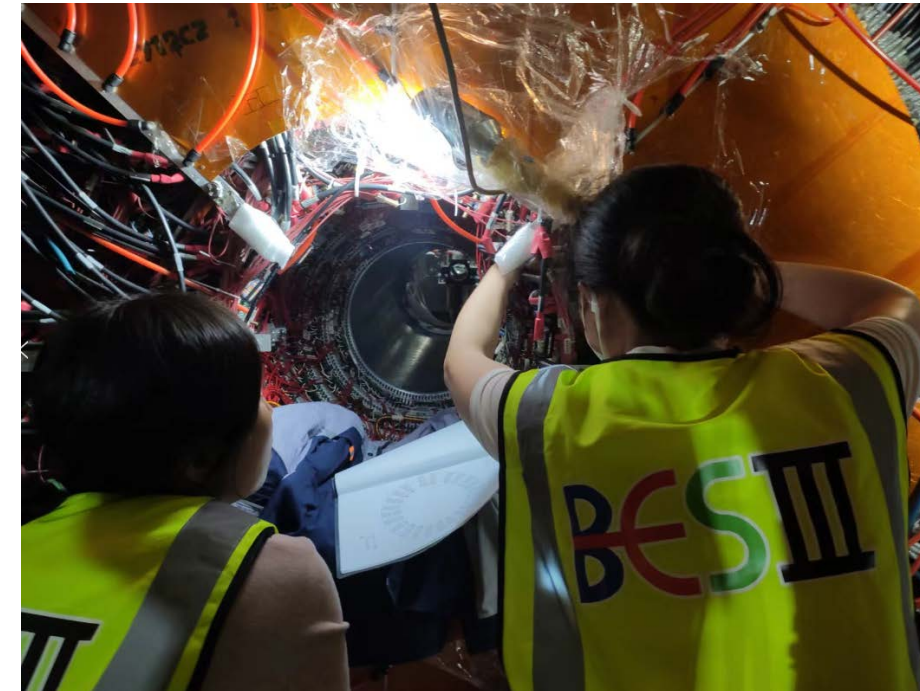
Laser measurement and changing preamp

- September 24
 - Laser measurement of MDC position after removing the inner DC (two times on west side, one time on east side)
 - Changed the dead preamplifiers of the step parts (6 preamplifiers were changed)
 - Removed the glue on the Al ring in z direction, leaving only 2.5mm

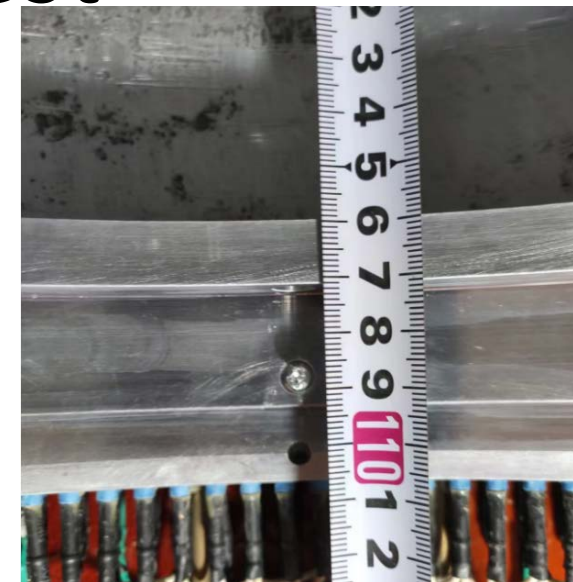
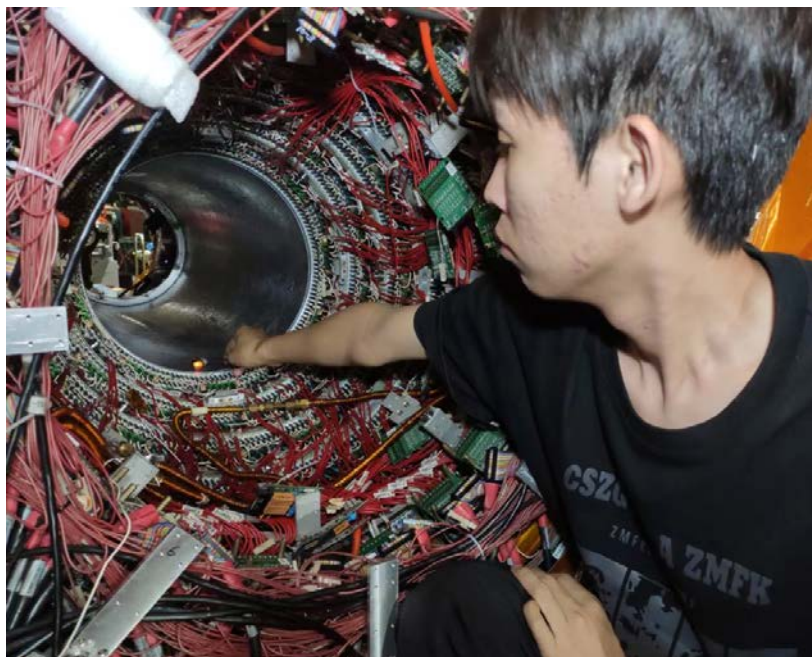
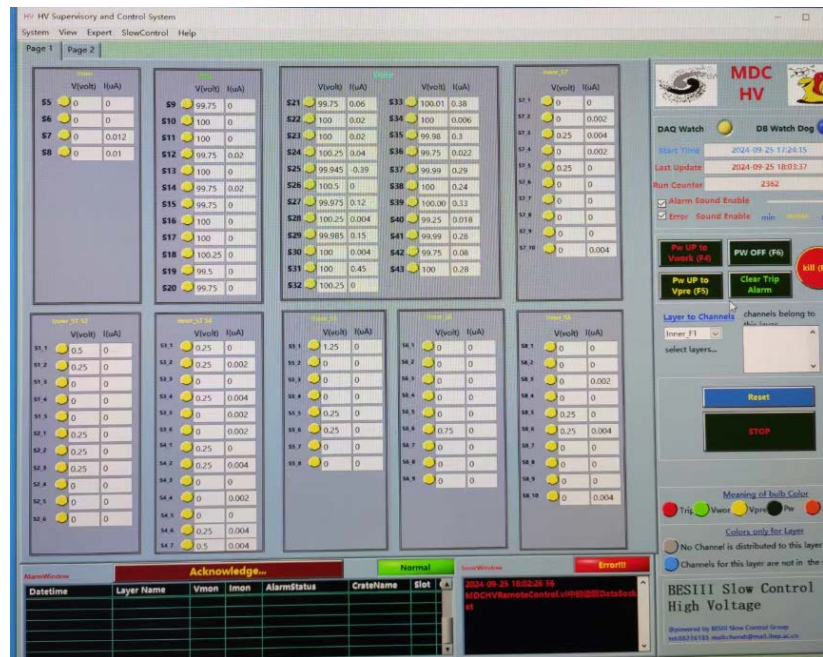
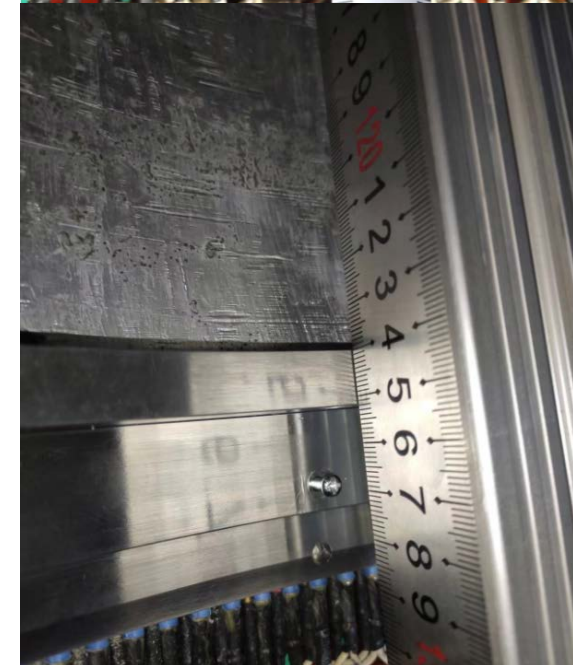
Cavity measurement and HV test

- September 25
 - Laser measurement of MDC position on east side (the second measurement), including the diameter of the cavity
 - Try installation of the east flange. It is ok
 - Measured the length between the east flange 2 and the aluminum ring at the west end of the CF cylinder (with Stefano) (test result: 1044mm, Very good agreement with design value)
 - Powered on MDC High voltage, with a voltage of 100V

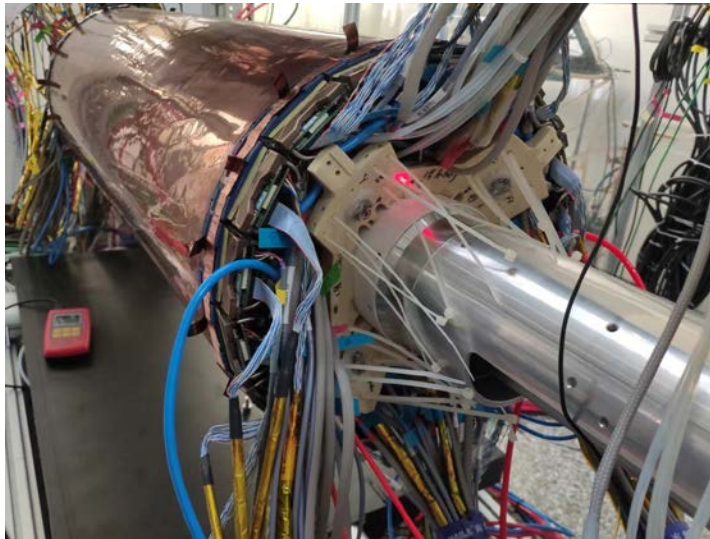
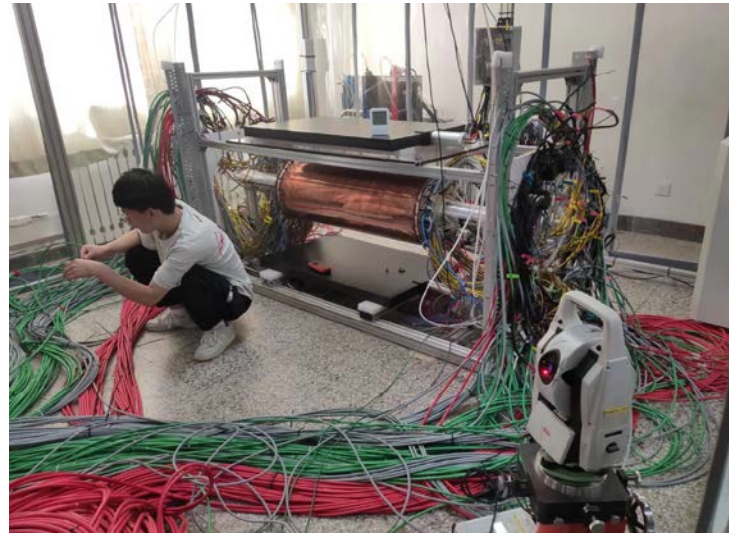
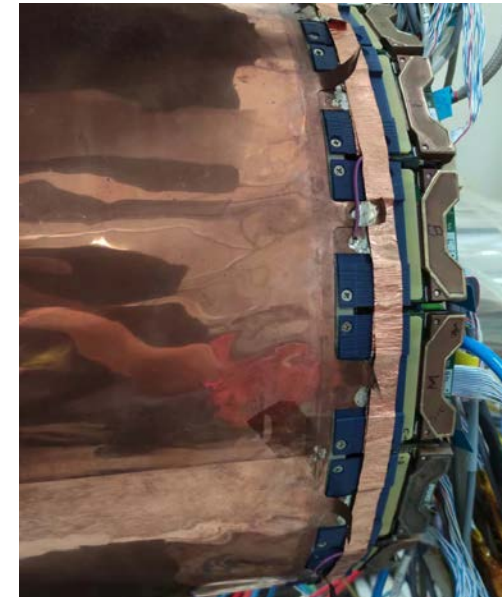
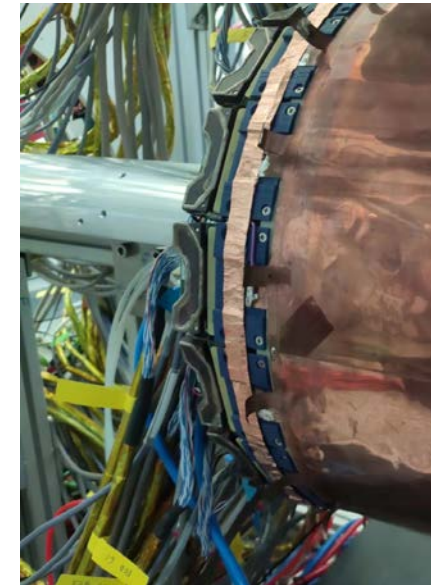
Laser measurement of CGEM

- September 25
 - Laser Measurement of CGEM in room106
 - The diameters of the some area is larger than design. Italy colleague said it would be reduced to the design size
 - Today we arranged another laser measurement

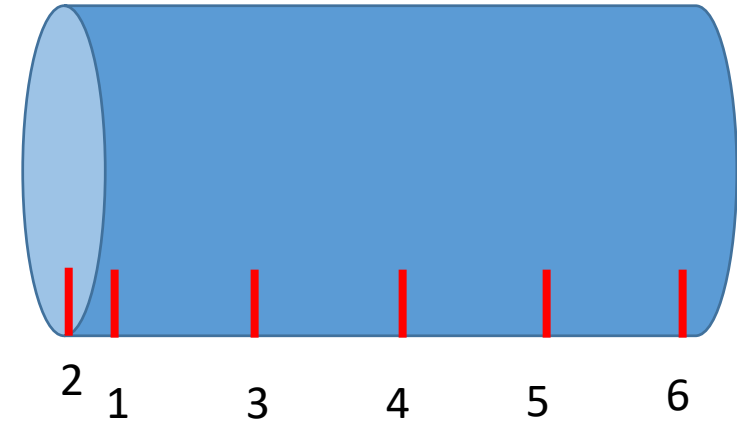
Test results

circle	diameter	Maximum deviation	Minimum deviation
1	365.532	0.14633	-0.192
2	365.107	0.104	-0.115
3	365.531	0.129	-0.114
4	365.553	0.176	-0.218
5	365.411	0.279	-0.251
6	365.314	0.068	-0.068

About 8 points were measured in each circle

- Design value of the cavity diameter: 365mm. The test results are little larger than design value
- Test result of length between the east flange 2 and the aluminum ring at the west end : 1044mm, Very good agreement with design value

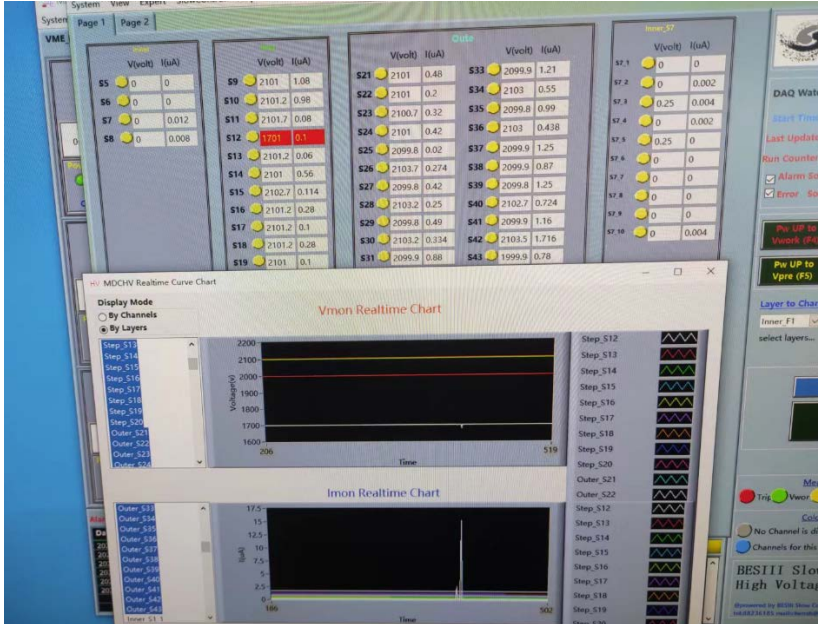
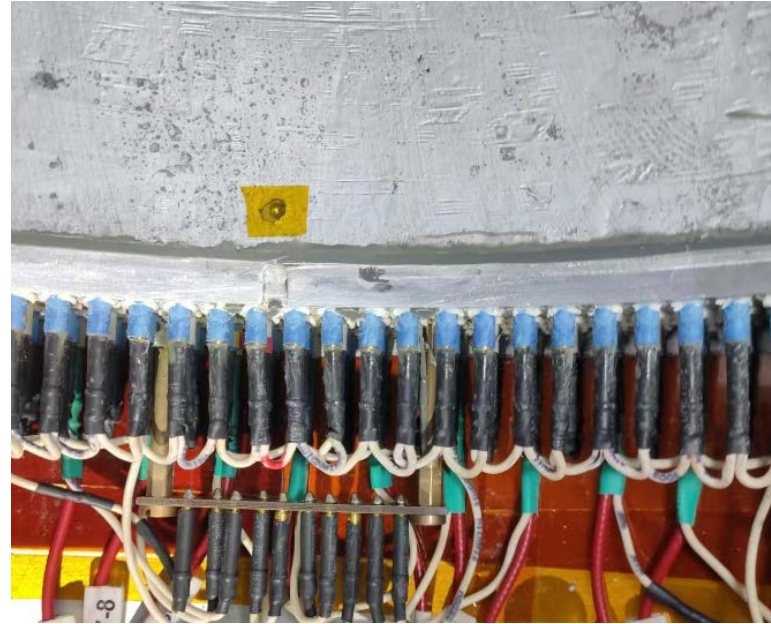
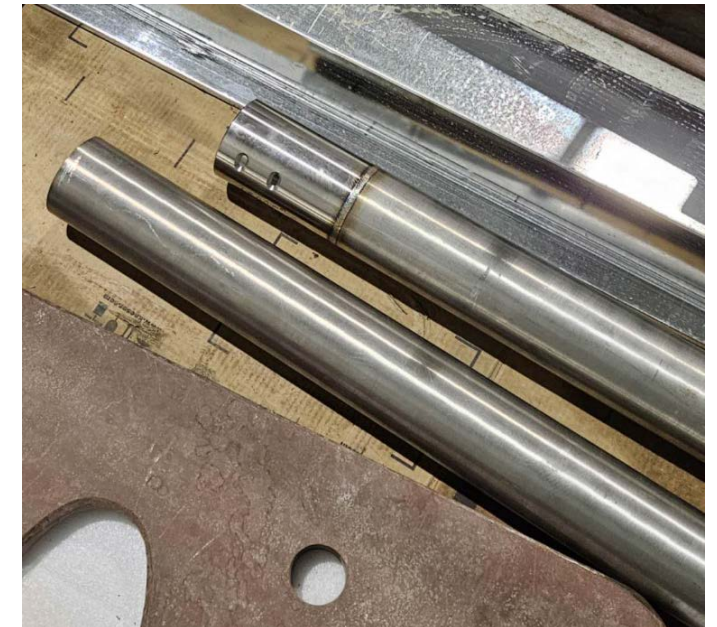
Restoration of the step part

- September 26
 - MDC HV training. MDC high-voltage training reached 2100V, but half an hour later, layer12 had a HV trip
 - Tested MDC with Cosmic- rays
 - Seal the 8 screw holes on the CF cylinder with epoxy (with screws inside the holes)
 - Cut the short part of the rail, and welded with the CGEM connection part

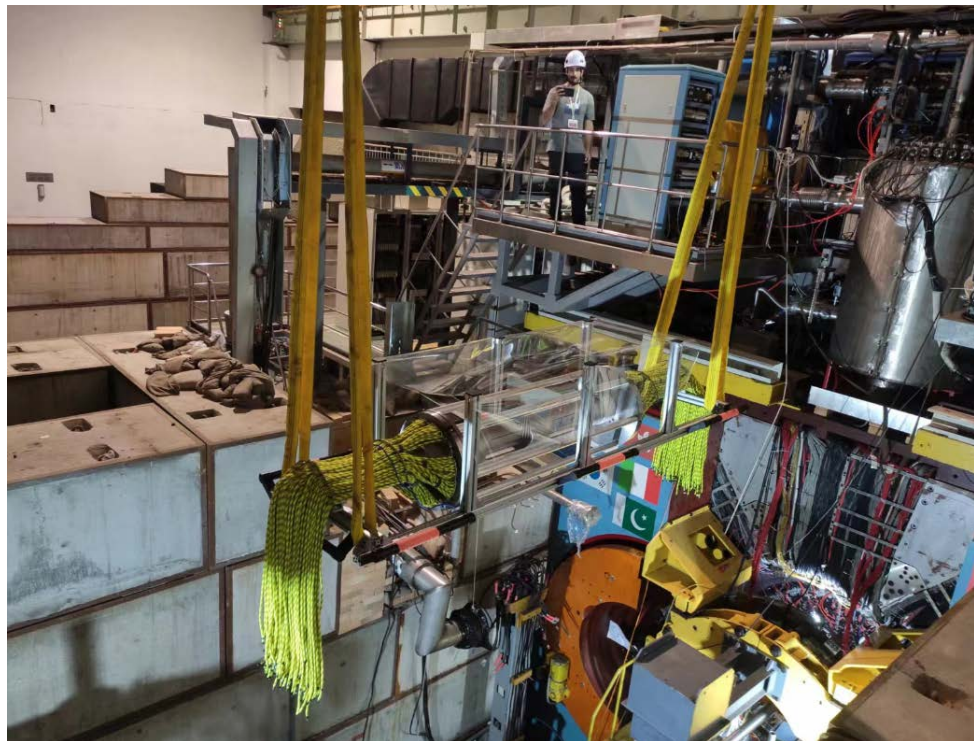
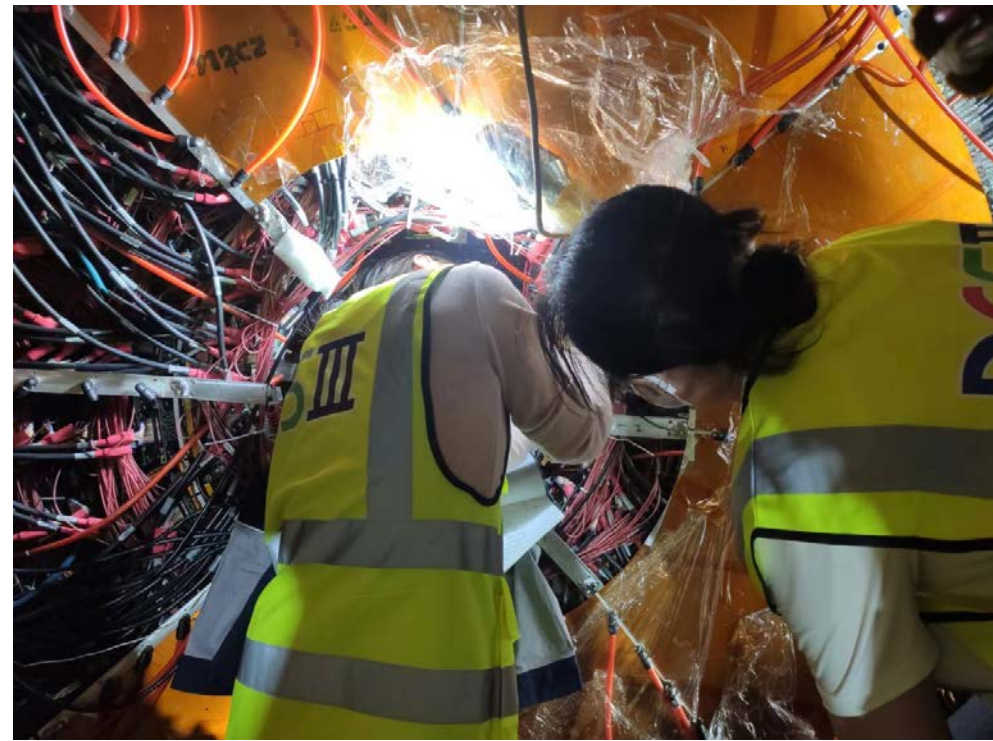
- September 27
 - Performed CGEM mockup lifting test (from the south platform to the detector region)
 - Changed the dead preamplifiers of the outer chamber (11 preamplifiers were changed)
 - Checked the leakage around the screw holes, no leakage with the screws inside the holes
 - Resealed the CF cylinder with LOCTITE 609

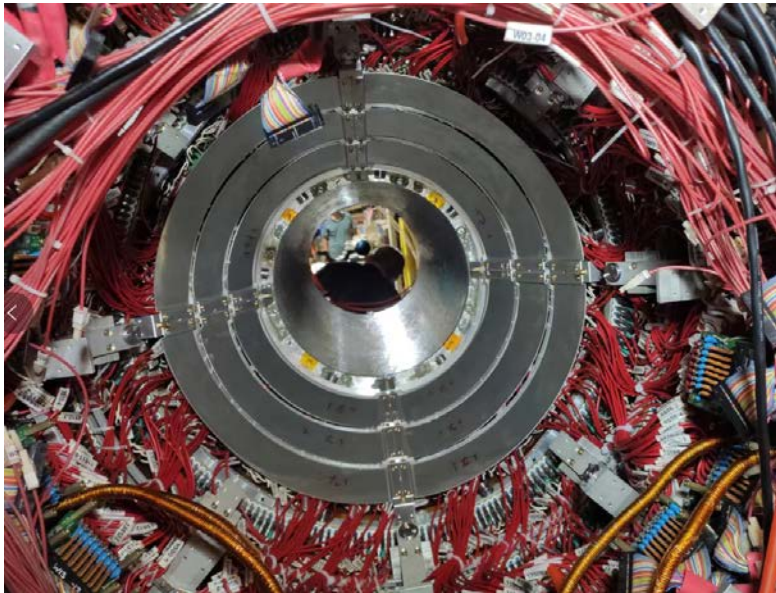
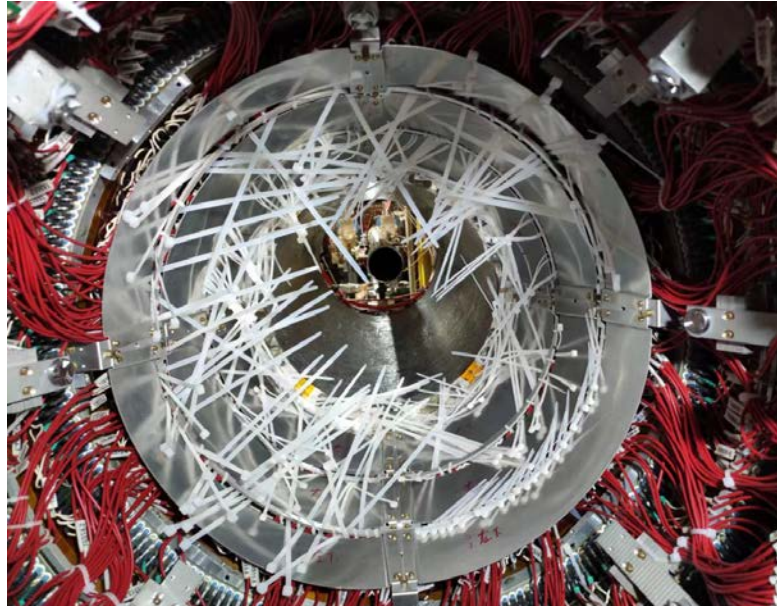
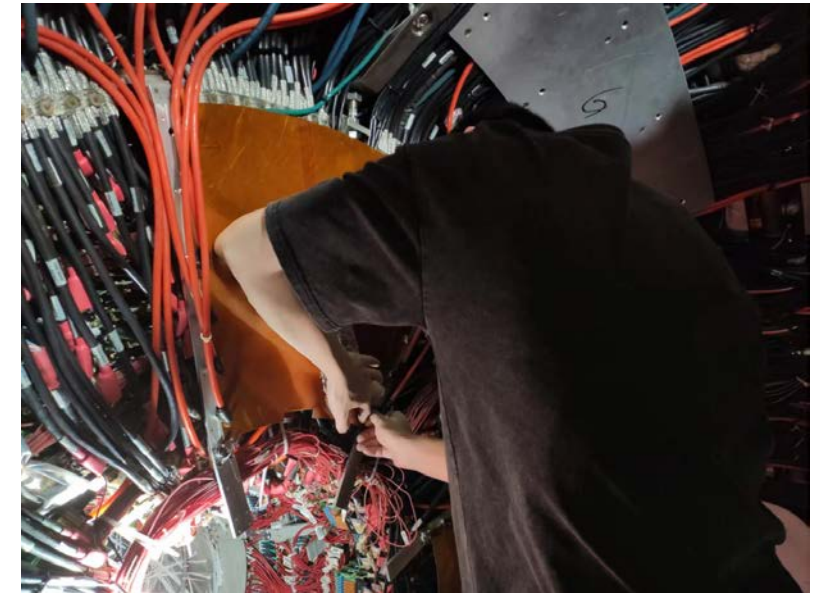
HV training and Cosmic-ray test

- September 28
 - HV training, solved the HV problem of layer12 (Changed the preamp, but found feedthrough connector of E12_3-6 fell off, almost touching the Al plate)
 - Tested MDC with cosmic-rays, one noise board was found
 - Installed the new shielding plates for MDC step part on west side. The east shielding plates will be installed after insertion of the CGEM (there is interface)
 - Recovered the installation of the shielding plates of the outer chamber
 - The work related to the removal of the inner chamber has been completed as scheduled

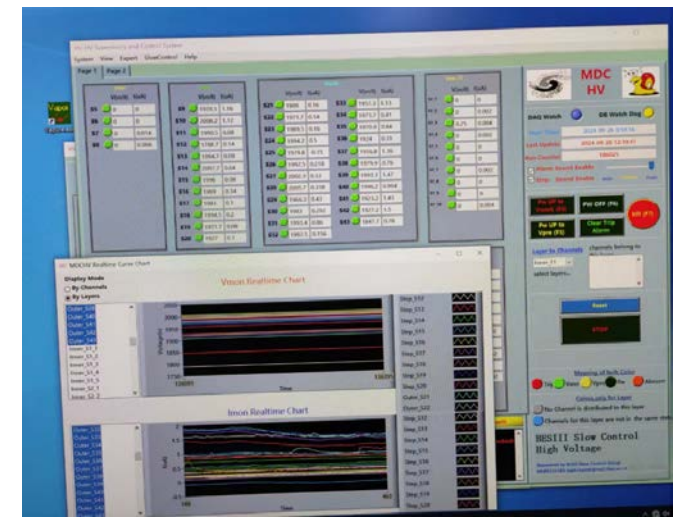
Cosmic-ray test

- Most dead channels were recovered. One noise board (W11-2) was found

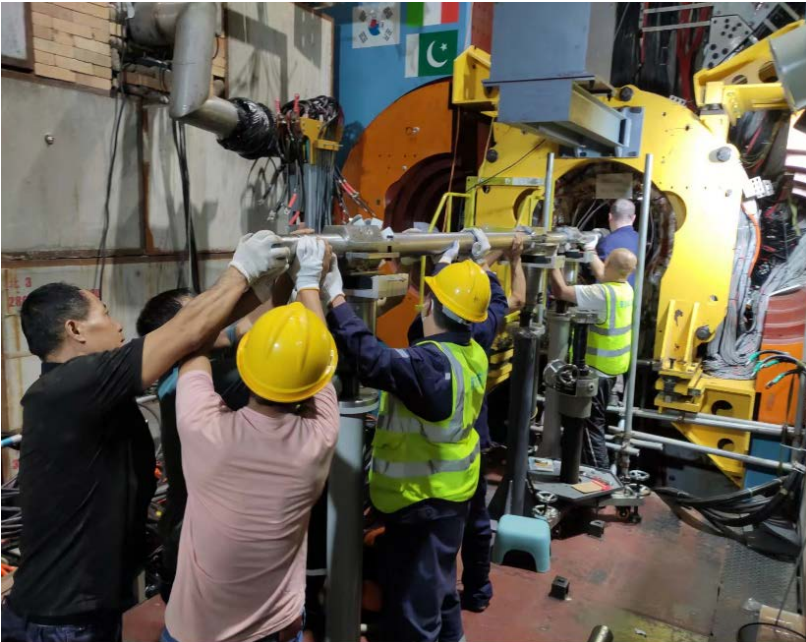
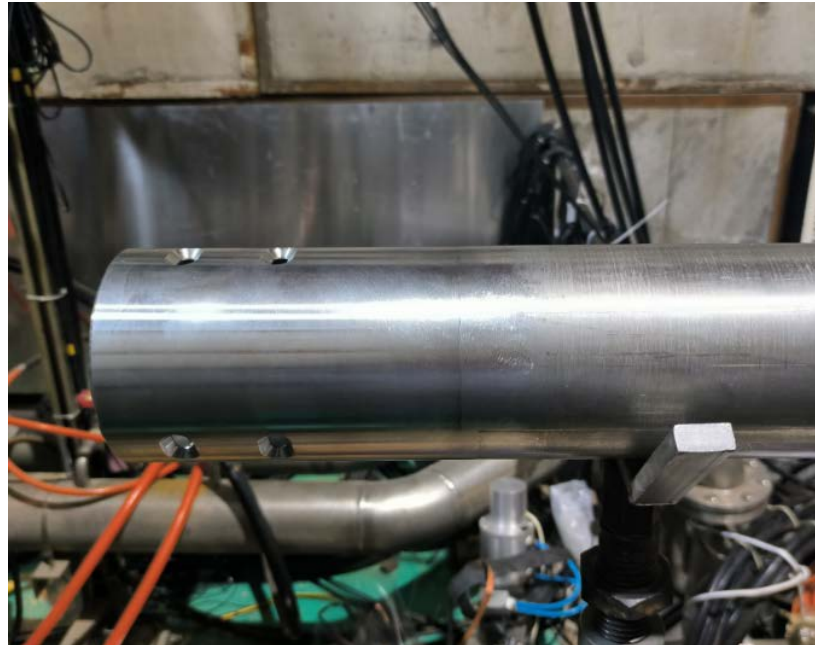
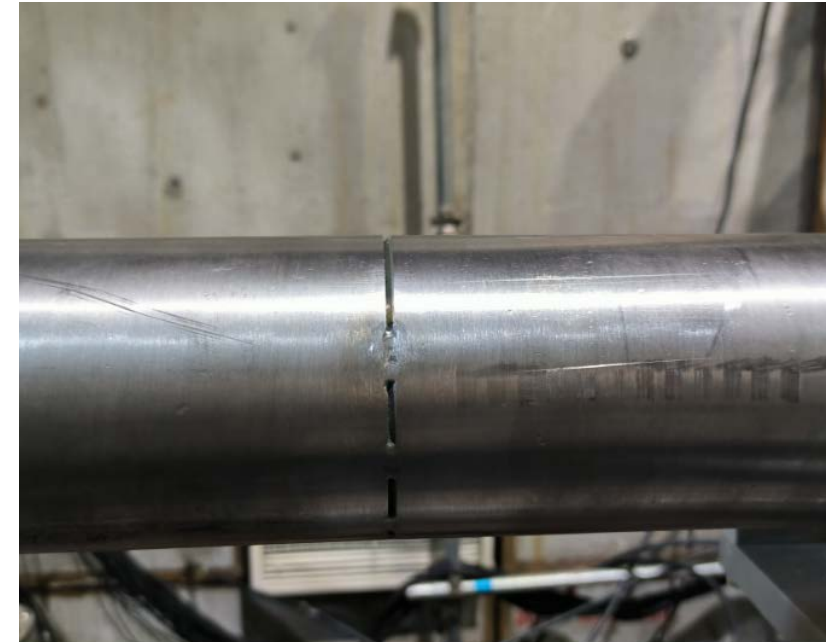
Installation of the long rail for CGEM installation

- September 29
 - Welded the long rail, and installed the long rail on the legs
 - Test MDC with cosmic-rays (changed preamplifier of W11-2)
 - Final check the step part of MDC in the evening
