Noise issues of MDC after installation of CGEM IT

2024.12.02

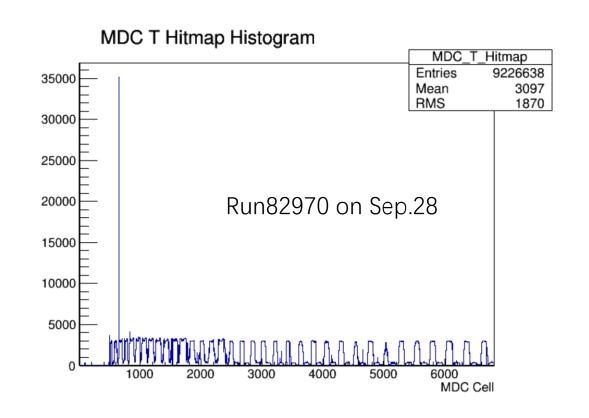
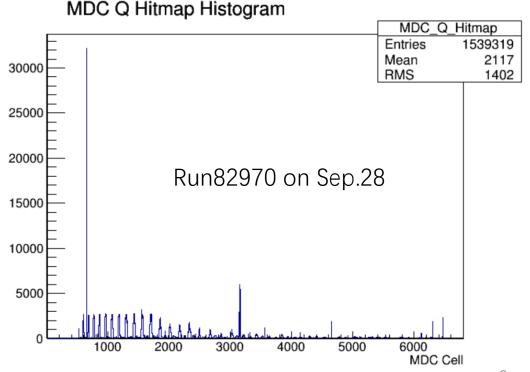
- After gas sealing and HV training, first cosmic-ray test showed that MDC could work normally with nominal HV (reference: 2200V) on Sep.28
- T and Q Hitmaps show the channels are normal
- No noise was found in T and Q measurements, except one noisy channel

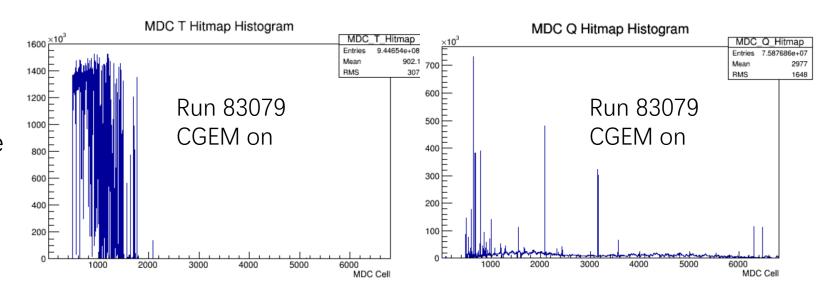
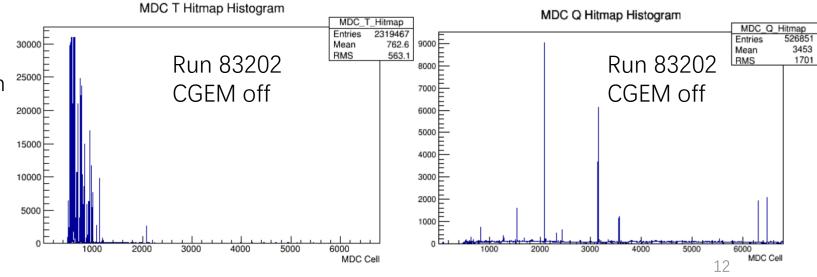
- In the joint testing of CGEM and MDC, both detectors can work well with nominal voltage
- Noise was found in MDC during the joint test.
 - The noise is in the step part of the MDC
 - The inner layers are larger, and the outer layers become smaller
 - Noise mainly impact on Time measurement, almost no impacts on Charge measurement
 - Noise has a larger impact on the even layers of MDC (readout electronics is at the east end)
 - Even if CGEM is powered off, there are still some channels with noise

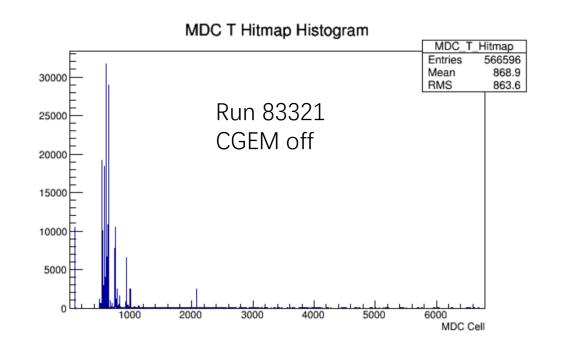
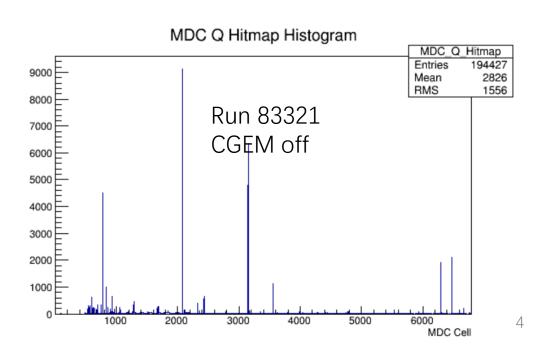
- Grounding and shielding have no significant effect on reducing noise
- The ground the CGEM is separated from MDC at the front end (the resistance between them is about 350 k Ω when the crates of the CGEM is disconnected from the ground)
- As each device in the CGEM system is powered off and disconnected from the ground one by one, the noise of MDC becomes smaller and smaller
- Compared to the case before CGEM installation, there is baseline noise because even if CGEM is powered off, there are still some channels with noise present

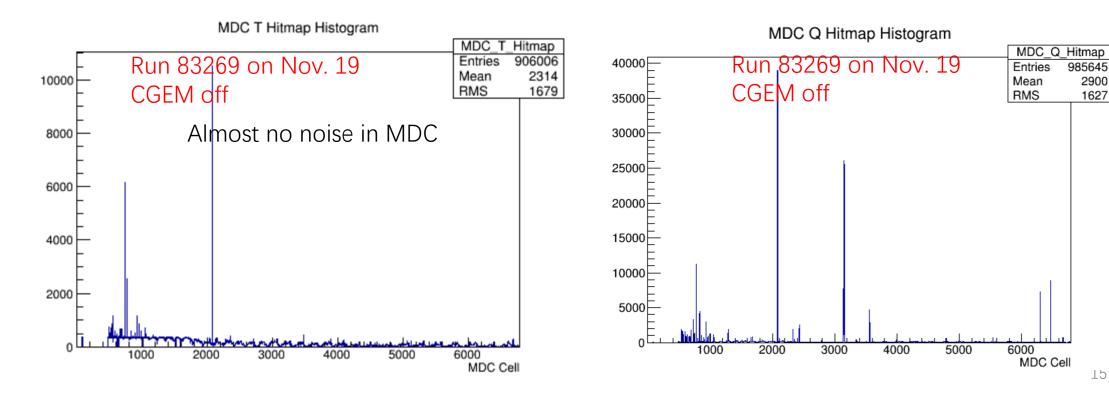
- The baseline noise does not seem to come from CGEM, as it disappeared between 14:00-16:00 on Nov.19. No operation related to this change was found (SCO test system, SSM, interlock door)
- When CGEM is powered on, the noise become serious, and even if the T threshold is increased by 2.5 times, the noise count rate is still very high

- Isolation transformers will be used for testing CGEM and MDC related equipment
- Testing will be conducted on CGEM cables using filtering magnetic rings
- We powered off accelerators and other related equipment one by one to search for the basic noise sources this morning, no noise source was found (everything was powered off, baseline noise still existed)
- After discussing with the machine people, we have postponed the installation and recovery of IP region. The start time will be discussed and finalized in the meeting on this Wednesday or Friday
