# BESII Vertex Chamber and MDCII Feedthroughs

Russell Malchow

# Mark III Vertex Chamber Rebuild

# MDC II Feedthrough Design

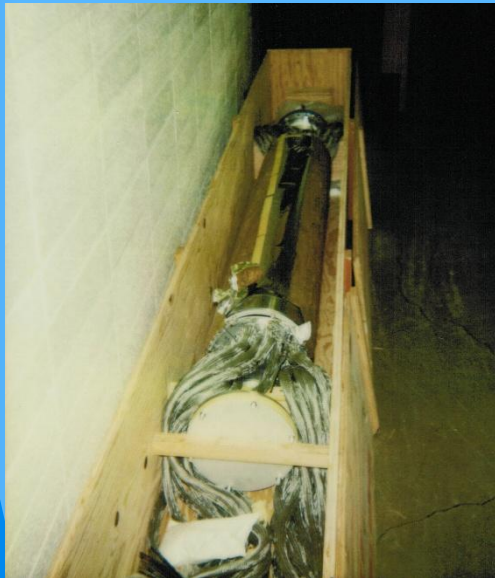
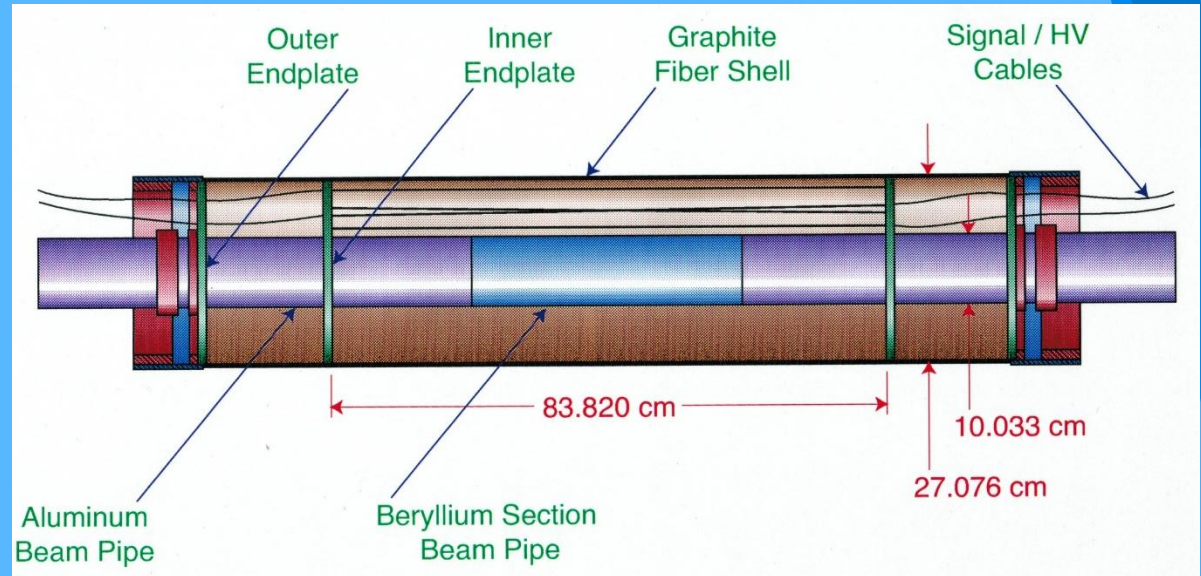
As delivered to CSU

Initially it was thought that the straws and sense wires were intact, and only the high pressure endplate needed to be repaired. (Front-end electronics also had to be replaced.)

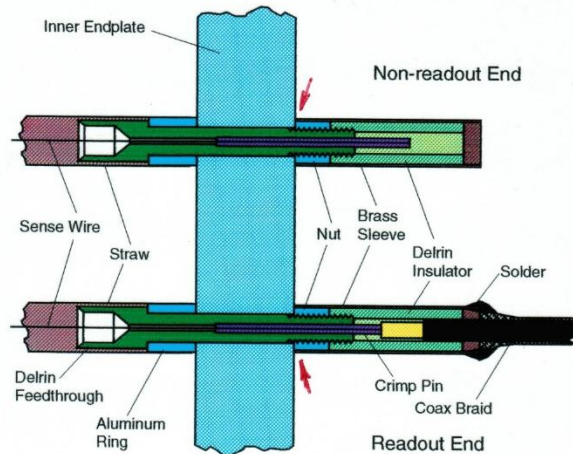
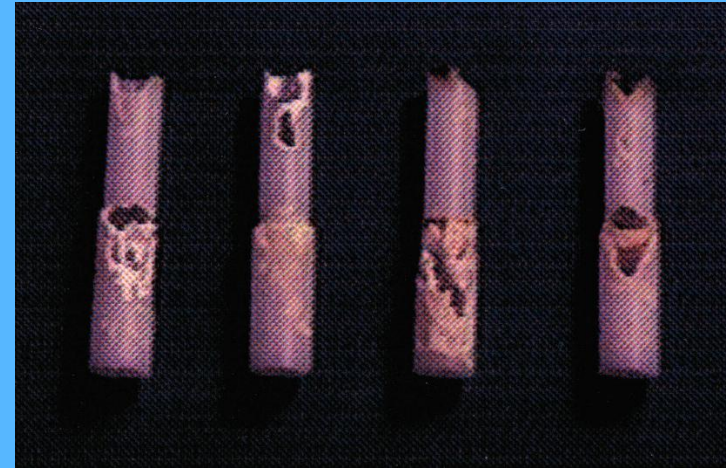
- 16% of the feedthroughs on the north inner plate were broken (46% on south, but disassembly was much quicker).
- ➔ About 1/3 of all channels affected.
- ➔ Breaks are between endplate and aluminum nut.

- More complex chemistry could be happening. DuPont says the following combination causes damage to Delrin:
  - 1) Zinc/zinc alloy (e.g. brass) in contact with acetal resin (Delrin).
  - 2) Halogen (F, Cl, etc.; common component of solder rosin).
  - 3) Intermittent moisture (Ar/ethane was bubbled through water).

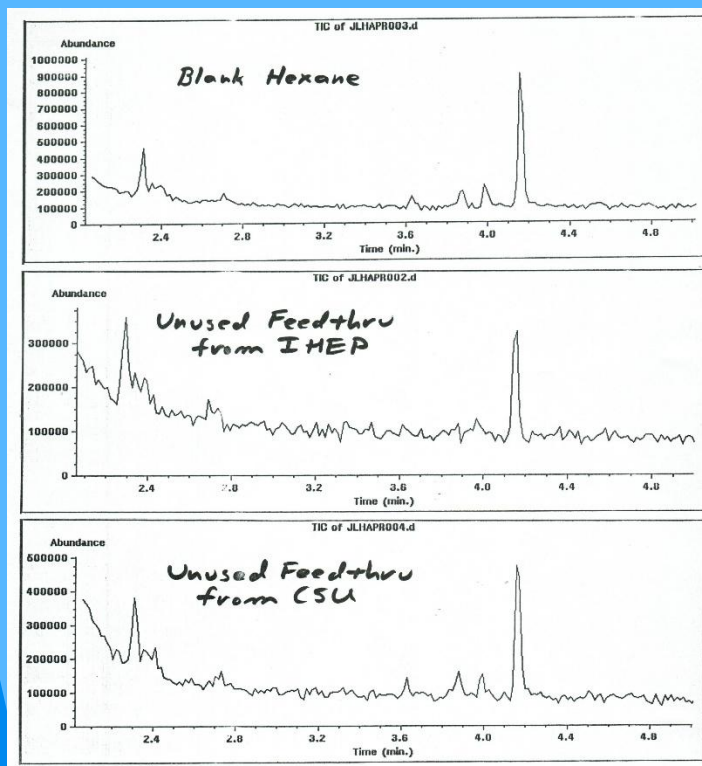
# Hexane Wash and Gas Chromatograph

- High current draw noticed on MDCII.
- Prototype chamber at IHEP also developed high current.
- Feedthroughs on HV at CSU showed similar behavior.
- Feedthroughs were checked for surface contamination (hexane wash and gas chromatograph). They were clean.
- Used and unused feedthroughs were returned to CSU for evaluation.
- Feedthroughs were examined in SEM.
- Samples were sent to DuPont for evaluation.

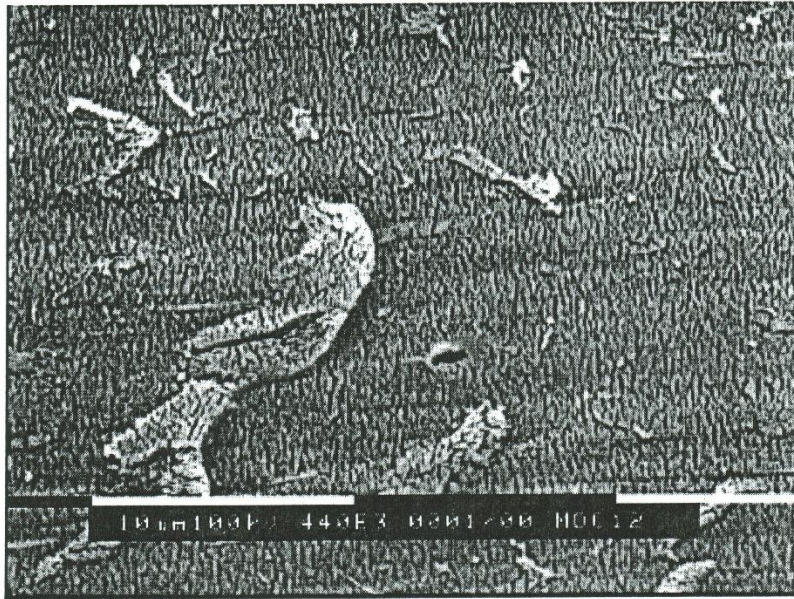
Unused Feedthrough: ~1 micron cracks

Figure 2. Micrograph of the outer surface of an unused MDC-II feedthrough. The first white bar in the information strip is 10 microns long. The feedthrough axis is horizontal in this picture. The widths of the cracks in the picture are less than 1 micron.

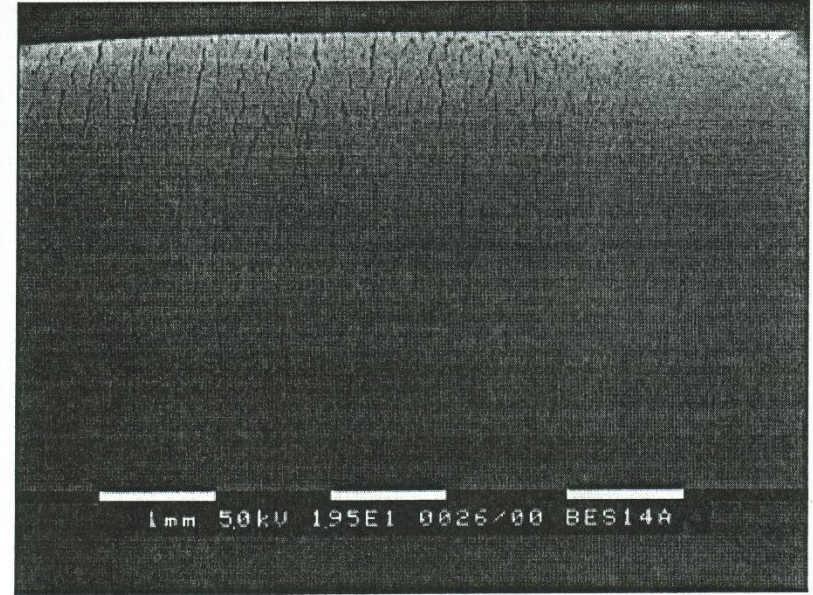
Used Feedthrough: ~10 micron cracks

Figure 3. Micrograph of the outer surface of an MDC-II feedthrough that was used in the prototype at IHEP. The first white bar in the information strip is 1 mm long. Nearly the full diameter of the feedthrough is seen. The width of the largest cracks is on the order of 10 microns.

The feedthroughs shrank with time, opening stress cracks, which enlarged in the high electric field of the endplates, degrading dielectric properties of the feedthroughs to the point of failure.

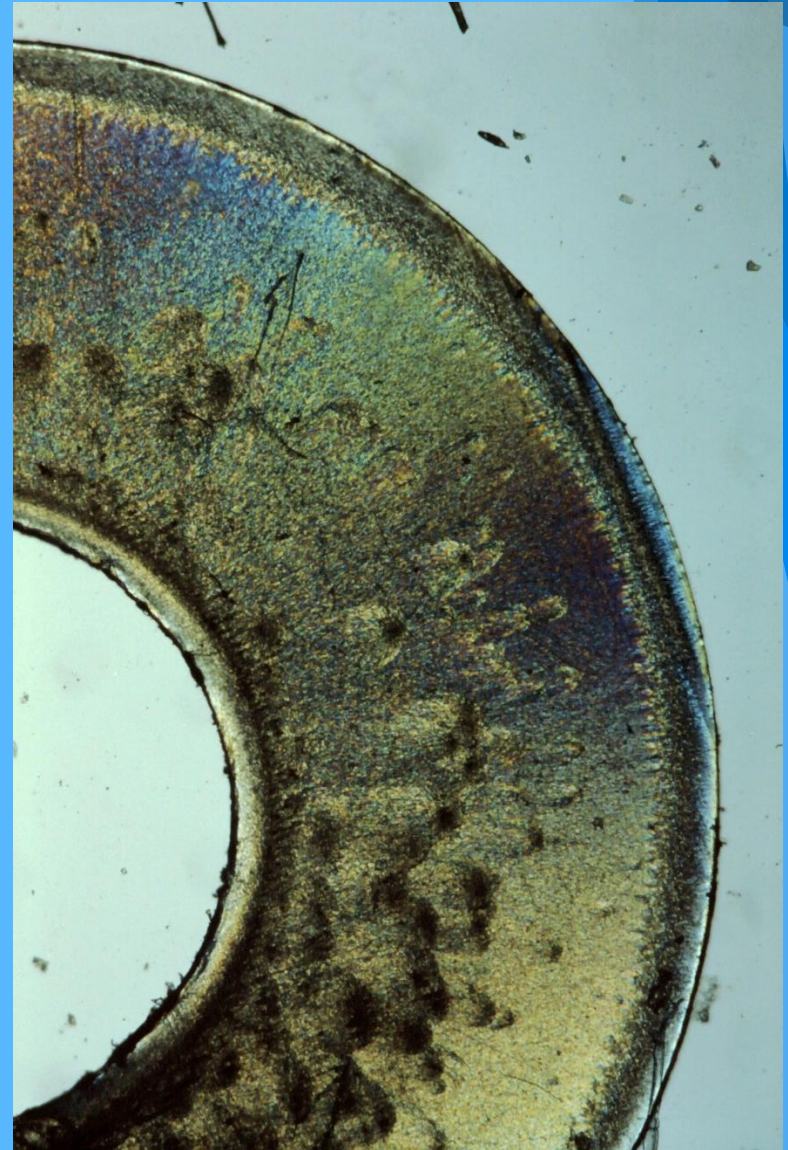
The parts that you sent to us were analyzed by use of MSA. In the enclosed picture you can see that the crystalline structure of the material is not good at the surface. This is usually due to cold mold temperatures or cold melt. Also, if the part is molded around a core pin that is not heated, this will also cause cold melt.

After showing your part to the Delrin® product specialist and another chemical engineer, they said that long term application of voltage could cause this kind of stress cracking, but since we have not done any testing of this kind, we could not say for sure. Exposure to glues, epoxies, or other solvents could accelerate this kind of stress cracking.
