FeCrAIY and TiN coatings on T91 steel after irradiation with 72 MeV protons in flowing LBE

Y. Dai, V. Boutellier, R. Restani, H. Glasbrenner* H.P. Linder, D. Gavillet, A. Weisenburger**, W. Wagner

Paul Scherrer Institut, Switzerland * Swiss Federal Nuclear Safety Inspectorate(ENSI), Switzerland ** Forschungszentrum Karlsruhe GmbH, IHM, Karlsruhe, Germany

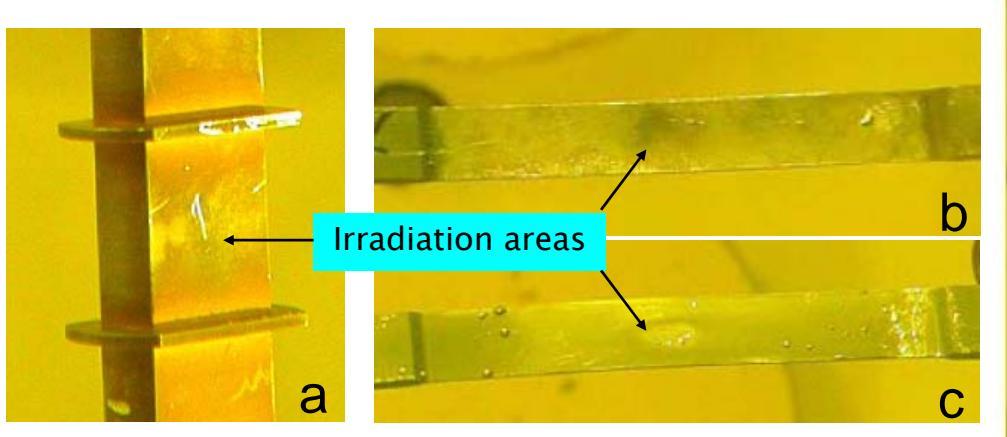
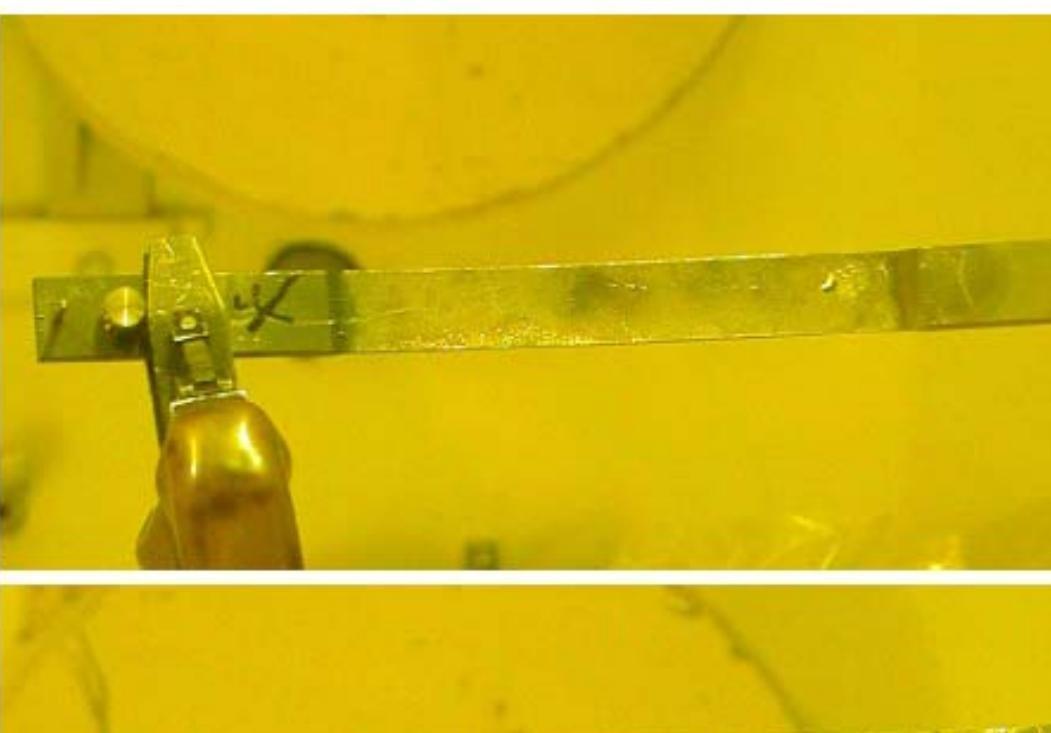
Lisor6 – Stressed Specimen

Sample bent during irradiation: \Rightarrow non-centric position in the test section tube \Rightarrow dpa-correction

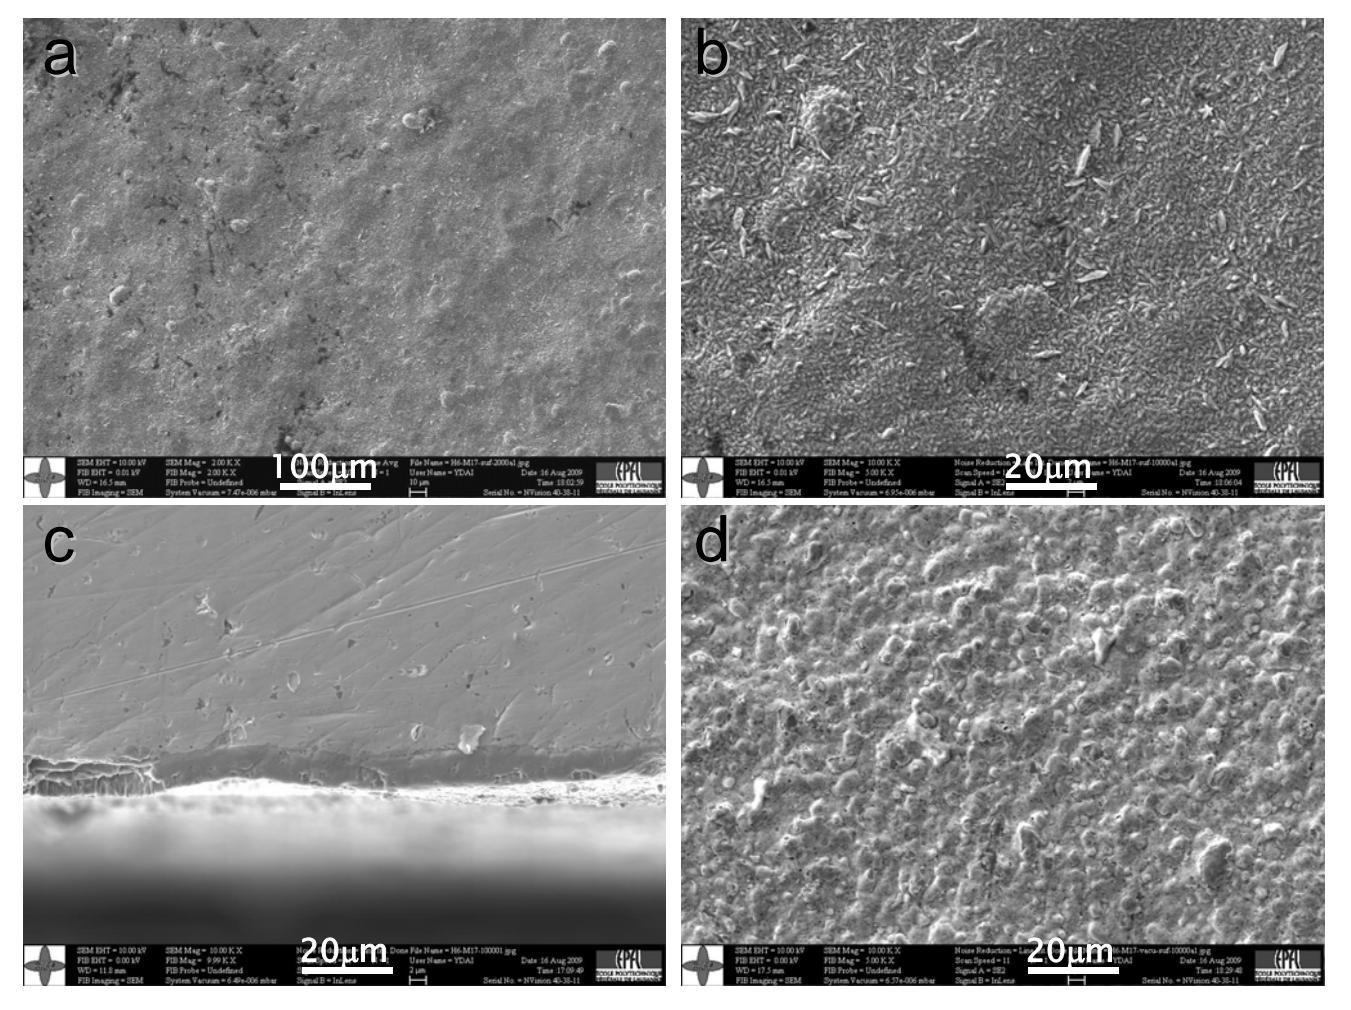
SEM Inspection TiN coating, irradiated to 1.8 dpa

c: surface facing to flowing LBE; d: surface facing to vacuum. No evident damage.

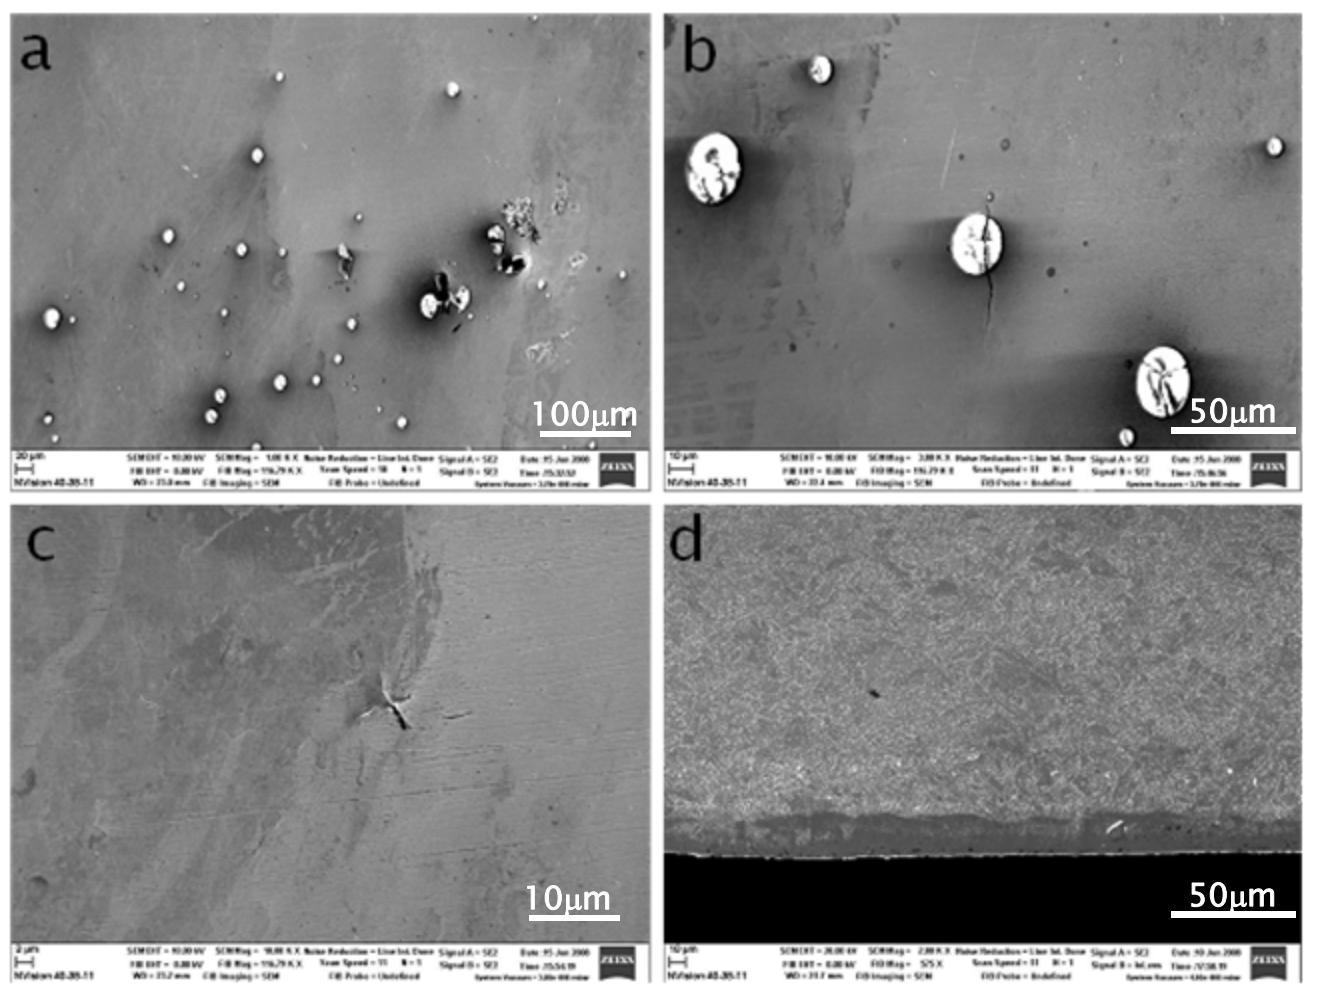
SEM Inspection FeCrAlY/GESA coating, unirradiated

With some micro-cracks and AI/Y oxides on surface

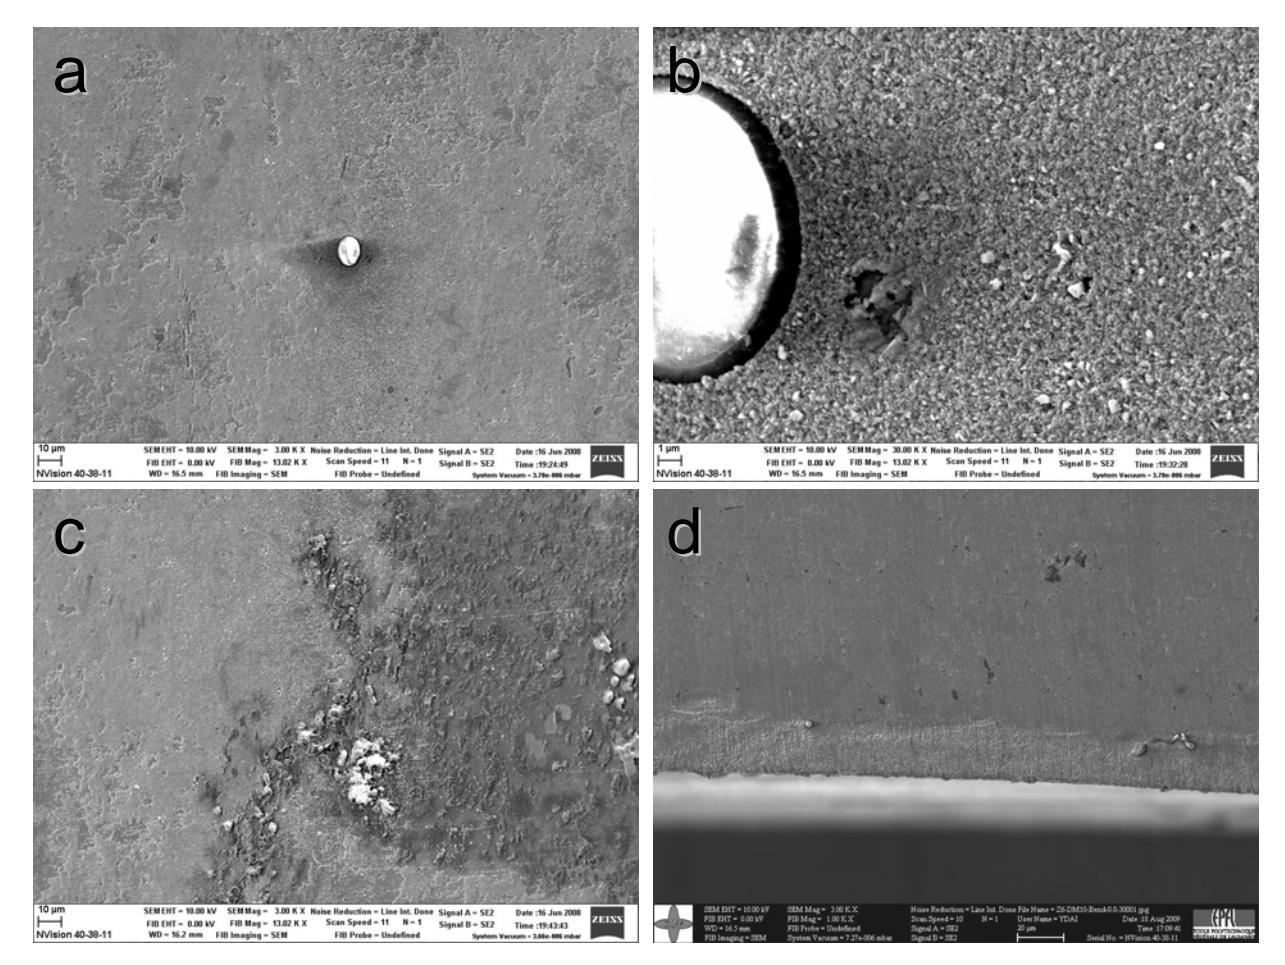
SEM Inspection FeCrAlY/GESA coating, irradiated to 2.5 dpa

surface facing to flowing LBE: slightly oxidized, no evident damage

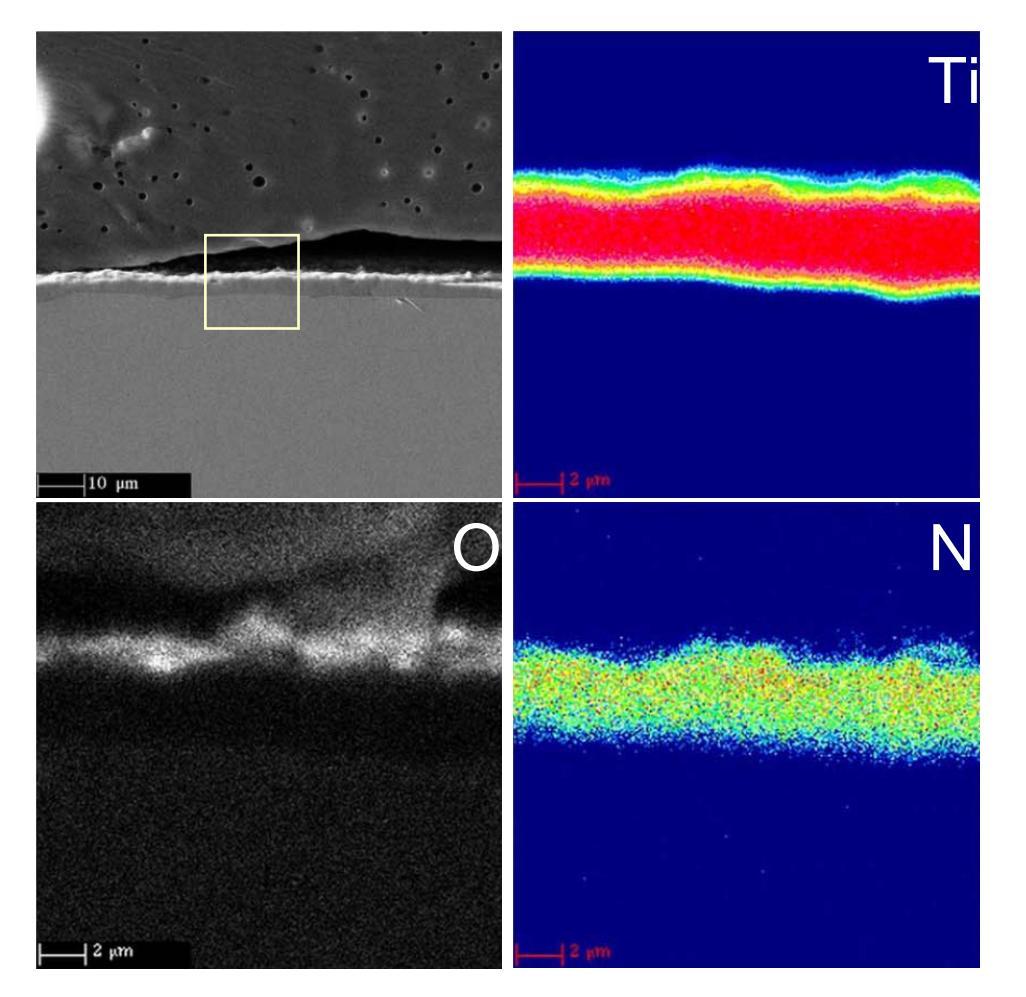
EPMA Inspection TiN coating, irradiated to 1.8 dpa

Confirm SEM observations: no evident damage

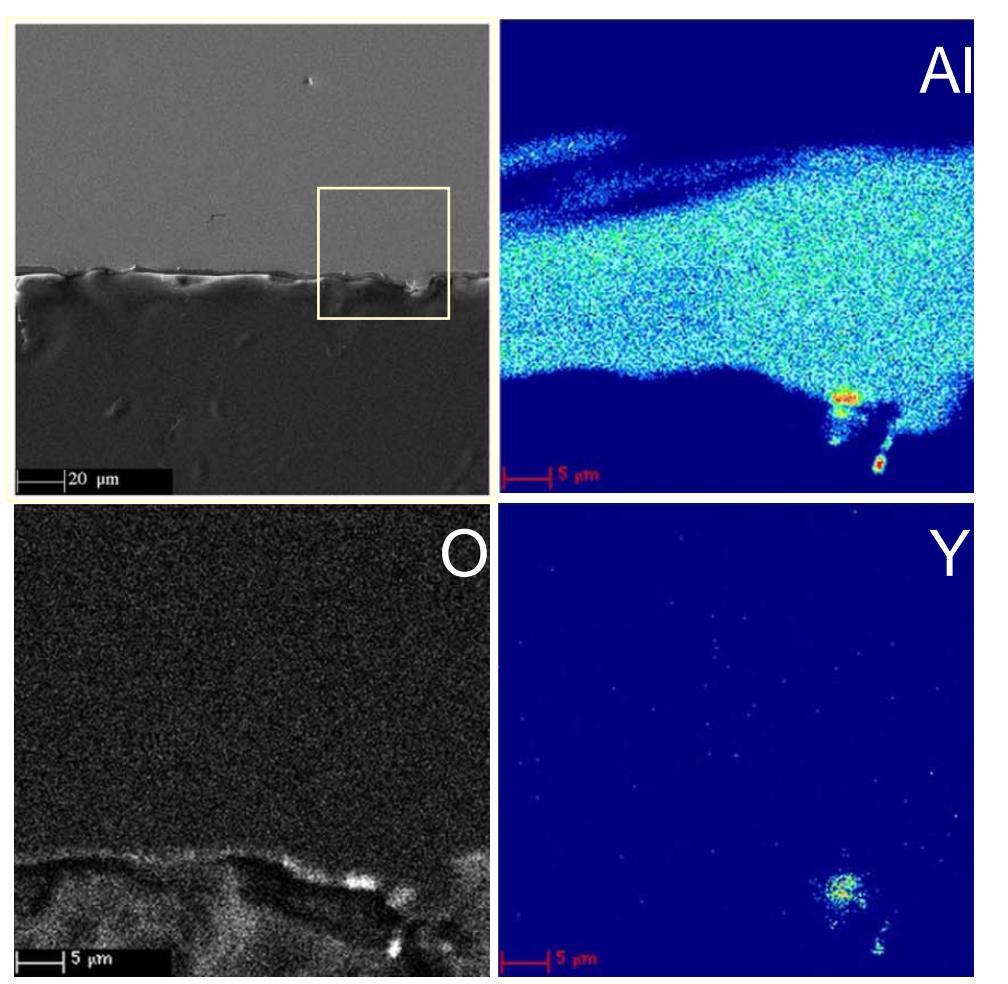
EPMA Inspection FeCrAlY/GESA coating, irradiated to 2.5 dpa

Confirm SEM observations: no evident damage, AI/Y oxides on surface
