CGEM Insertion Test

Stefano Gramigna on behalf of the working group IDC Upgrade Meeting - 2024/07/08

Insertion Test

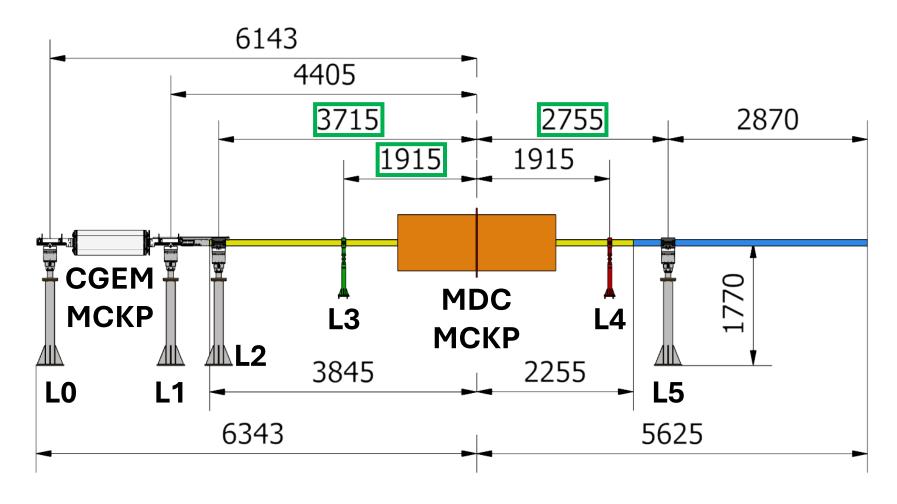
L5 could not be bolted directly to the floor due to the presence of some pipes

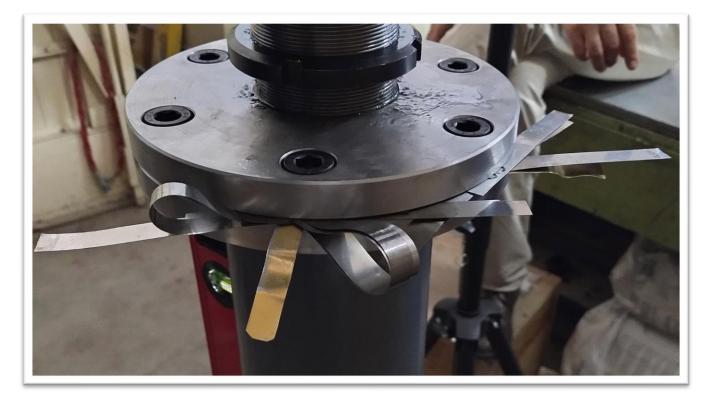
Issues with New Legs' Production

UNSATISFACTORY QUALITY OF PARTS PRODUCTION

"Workarounds" are necessary to make the legs usable

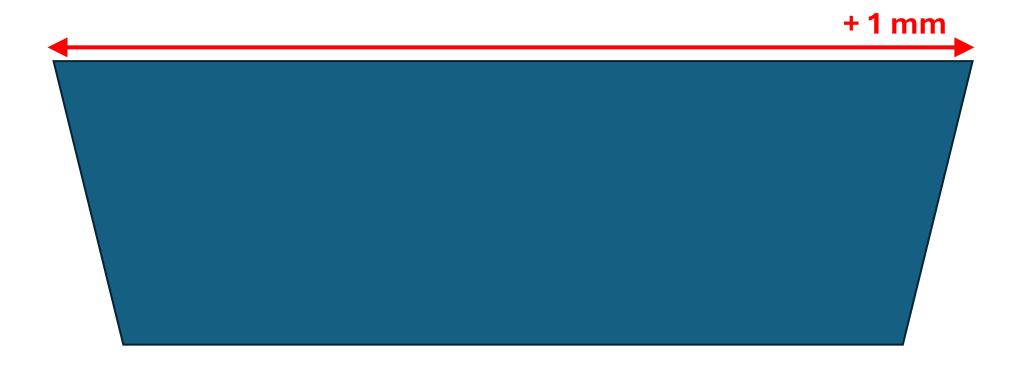
Asymmetry of the MDC Mock-up

The MDC mock-up is 1 mm longer on the top Shims had to be used to compensate this effect and test CGEM anchoring

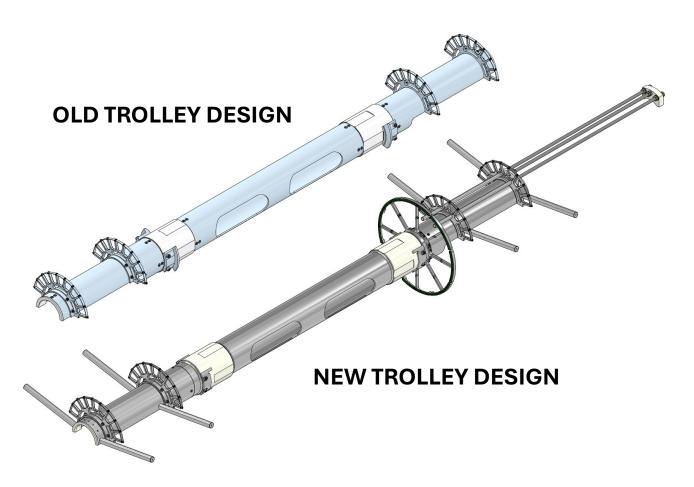
The old insertion trolley was **prone to bending** at the PTFE joints between
aluminum pipe sections

→ Great risk for the detector

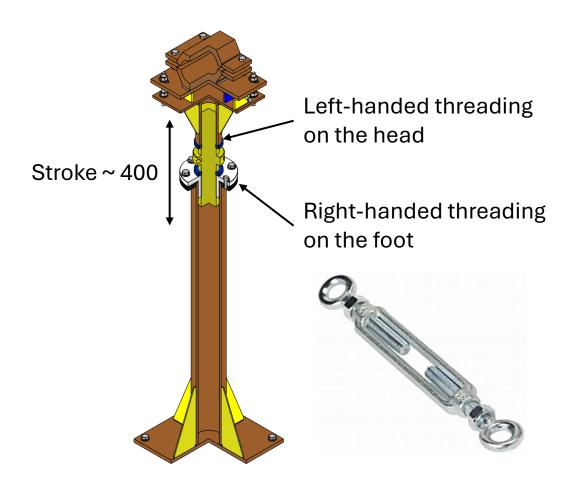
When **adjusting the height** under load, friction may transfer torque to the head

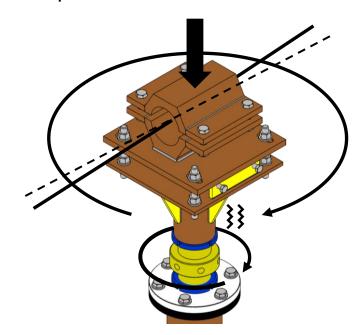
Uncontrolled movement in the horizontal direction

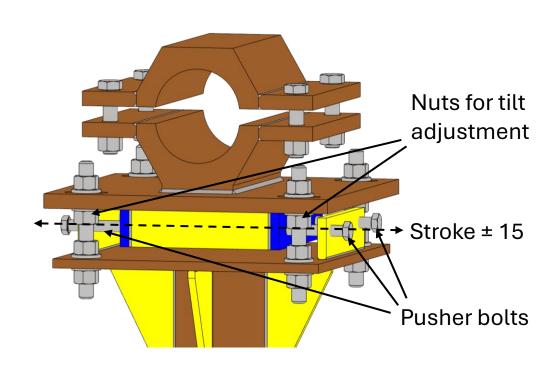
Unlocking the nuts to adjust tilt or horizontal position leads to uncontrolled movement of the rail in the vertical direction
