Mini TPC at Saclay : update

Boris Tuchming

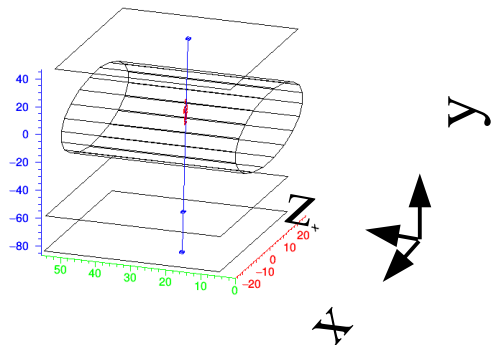
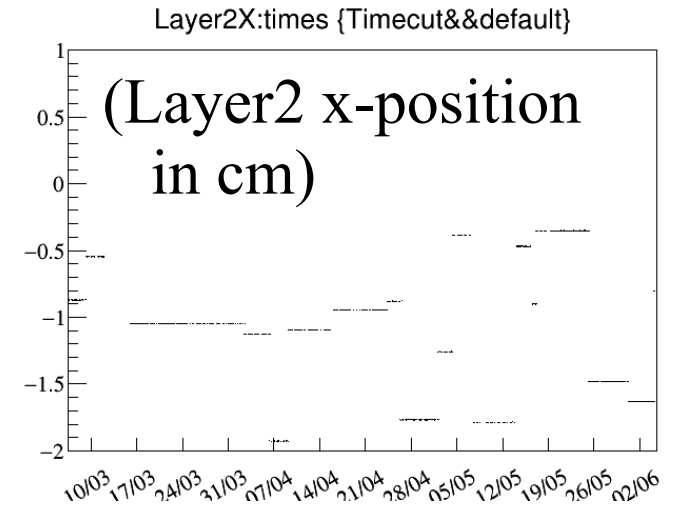
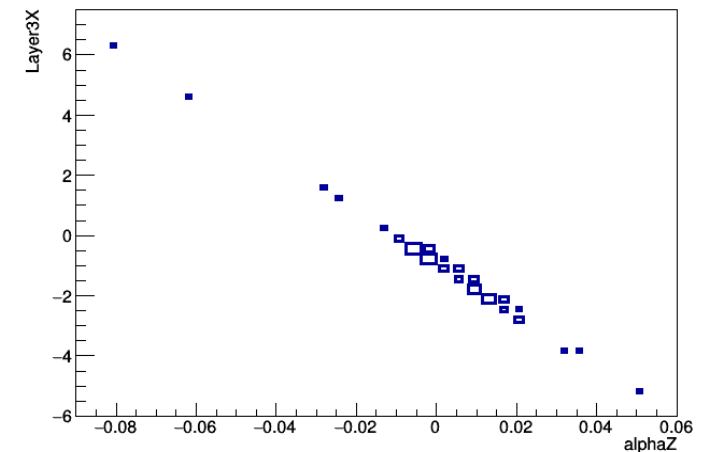
Layer3x- vs rotation
around Z-axis, in different runs

- They should be equal over a short period as we don't move the detectors
- They are not

- Evidence of degeneracy in fit outputs:
Not enough sensitivity to disentangle a rotation of TPC from a translation of Multigen ?
- Note: this does not track resolution
- This is a problem when you compare an absolute (x,y,z) coordinate between different runs (eg for Tomography)

- Fixed two rotations (around z-axis and x-axis)

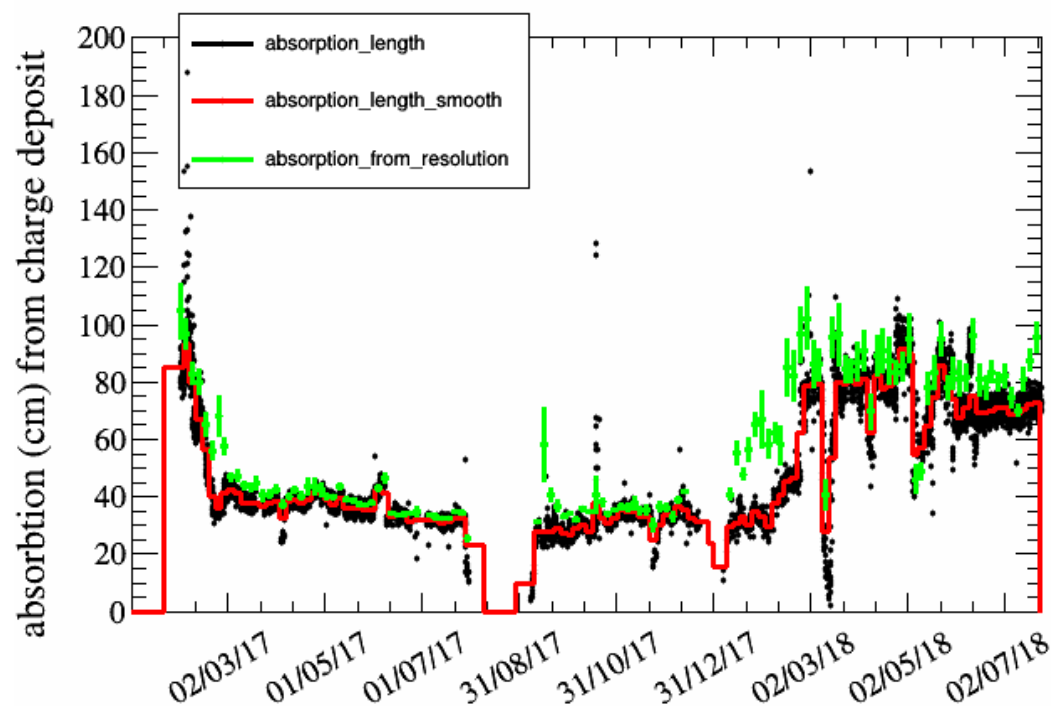
- Too large absorption in gas (electron capture) affecting resolution.
- Presumably O2 outgasing or leakage.
 - Suspected something wrong in gas.
 - In July, changed 10 m of gas pipe. Was nylon, now aluminum coated pipe.
 - No visible change. Now suspect a leakage in some pipe connector, or O2 in the Argon bottle

green: e- capture determined from resolution vs z
 red e- capture determined from charge vs z

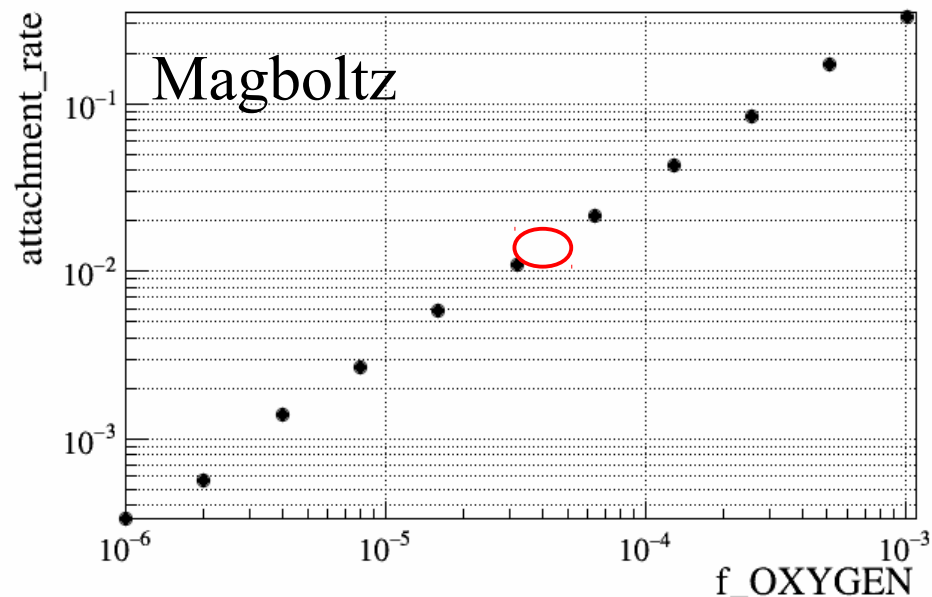
attachment_rate:f_OXYGEN

Attachment $\sim 1/80 \text{ cm}^{-1} \leftrightarrow f_{\text{O}_2} \sim 3\text{E}-5$

This is expected from atmosphere due to a leak of $\sim 1.5 \text{ ml/hr}$

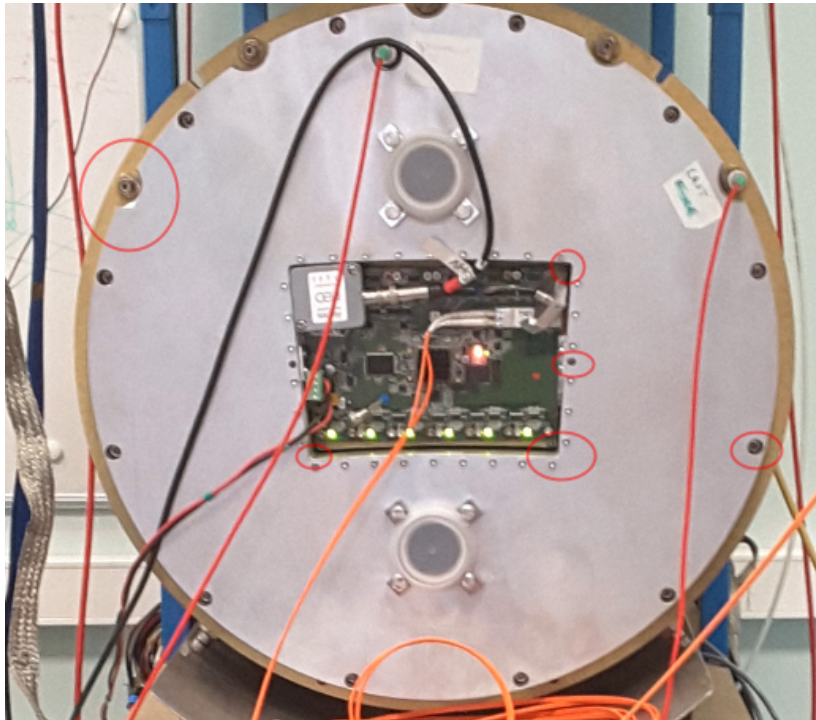
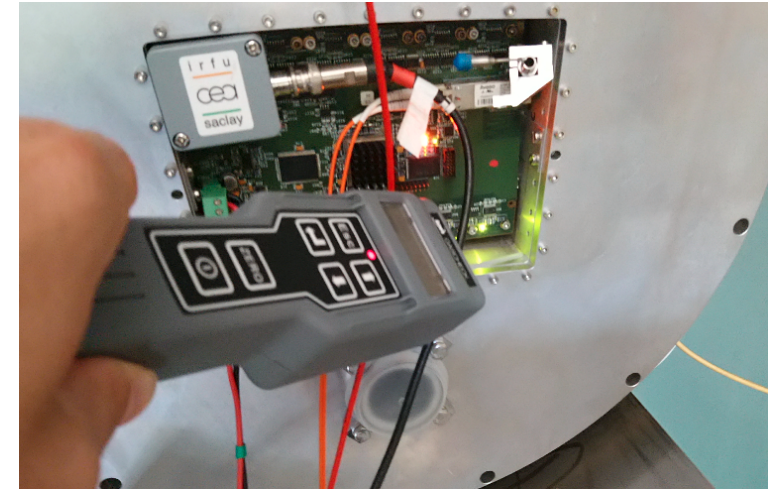
Test with a gas sniffer

- Use a gas sniffer to detect any Argon leakage
- Several leaking zones have been spotted where Oxygen may flow in

- Need to open in clean room to fix the most important leak
- This should happen in a few weeks, as there are some plans to change the module with a new prototype (designed to get 100% of the 1728 channels responsive)
