The experience of the MEG II drift chamber

The 2020 International Workshop on the
High Energy Circular Electron Positron Collider

Marco Chiappini
INFN Pisa (Italy)
October 26, 2020

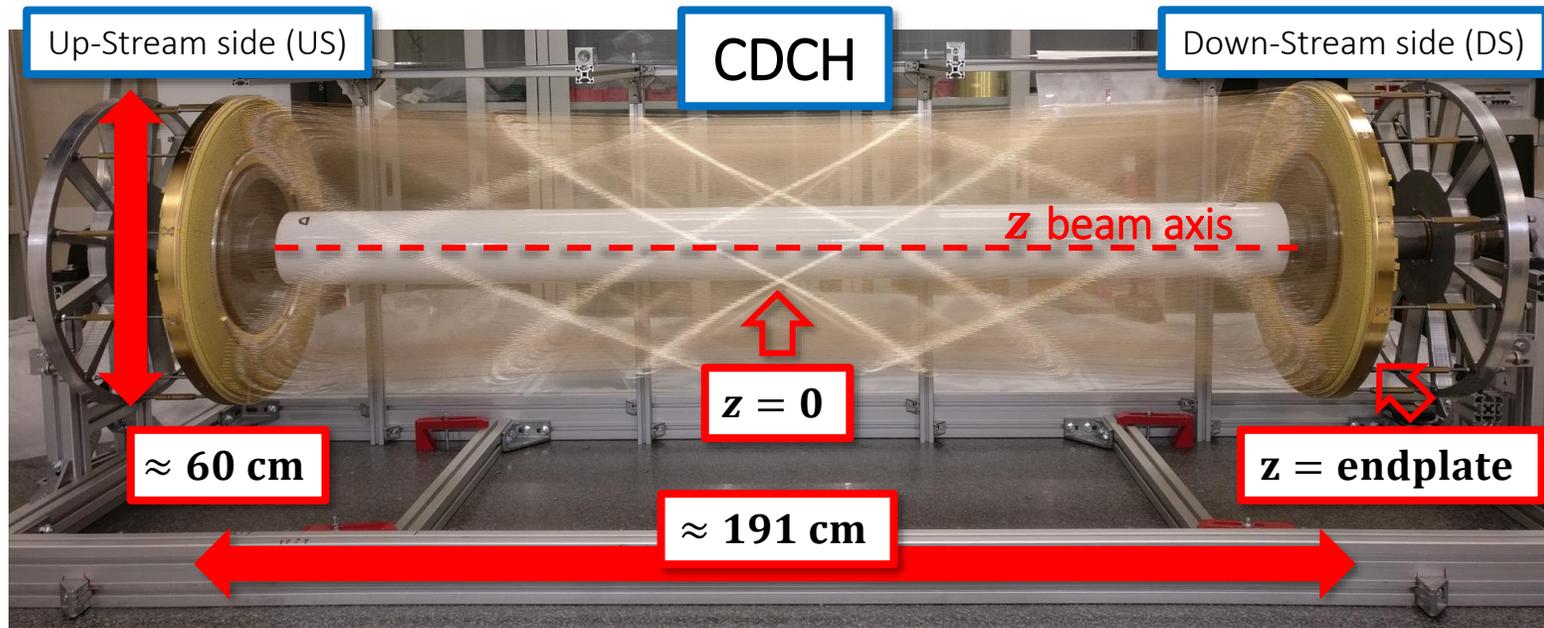
The MEG II Cylindrical Drift Chamber

e^+ variable	MEG	MEG II
ΔE_e (keV)	380	90
$\Delta\theta_e, \Delta\varphi_e$ (mrad)	9, 9	6, 5.5
Efficiency $_e$ (%)	40	65

- Low-mass unique volume detector with high granularity filled with He:Isobutane 90:10 gas mixture
 - 9 concentric layers of 192 drift cells defined by 11904 wires

- Small cells few mm wide: occupancy of ≈ 1.5 MHz/cell at CDCH center near the stopping target
 - High density of sensitive elements: **x4 hits more than MEG drift chamber (DCH)**

- Total radiation length $1.5 \times 10^{-3} X_0$: less than $1.7 \times 10^{-3} X_0$ of MEG DCH
 - MCS minimization and γ background reduction (bremsstrahlung and Annihilation-In-Flight)

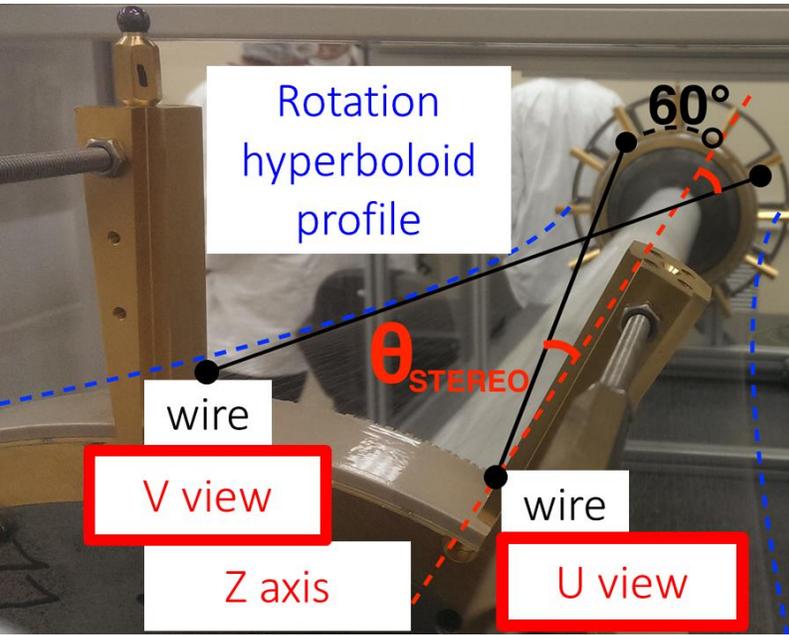
Stereo wires geometry for longitudinal hit localization

- $\theta_{stereo} \approx 6^\circ \div 8.5^\circ$ as R increases

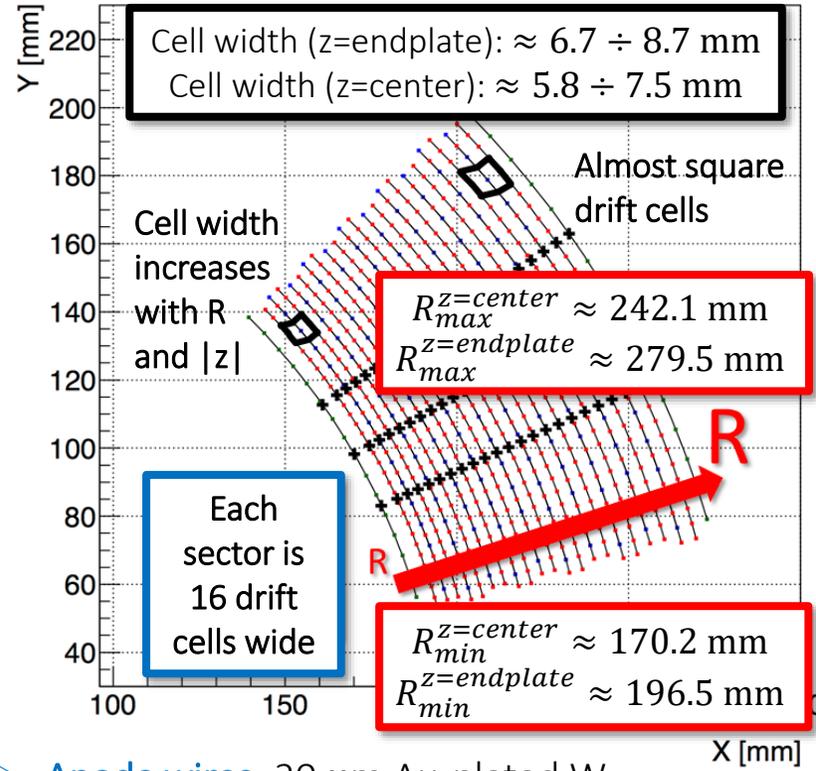
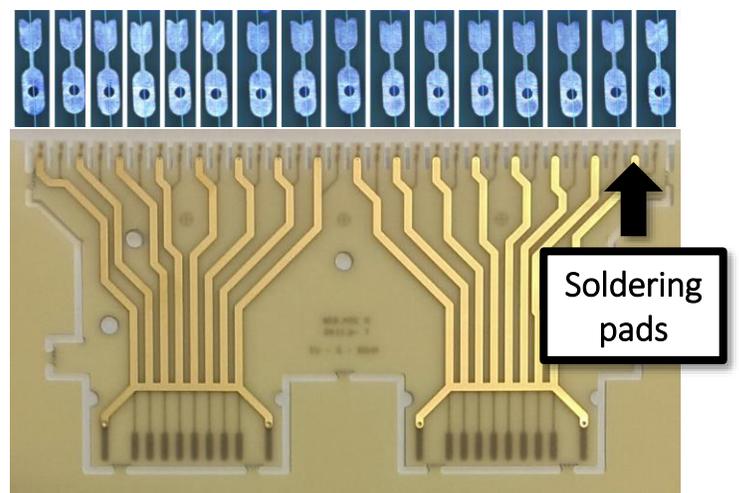
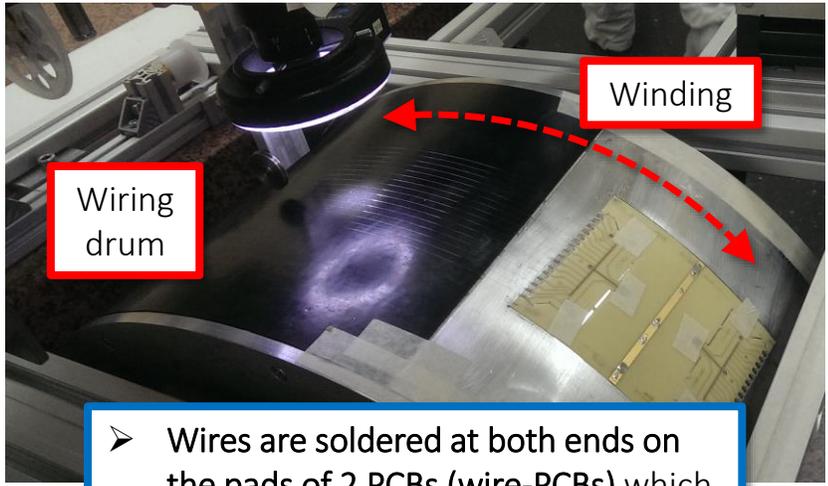
Endplate

- Wires are soldered at both ends on the pads of 2 PCBs (wire-PCBs) which are then mounted in proper slots of the CDCH endplates
- Wiring inside a cleanroom

- Anode wires: 20 μm Au-plated W
- Cathode wires: 40/50 μm Ag-plated Al
 - 40 μm ground mesh between layers
- Guard wires: 50 μm Ag-plated Al
- Field-to-Sense wire ratio 5:1

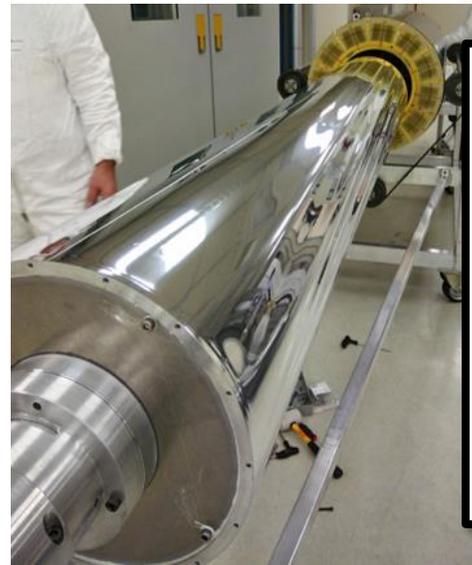
- 20 μm -thick aluminized Mylar foil at inner radius
- To separate the inner beam + target volume filled with pure He from the wires volume filled with He: IsoB 90:10 mixture

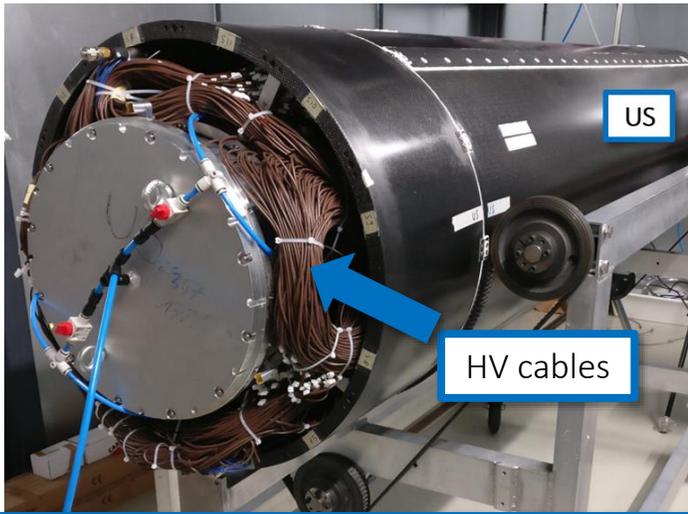
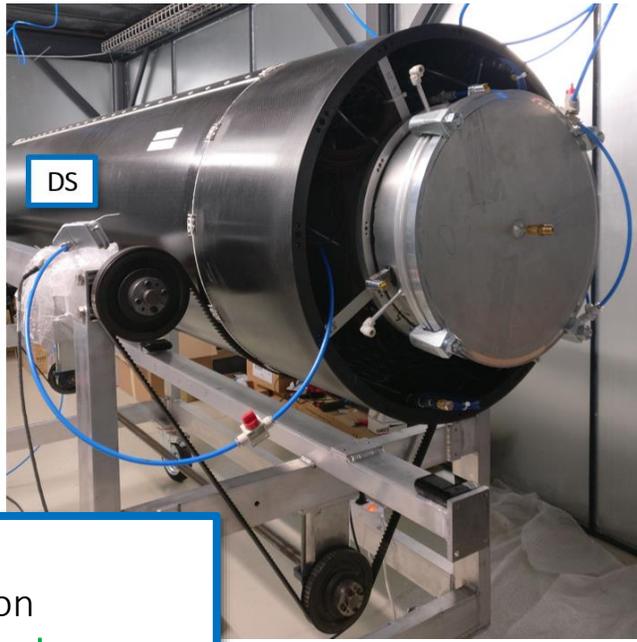
- External CF structure
 - Structural + gas tightness function
- CDCH mechanics proved to be stable and adequate to sustain a full MEG II run

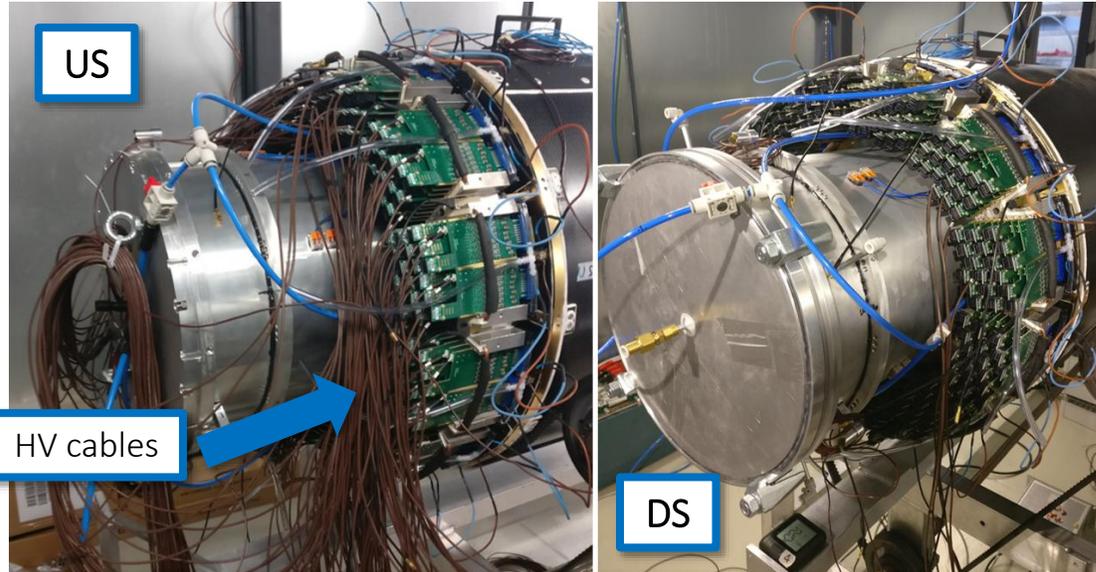
FE electronics

- 216 FE boards per side
 - 8 differential channels each to read out signal from 8 cells
 - Double amplification stage with low noise and distortion
 - High bandwidth of nearly 900 MHz
 - To be sensitive to the single ionization cluster and improve the drift distance measurement (cluster timing technique)
- Signal read out from both CDCH sides
- HV supplied from the US side

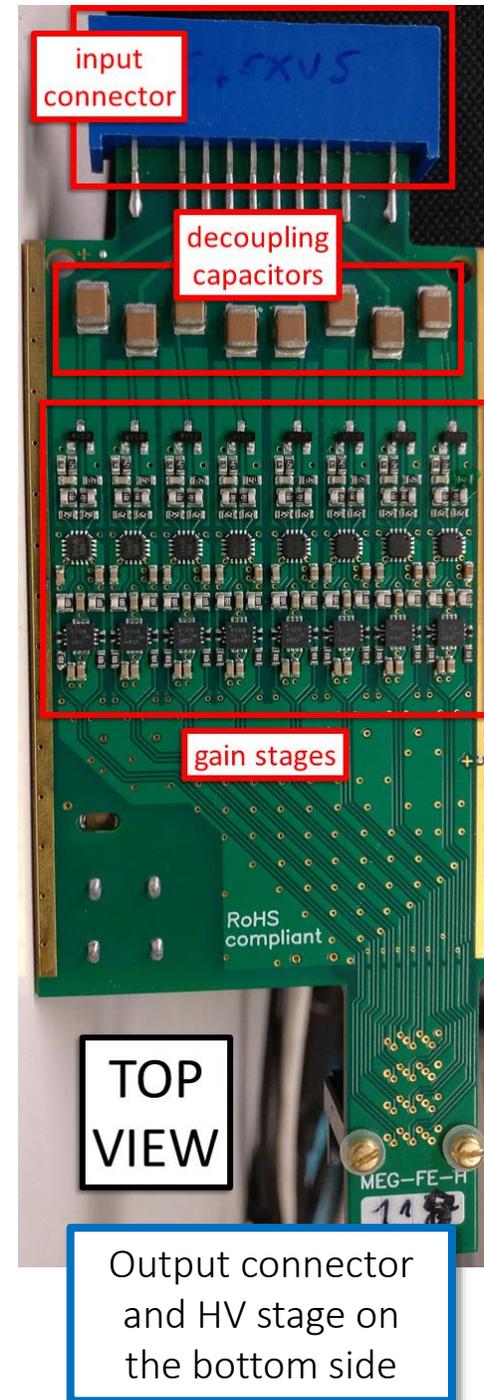
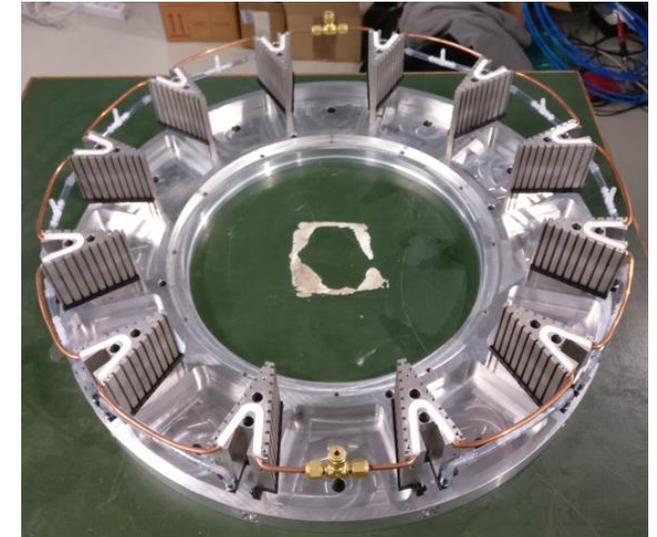
- FE electronics cooling system embedded in the board holders
 - Power consumption for each channel: 60 mA at 2.5 V
 - Heat dissipation capacity granted by a **1 kW chiller system**: 300 W/endplate
- Dry air flushing inside the endcaps to avoid water condensation on electronics and dangerous temperature gradients

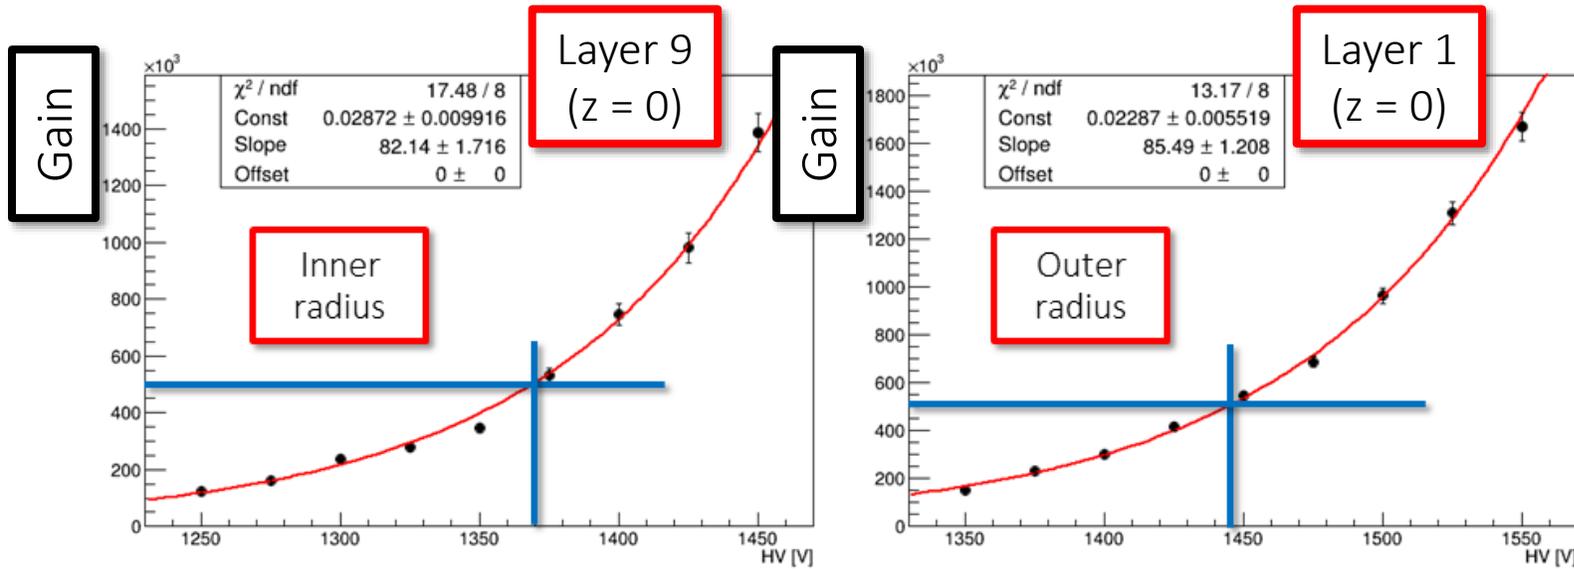
Expected gain variation vs. longitudinal coordinate z given the CDCH hyperbolic shape

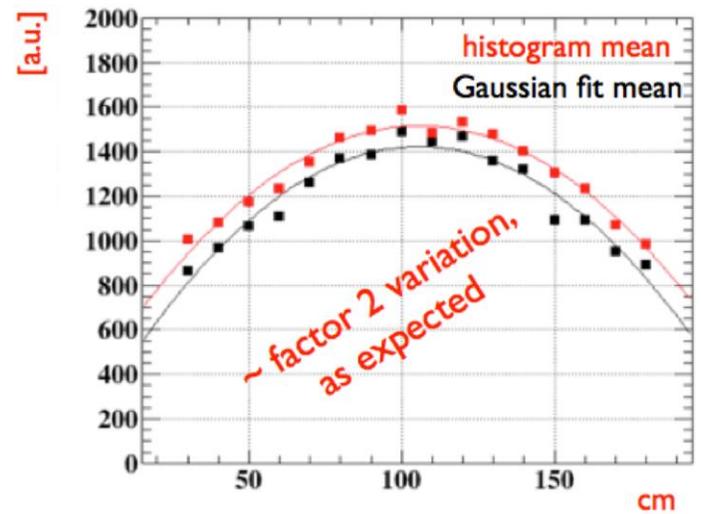
- Garfield simulations on single electron gain
 - Gas mixture He:Isobutane 90:10 and P = 970 mbar (typical at PSI)
- Working point → HV for gain $G = 5 \times 10^5$
 - To be sensitive to the single ionization cluster

HV tuning by 10 V/layer to compensate for the variable cell dimensions with radius and z

L1	L2	L3	L4	L5	L6	L7	L8	L9
1480 V	1470 V	1460 V	1450 V	1440 V	1430 V	1420 V	1410 V	1400 V

Average HV Working Point (WP) as a function of the layers

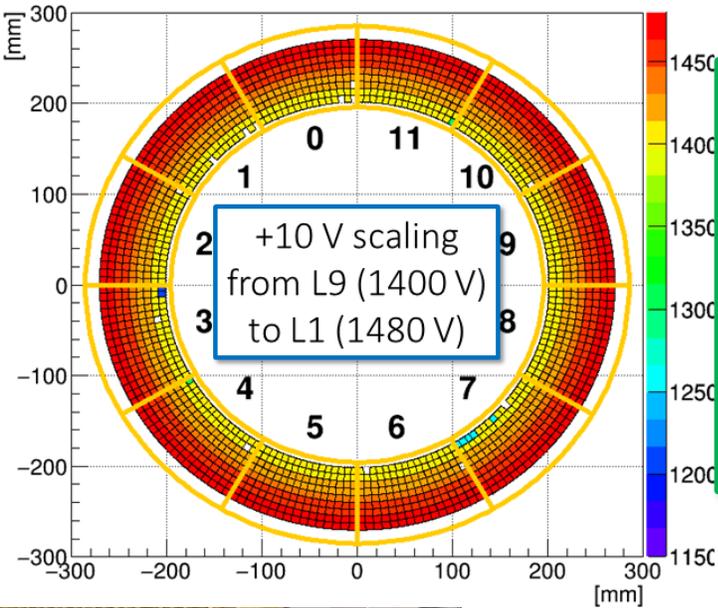
HV map working point (US endplate)

Cell inefficiency experimentally measured

- Negligible in e^+ reconstruction
 - 0.3% worsening in resolutions
- Tests with high statistics full MC

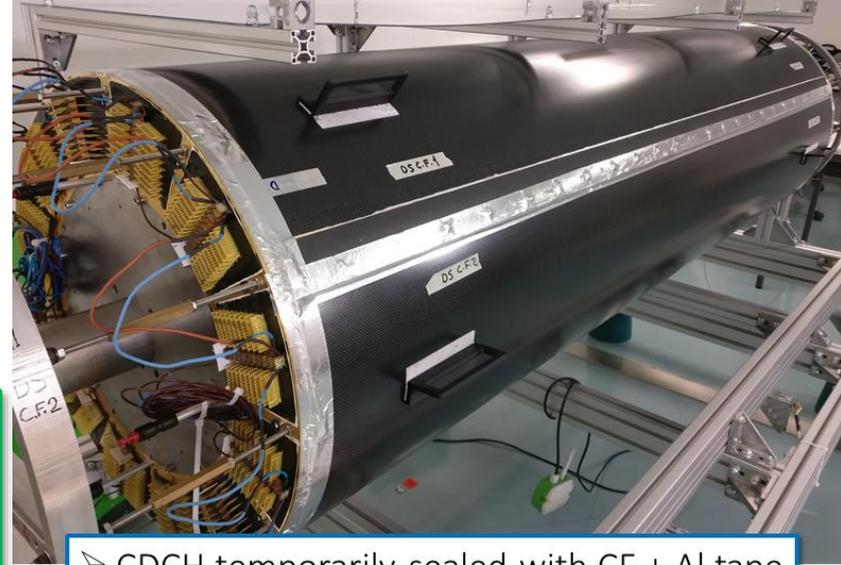
- CDCH temporarily sealed with CF + Al tape
- Nitrogen flux

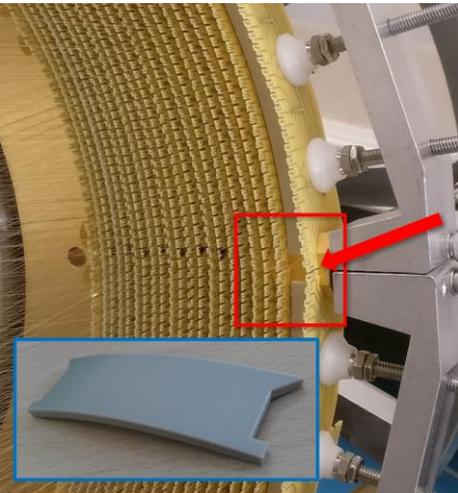
- Some drift cells at the border between 2 adjacent sectors presented electrostatic instability
 - Due to wire-PCB geometry
- Once the PEEK spacers are mounted the correct circular shape is expected to be recovered
- But sometimes deformations $O(\text{a few hundred } \mu\text{m})$ remain causing electrostatic instabilities
- HV kept at lower values for the involved cells

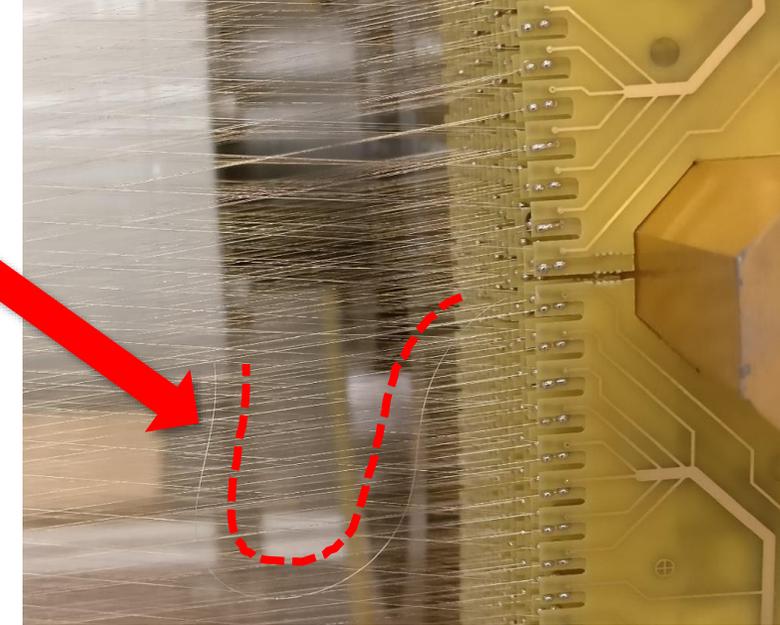
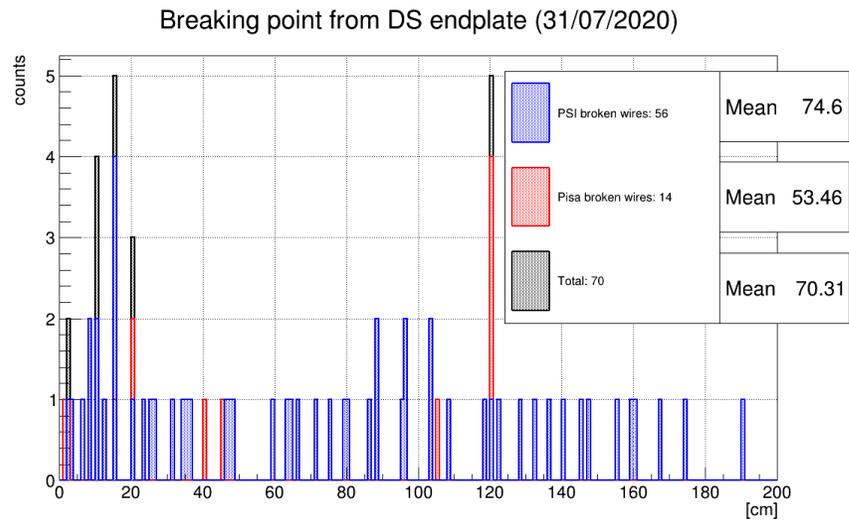
Broken wire

- During assembly at Pisa and the final lengthening operations at PSI we experienced the breakages of Al wires in the chamber
 - Mainly the 40 μm cathodes were affected
 - A few 50 μm cathodes and guards
- 70 broken wires in total during CDCH life (14 at Pisa)
 - 63 cathodes (40 μm)
- Consequent delay in construction and commissioning

Wires length ≈ 193 cm

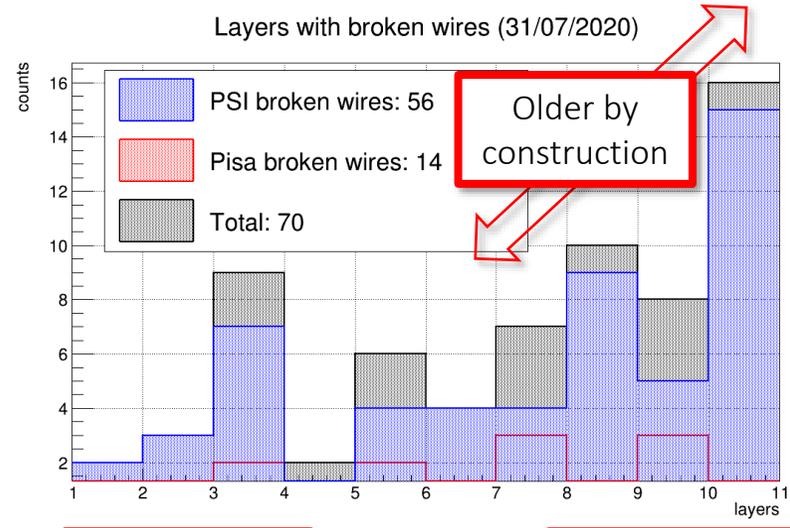
Outer layers

Inner layers

Older by construction

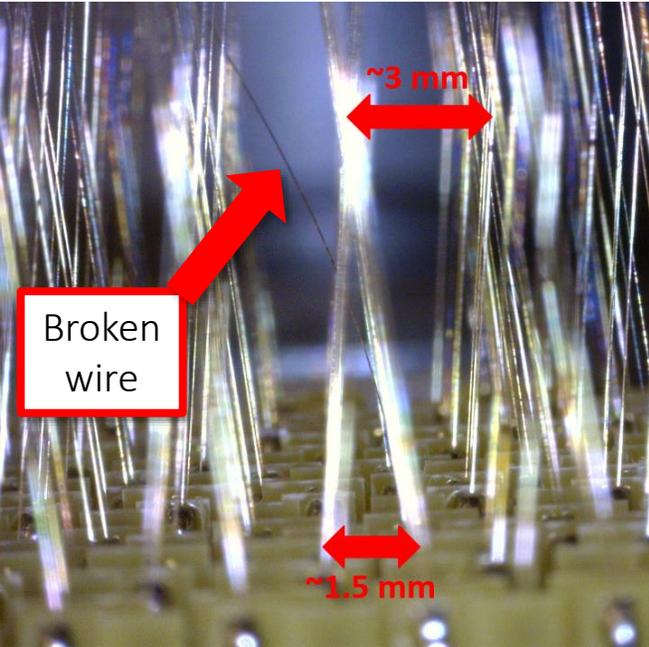
Broken wires extraction

- Each broken wire piece can randomly put to ground big portion of the chamber
- They must be removed from the chamber
 - Very delicate and time-consuming operation
- We developed a safe procedure to extract the broken wires from inside CDCH
 - Exploiting the radial projective geometry given by the stereo wire configuration

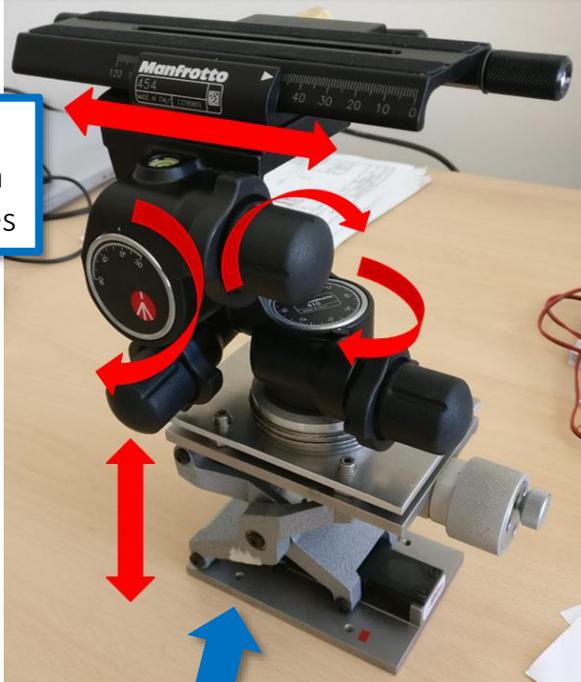
Commercial camera mount with precision movements for all axes

Example of extraction with a broken wire hooked by a stainless steel rod

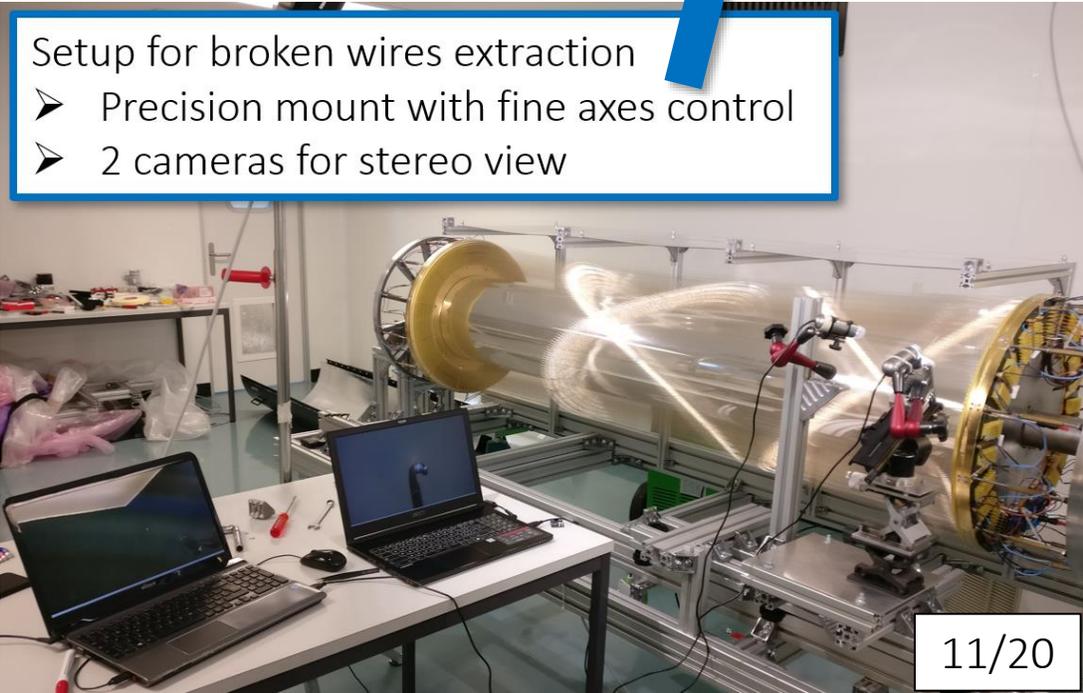
Setup for broken wires extraction

- Precision mount with fine axes control
- 2 cameras for stereo view

1. Enter with a small tool inside the chamber (few mm space)
2. Hook the wire piece as close as possible to the wire-PCB
3. Extract the wire segment
4. Pull it perpendicularly in the radial direction to break it at the soldering pad

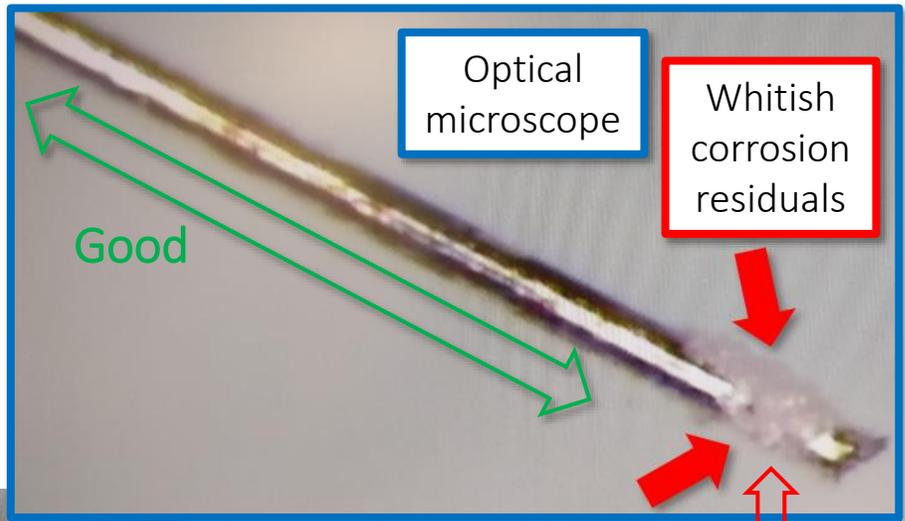
- Breakages due to corrosion of the Al wire core
- Two hypotheses
 1. Galvanic process between Al and Ag coating
 2. Al corrosion by Cl
- Both imply **water as catalyst**
 - Air moisture condensation inside cracks in the Ag coating even at low Relative Humidity (RH) levels < 40%
 - Al oxide or hydroxide deposits

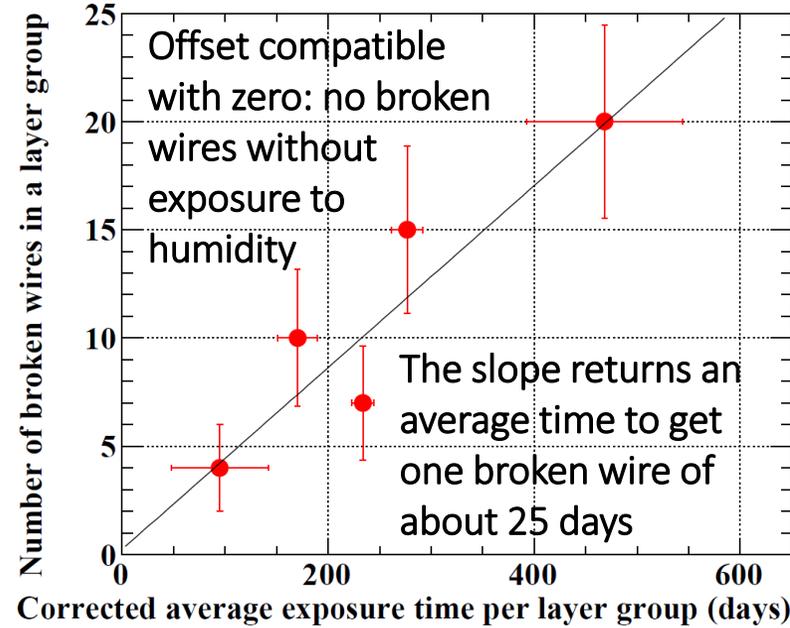
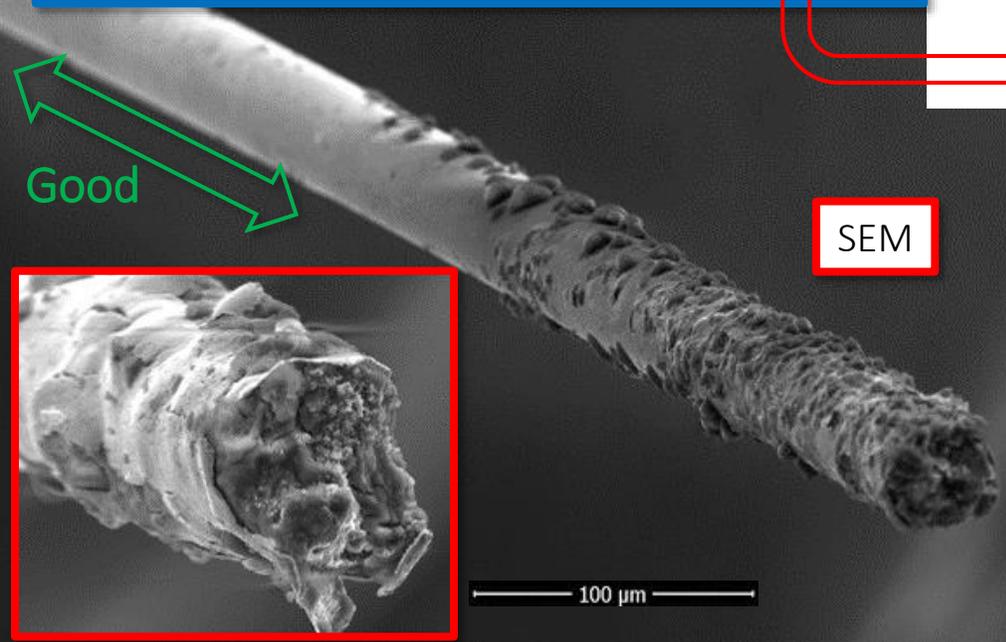
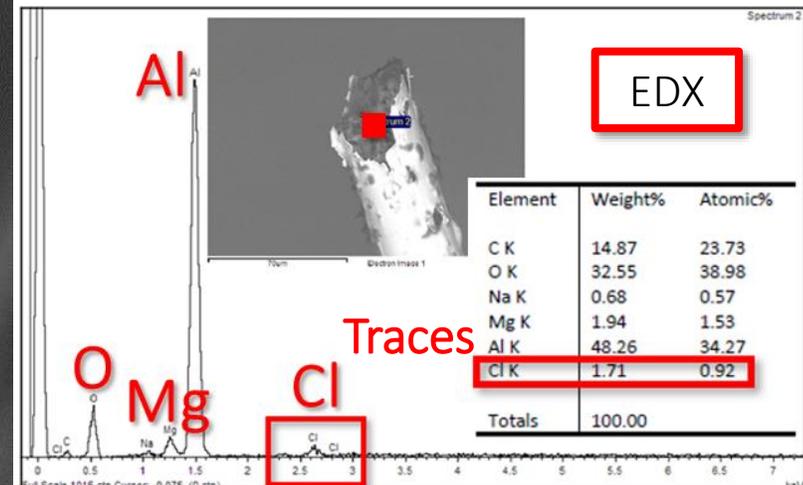
- Found a good linear correlation between number of broken wires and exposure time to humidity
- The only way to stop the corrosion is to keep the wires in an inert atmosphere
- No more broken wires due to corrosion for 2 years since CDCH was flushed with Nitrogen or Helium once sealed

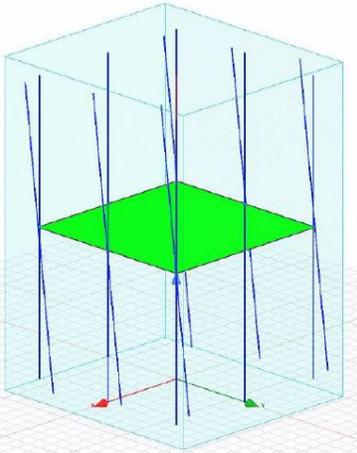
Ideal case

ANSYS 3D model

E field

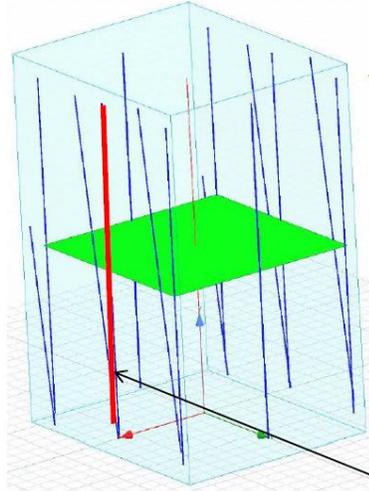
Missing wire removed

ANSYS 3D model

E field

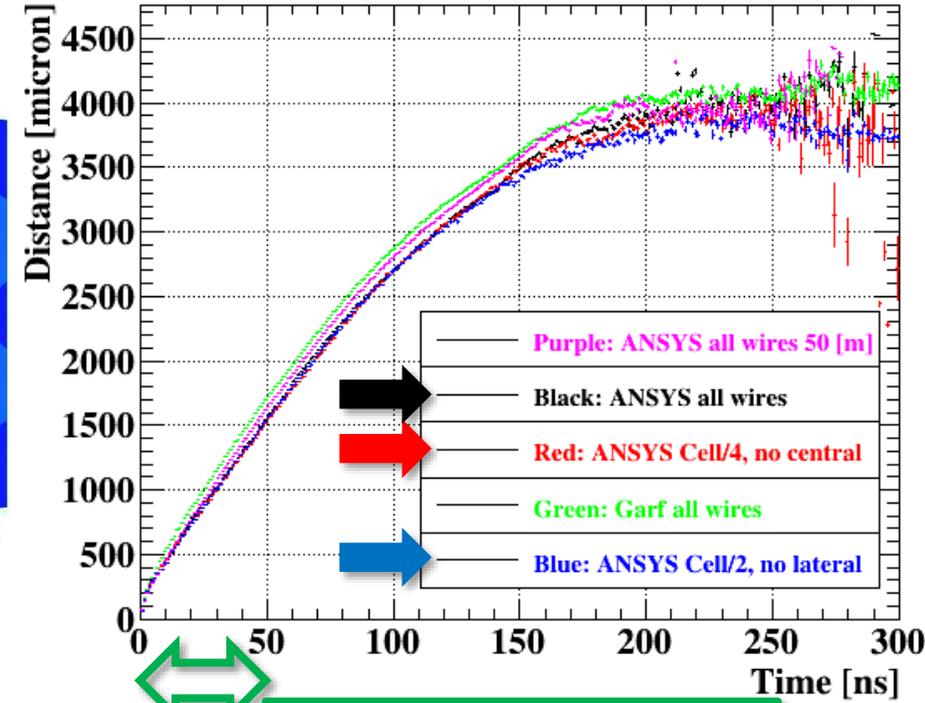
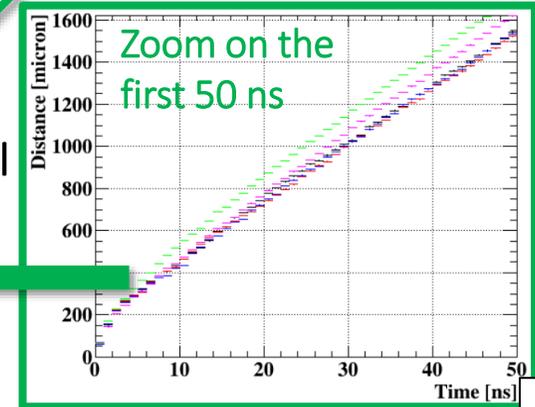
Drift distance vs. drift time relations computed with Garfield

- Study the effect of a missing cathode on isochrones → e^+ reconstruction
- Used Garfield and ANSYS to simulate the electric field in a $6 \times 6 \text{ mm}^2$ representative drift cell
 - Single-hit resolution $\sigma_{hit} < 120 \mu\text{m}$
 - Difference between different curves → $\approx 10 \mu\text{m}$
- Missing wire effect negligible

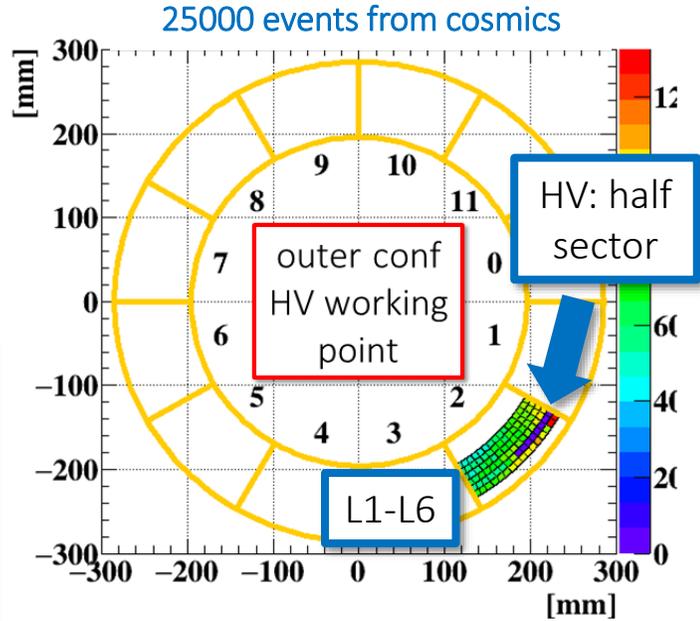
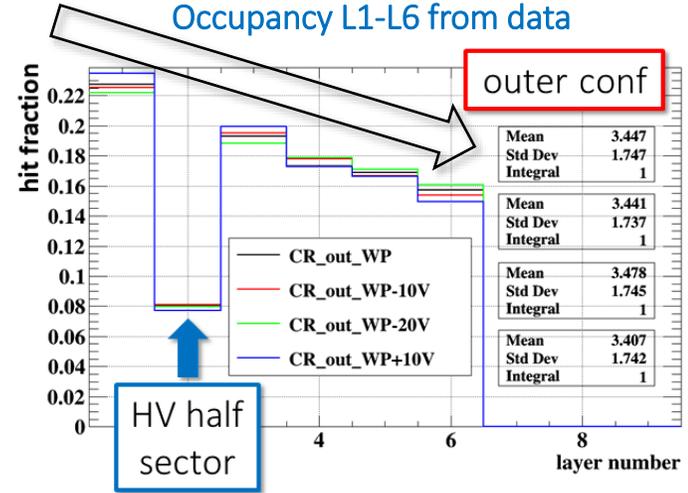
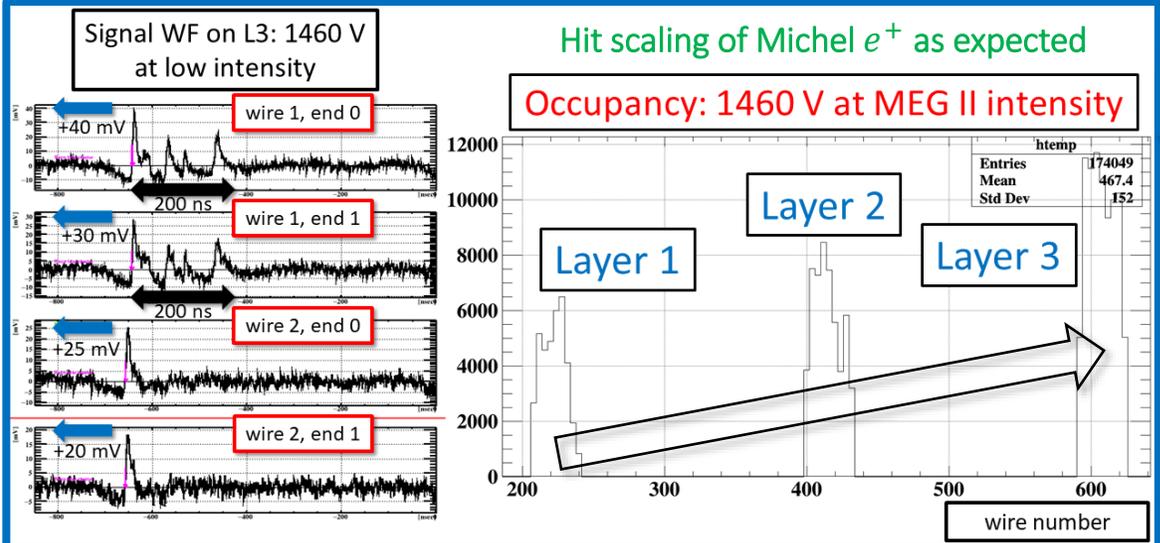
μ^+ beam

- Hit scaling as expected from the outer layer (L1) to the inner layer (L9)
- Different HV configurations tested around the working point

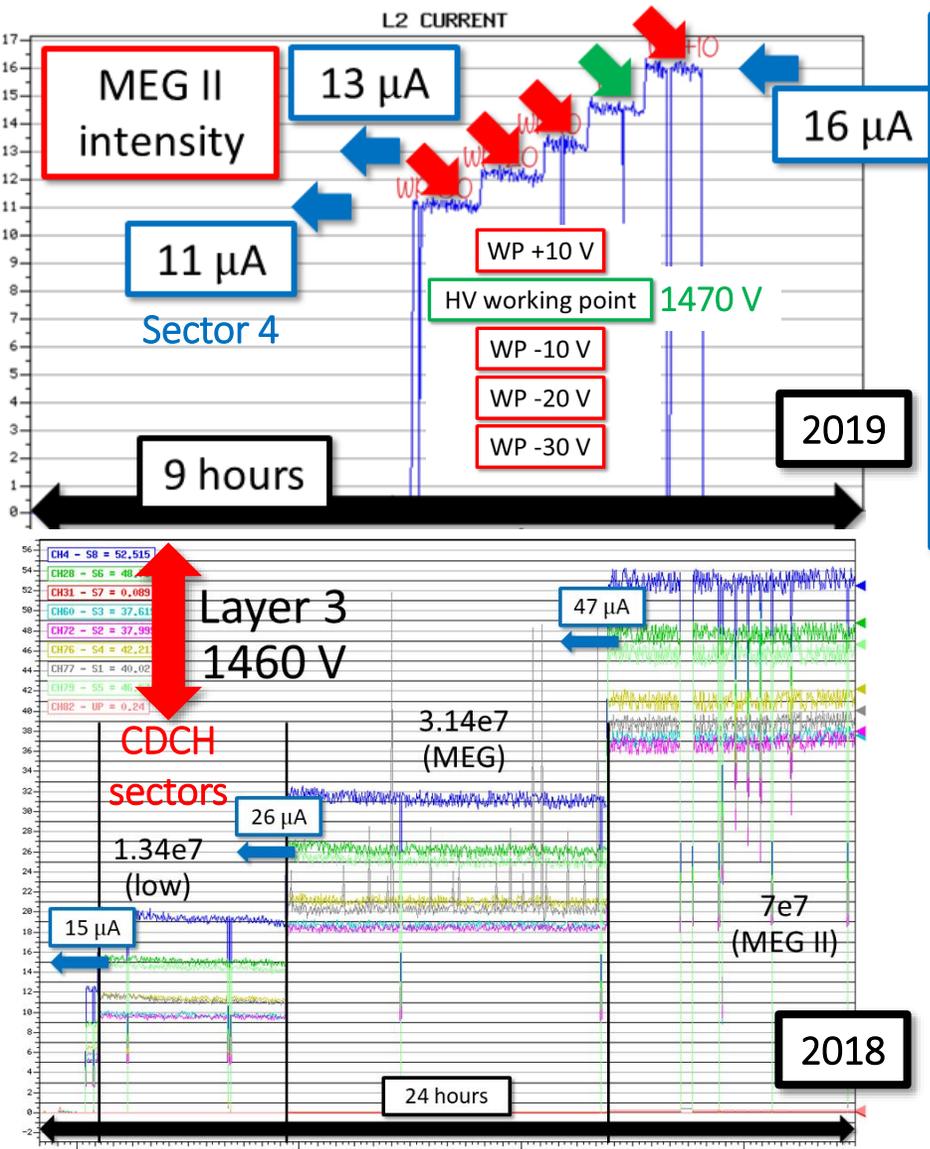
- Example of gain curves for L2 and L3
 - Currents drawn by the HV channels with μ^+ beam at different intensities
- ~ exponential behaviour in the current value with the HV increase as expected from simulations

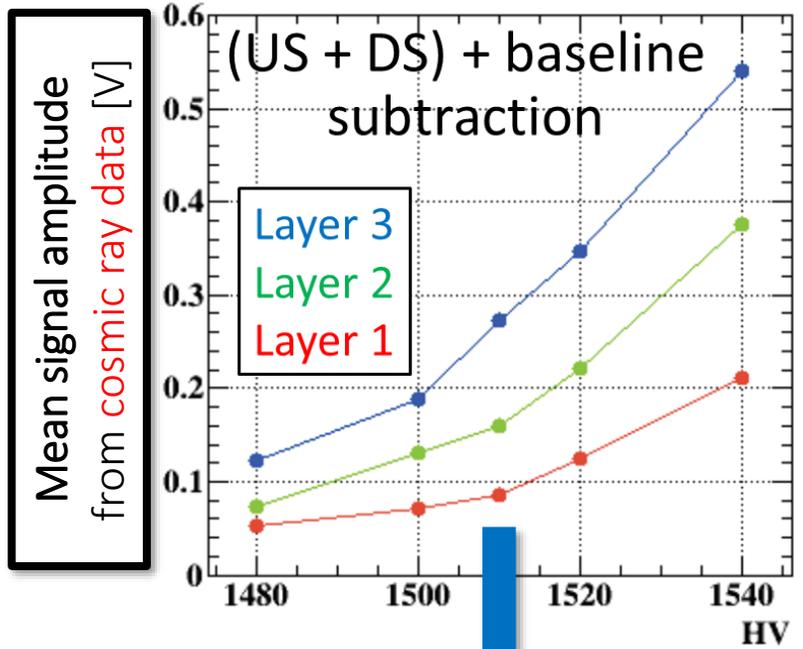
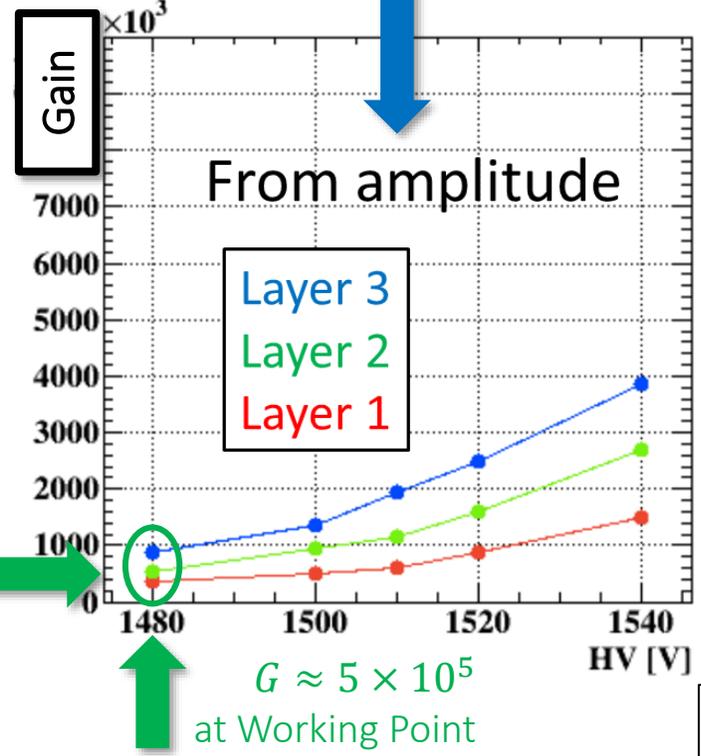
- The mean amplitude from cosmic ray data are converted into the effective gas gain G
- By means of simulations of the ionization clusters and the response of the FE amplification stage
 - Calibrated gain curves in agreement with simulations

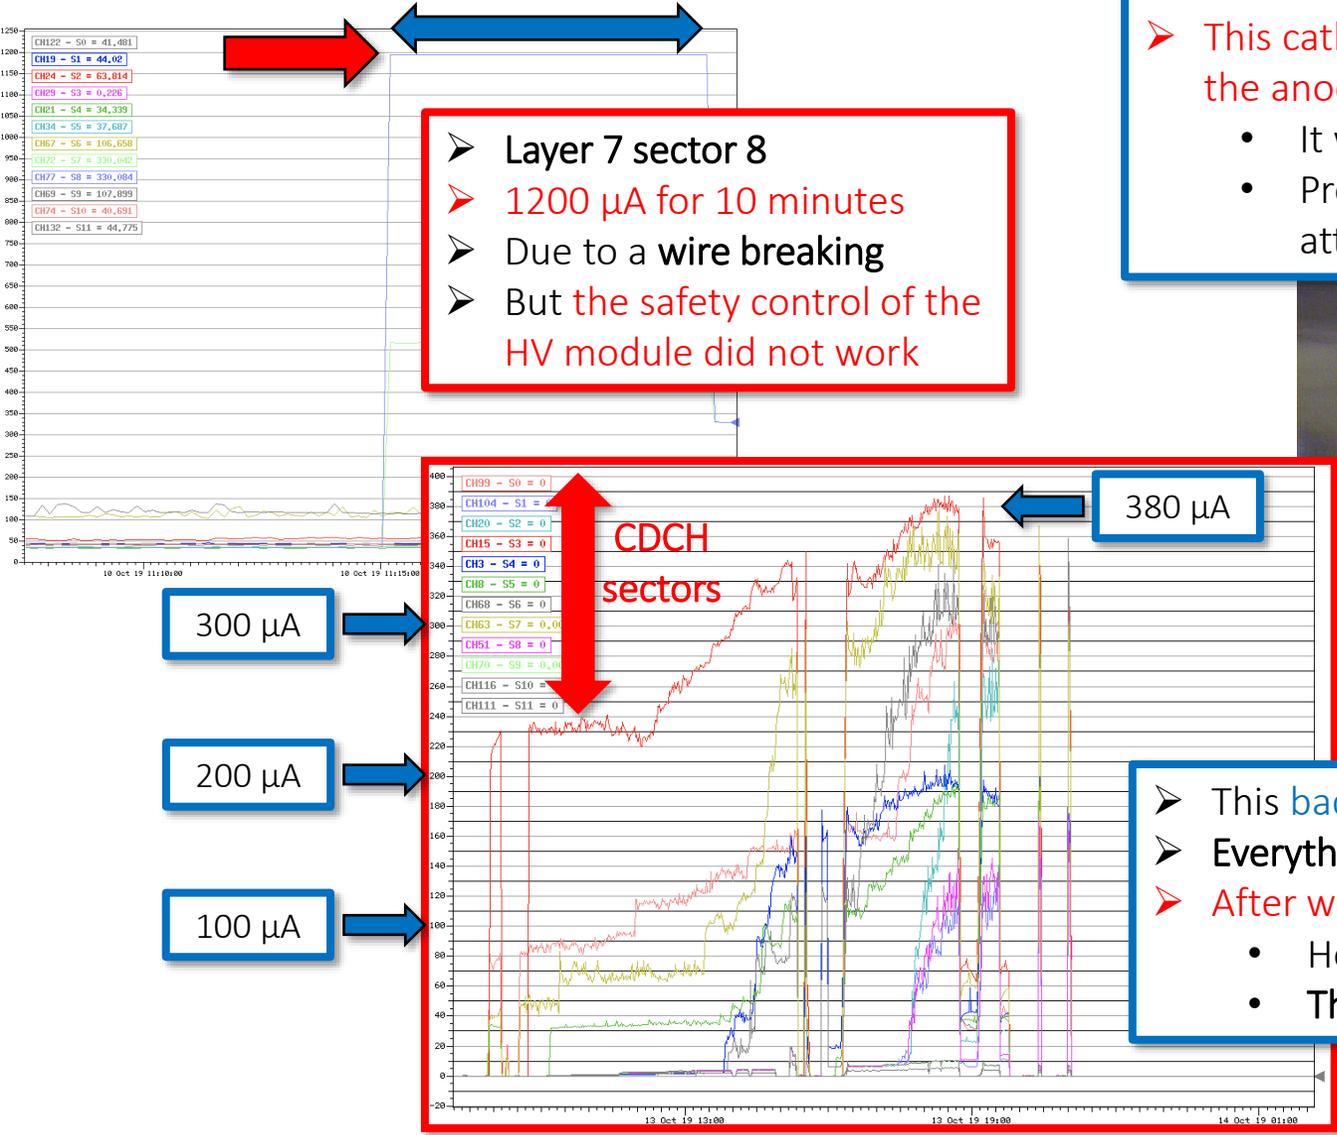
Bad event last year

➤ Layer 7 sector 8
 ➤ 1200 μA for 10 minutes
 ➤ Due to a wire breaking
 ➤ But the safety control of the HV module did not work

➤ During investigations this year we found **one broken cathode wire** together with a few mm anode wire segment pointing to it

- Both show burn marks in the final portion
- No breaking due to corrosion

➤ This cathode was broken by the contact with the anode short segment left inside by mistake

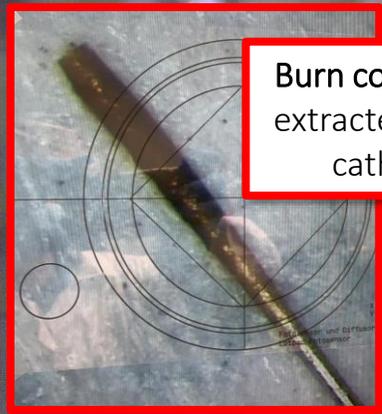
Burn confirmed once extracted the broken cathode wire
