The experience of the MEG II drift chamber

The 2020 International Workshop on the
High Energy Circular Electron Positron Collider

Marco Chiappini
INFN Pisa (Italy)
October 26, 2020

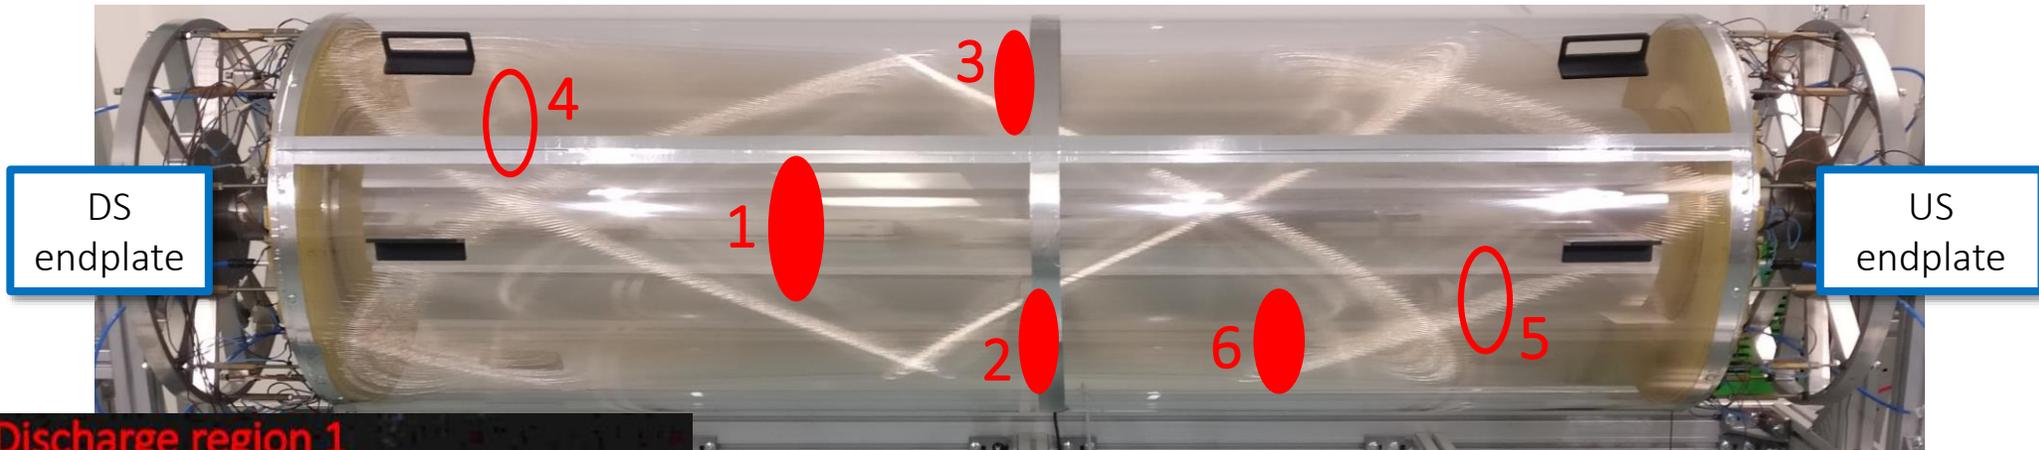
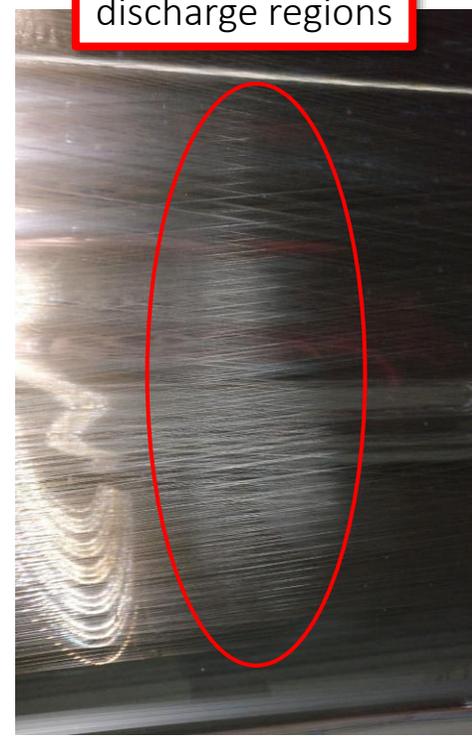
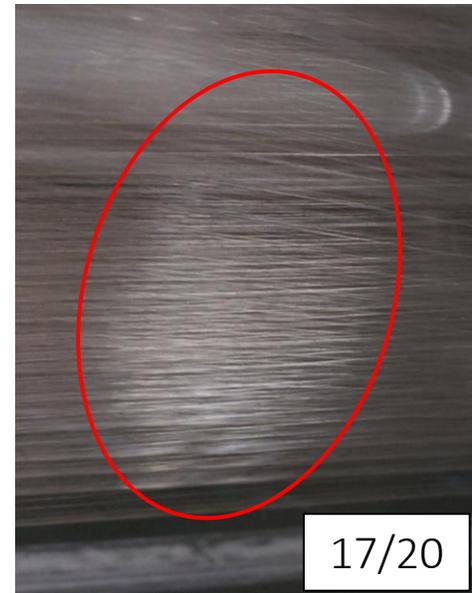
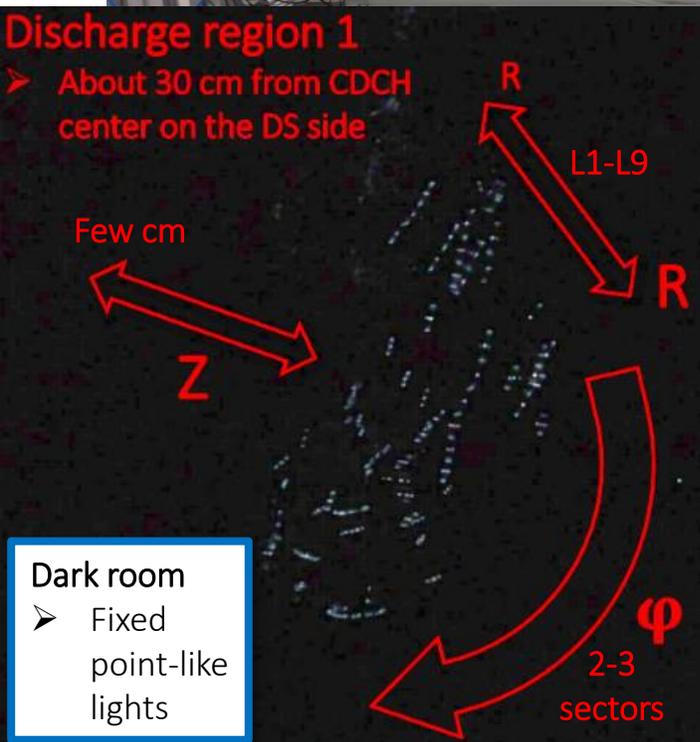
Two of the discharge regions

- We performed HV tests with CDCH closed with a transparent shell and filled with the standard He:IsoB 90:10 gas mixture
- We saw corona-like discharges in correspondence of 6 whitish regions
- Further investigations are ongoing during the 2020 data taking run
- We are trying different additives to the standard gas mixture to test the CDCH stability and try to recover the normal operation
 - 5% CO₂
 - 2000-4000 ppm of H₂O
 - From 500-600 ppm to 1% of O₂ (also in combination with H₂O)
- Oxygen seems to be effective in reducing high currents ([plasma cleaning?](#))

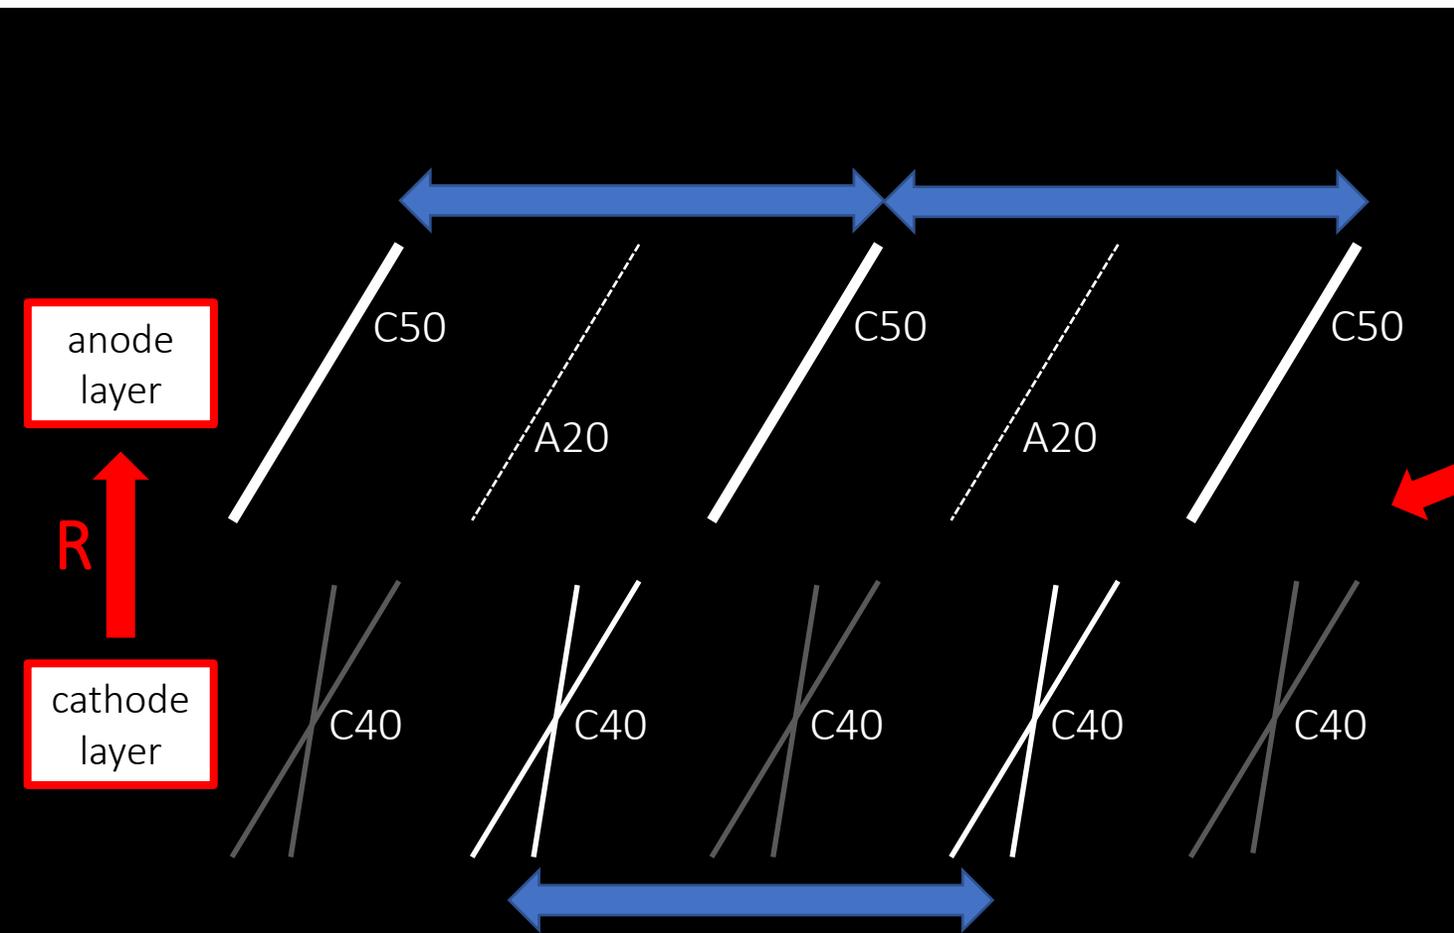
Pattern in the white spots

- White spot in correspondence of the 40 μm cathode wire crossing points
- The period is that of the 50 μm cathode wire: higher E field?

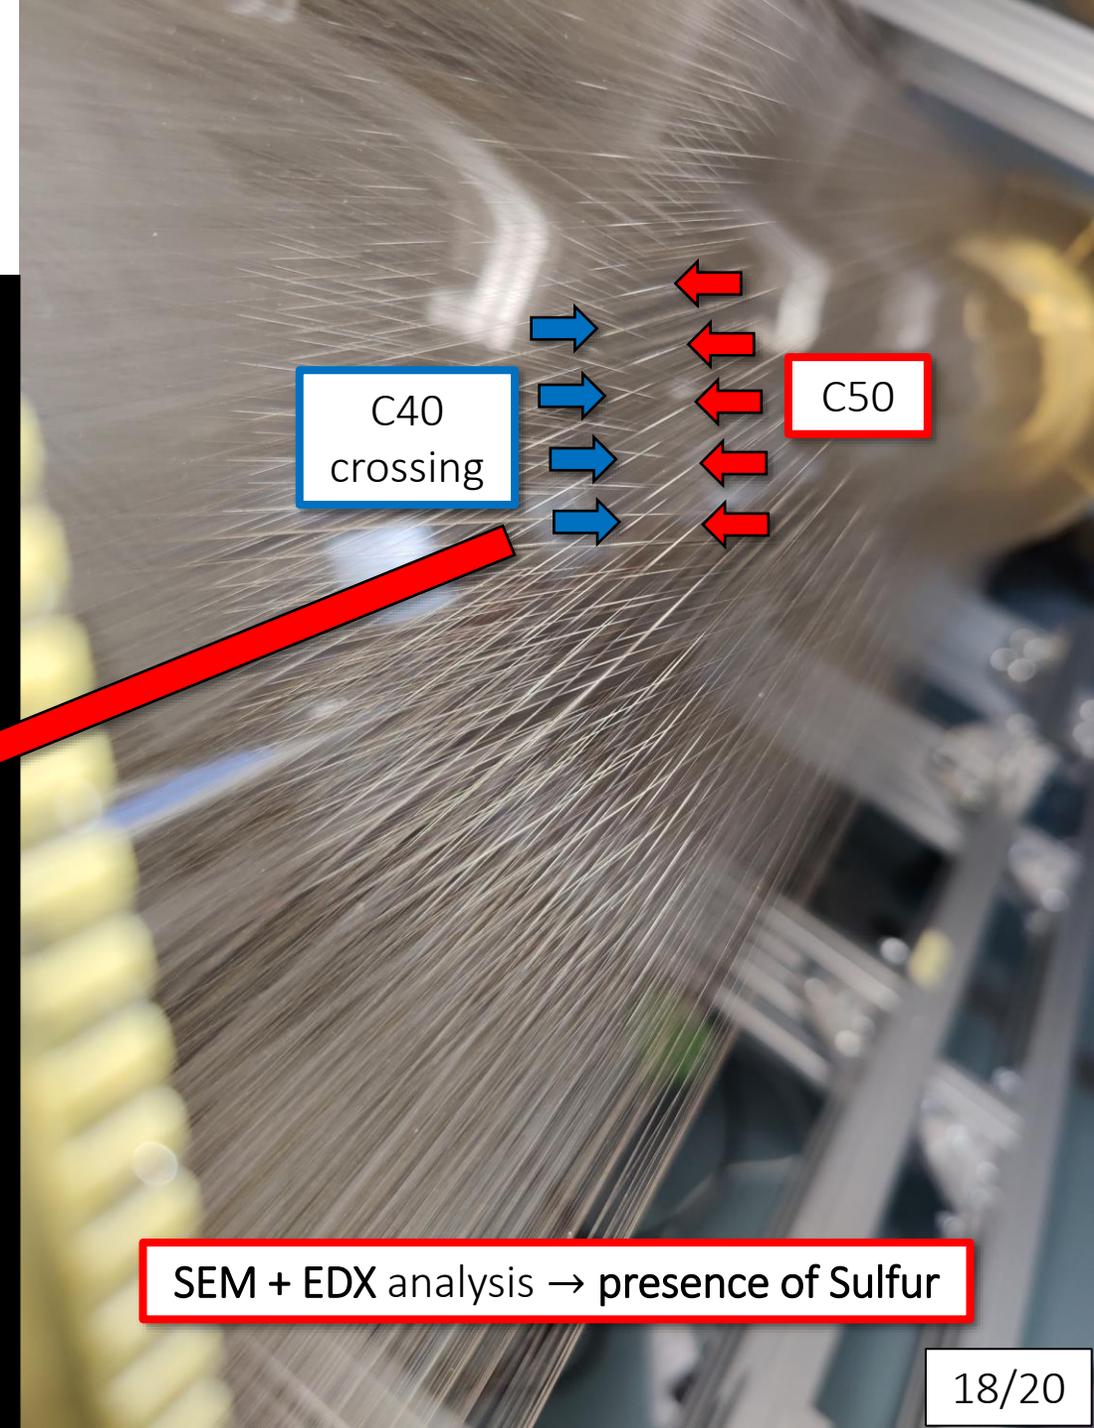
SEM + EDX analysis → presence of Sulfur

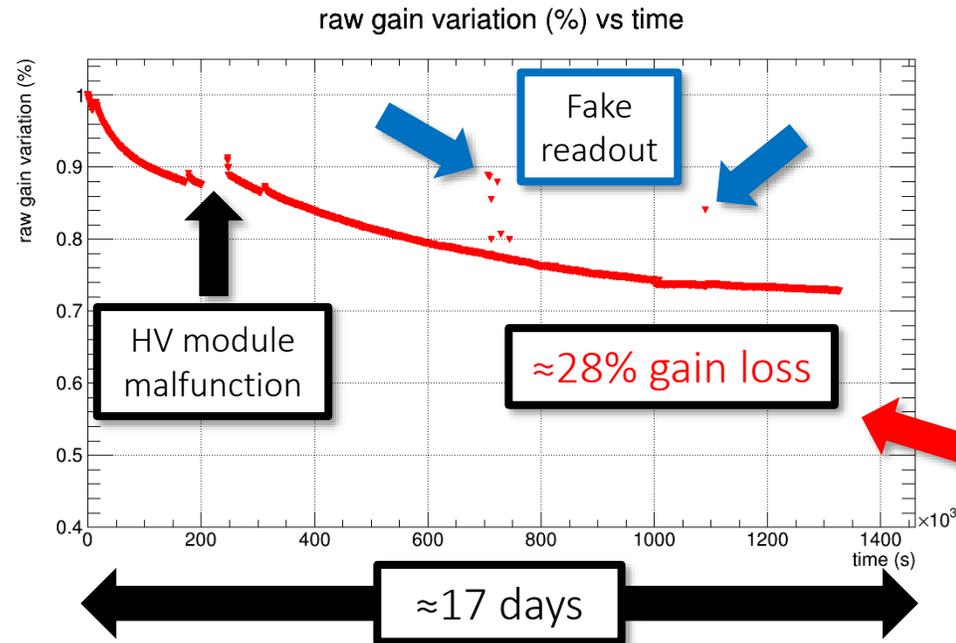
- Accelerated ageing tests on different prototypes were performed
- Prototypes with increasing complexity were used
 - From a 1-cell prototype to a small 2-layer stereo prototypes (6 cells)
 - This latter is presented here and it featured the same geometry and materials of the CDCH endplates

Stereo prototype with 2 layers of 3 drift cells each

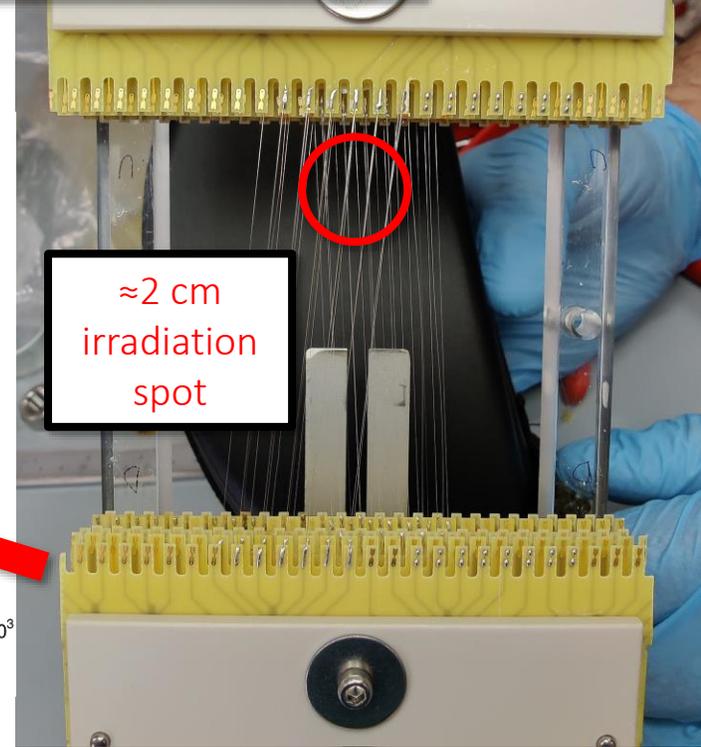
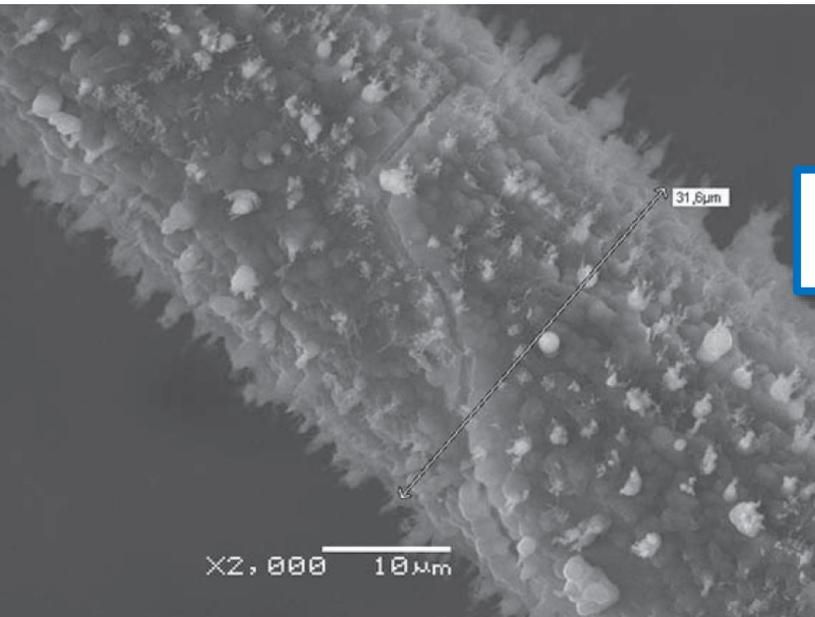
- SEM image of an aged anode wire
- No problems on cathode wires

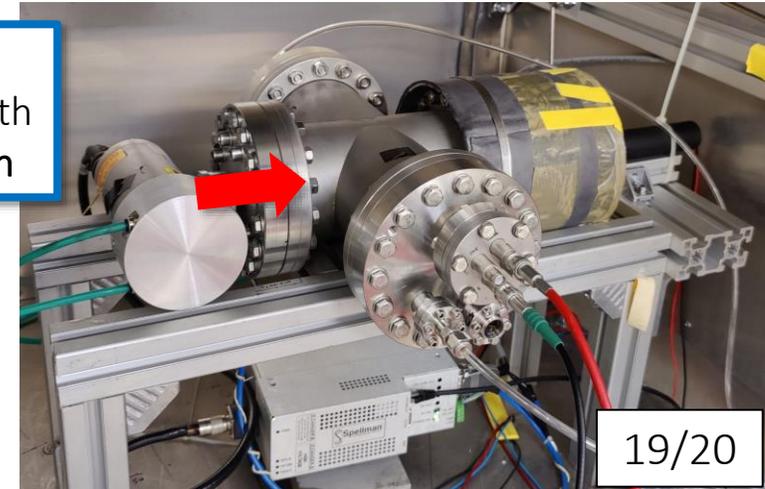
Ageing facility with X-ray gun

- Total ageing acceleration factor $10 < A < 100$
 - Accumulated charge comparable to the total MEG II life
- No issues/discharges observed
