Material Loss Rate for Tungsten Irradiated with 800 MeV Protons

Irradiation of Pure Tungsten in Proton Beam Revealed high Corrosion Rate

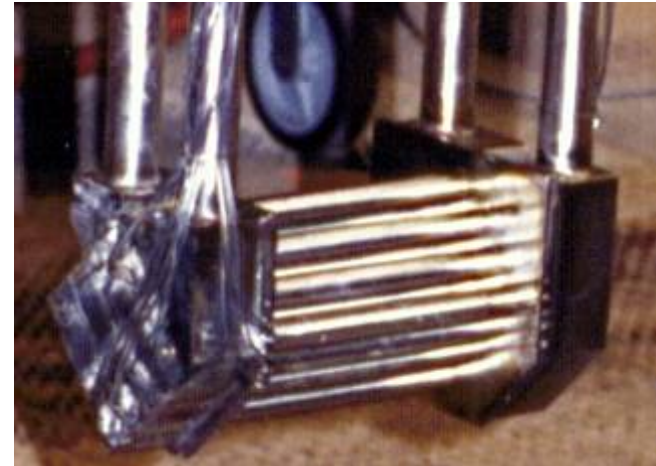
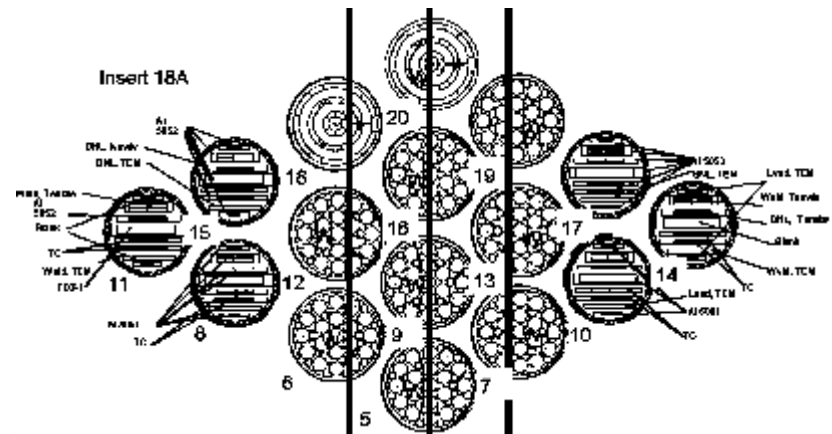
Bare Tungsten Neutron Source Capsule

- 1/8 in. diameter rods
- 19 rods per bundle
- Cooled with flowing water
- Water inlet Temperature ~30C, Delta T~10C
- Max. W surface T~166C
- System pressure = 13bar
- Coolant velocity ~ 2.9 m/s
- Water pH during operation ~ 4.5

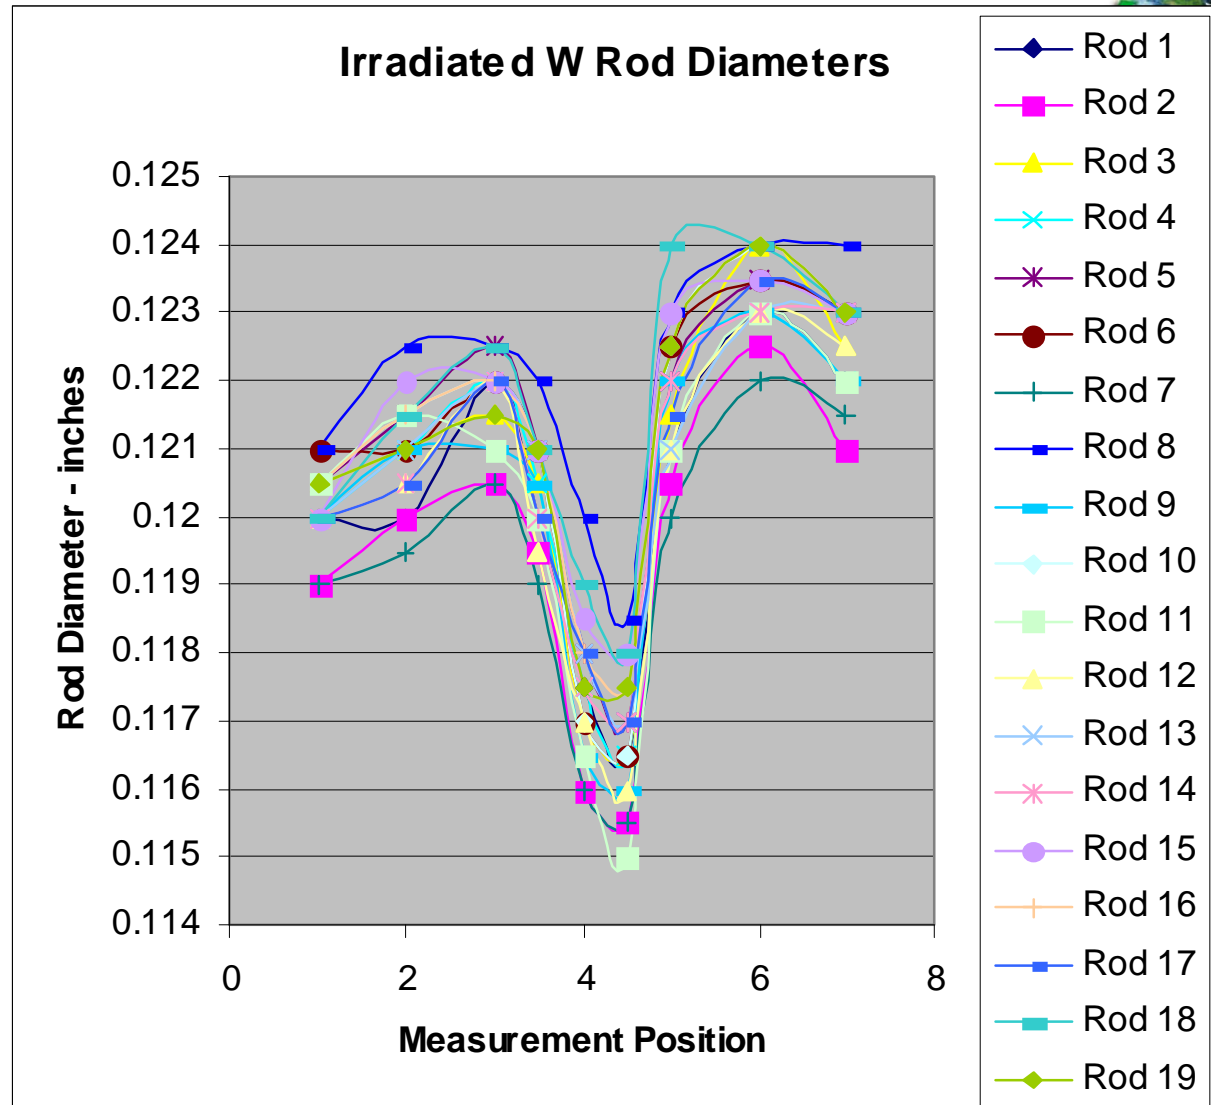
Decrease in Diameter of Bare Tungsten Rods Confirmed Tungsten Corrosion Rate

- Capsule irradiated for 2 months in 800 MeV, 1 mA proton beam (1.32×10^{21} p/cm²)
- Measured the diameter of all 19 tungsten rods in the leading rod bundle.
- The loss of tungsten on rods scaled with Gaussian beam shape.
- Measured Helium concentration of ~740 appm

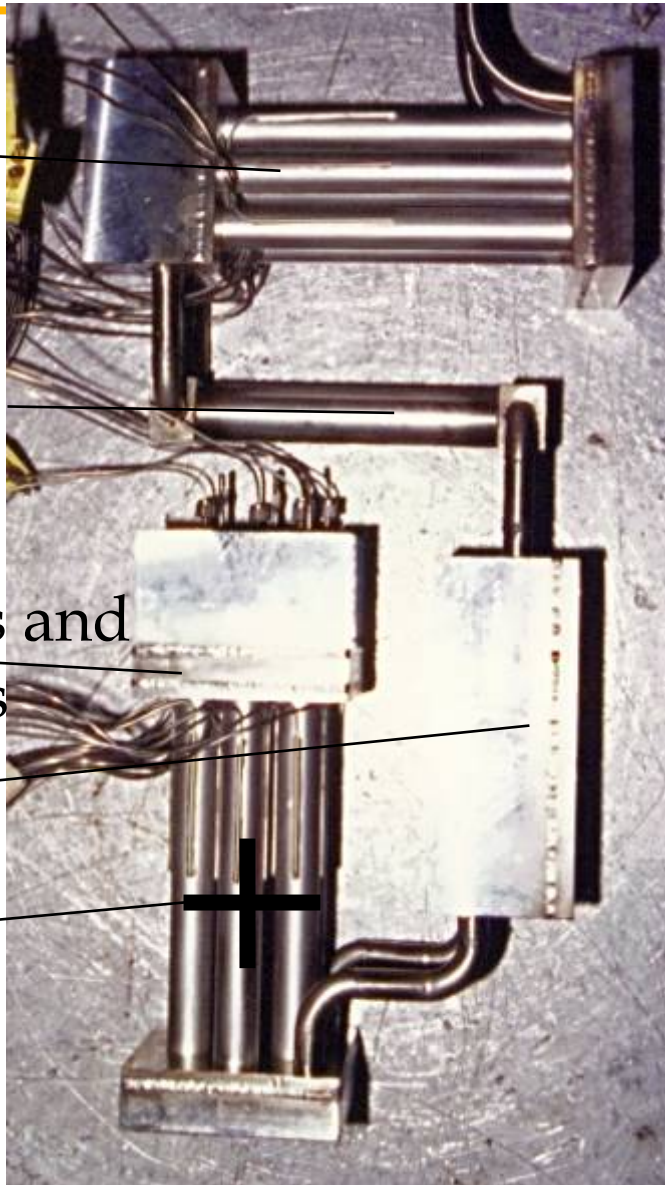
Corrosion Rates Measured on Samples from Corrosion Insert

Out-of-Beam
Weight Loss
Specimens

W/Ti and W/Re
Samples

Corrosion Probes and
In Beam Wt. Loss
SCC Specimens

Beam Center

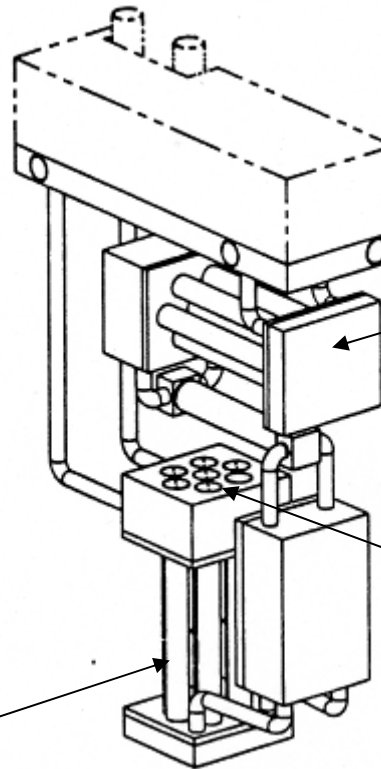
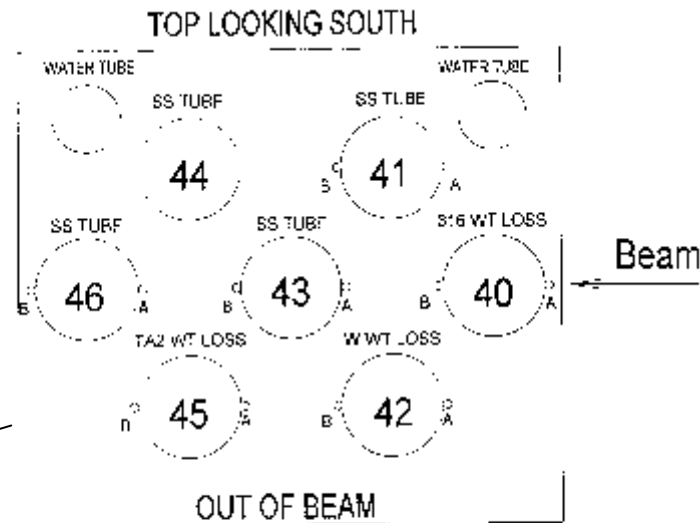
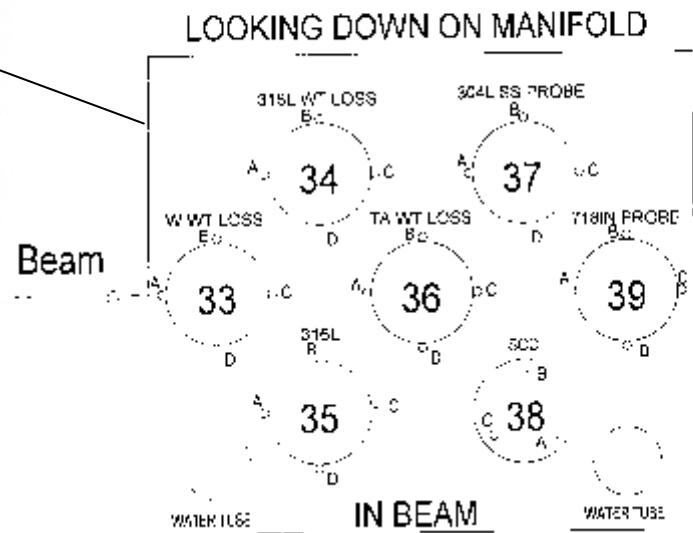
Set-up of Corrosion Insert

- Coupons irradiated in '97 APT irradiation for ~4 months
- Separate water system used for cooling samples

Incident Beam,
800 MeV, 1 mA
p+ beam
Calculated energy
at this insert is
~400 MeV

Installed During Accelerator Break
(11/96-2/97)

Contained In-beam corrosion probe of
Inconel 718

Cooled with separate controlled water
system

- Bubbled Hydrogen during irradiation
- Used High resistivity water
- pH=4.5

Contained weight loss samples in proton
beam and out-of-beam.

Contained U-bend Stress corrosion
Cracking specimens

Corrosion probes placed above insert to
measure corrosion rate in irradiated
water.

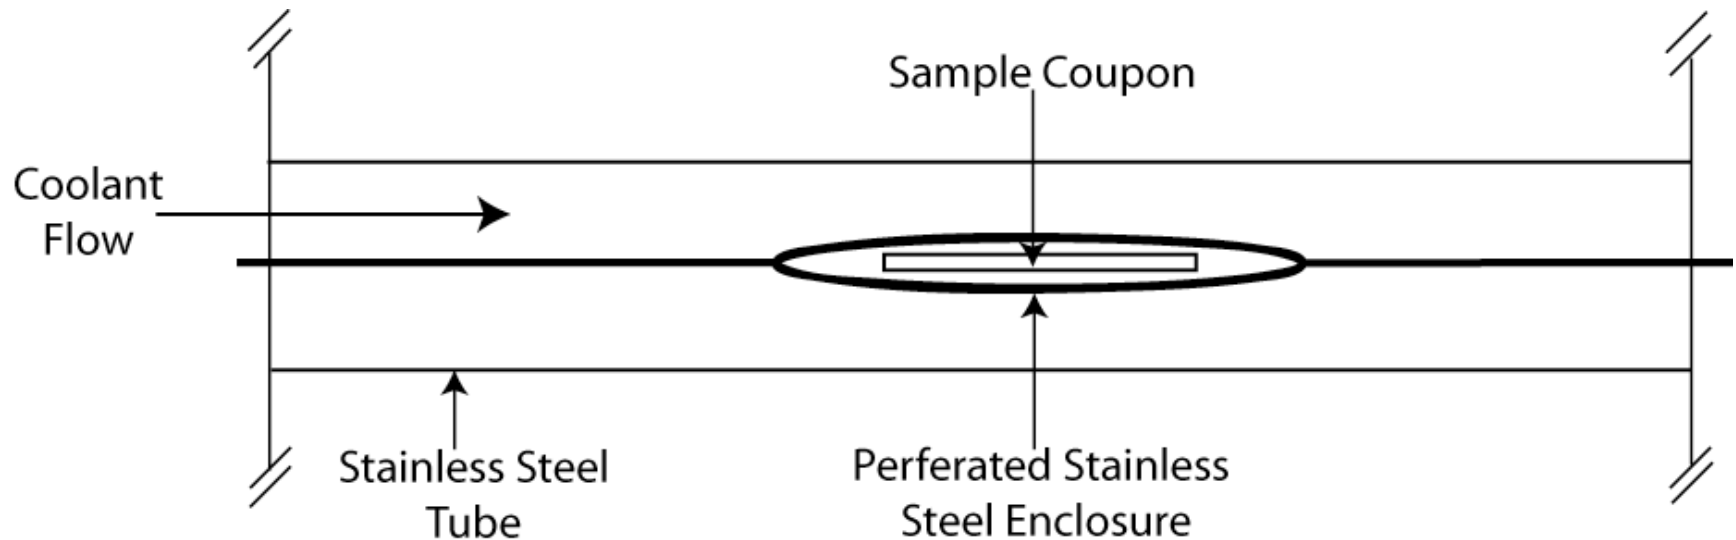
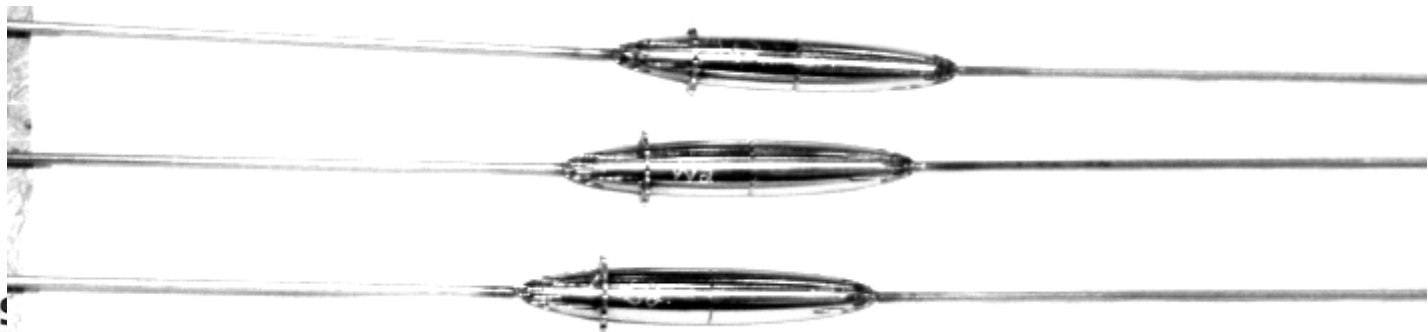
Corrosion Coupon Set-up

- Corrosion Measurements made on tantalum, tungsten and 316L corrosion coupons after irradiation in the LANSCE beam

- Dose calculated ranged from 0.02 to 2.0 dpa
- Corrosion was only observed for the W samples
- Calculated flow rate was 1.0 m/s

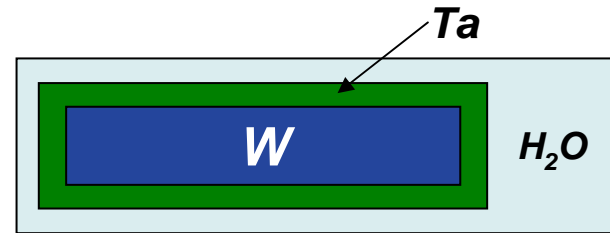
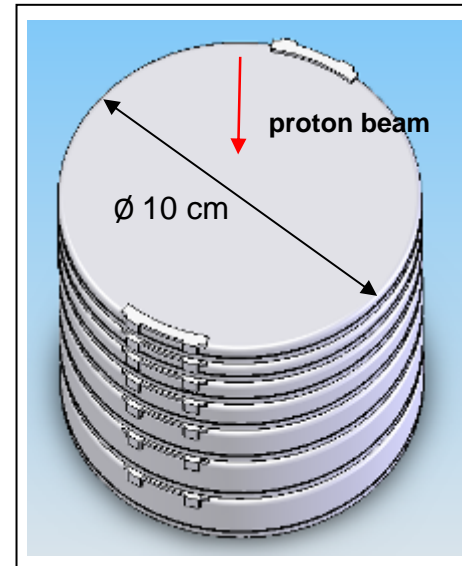
Plans underway to Clad MLNSC Target with Ta

- Main reason is to reduce activity for the water cooling system
- Initial HIP bonding tests at 1500C were successful
- Plan to have new targets fabricated by March 2009

Manuel Lujan Jr.
Neutron Scattering Center
LANSCE

- Tungsten target 'pucks'
- Light water coolant
- Tantalum cladding
