TS1 Project with-beam commissioning

Stephen Gallimore

ICANS XXIV, Dongguan, China

2nd November 2023

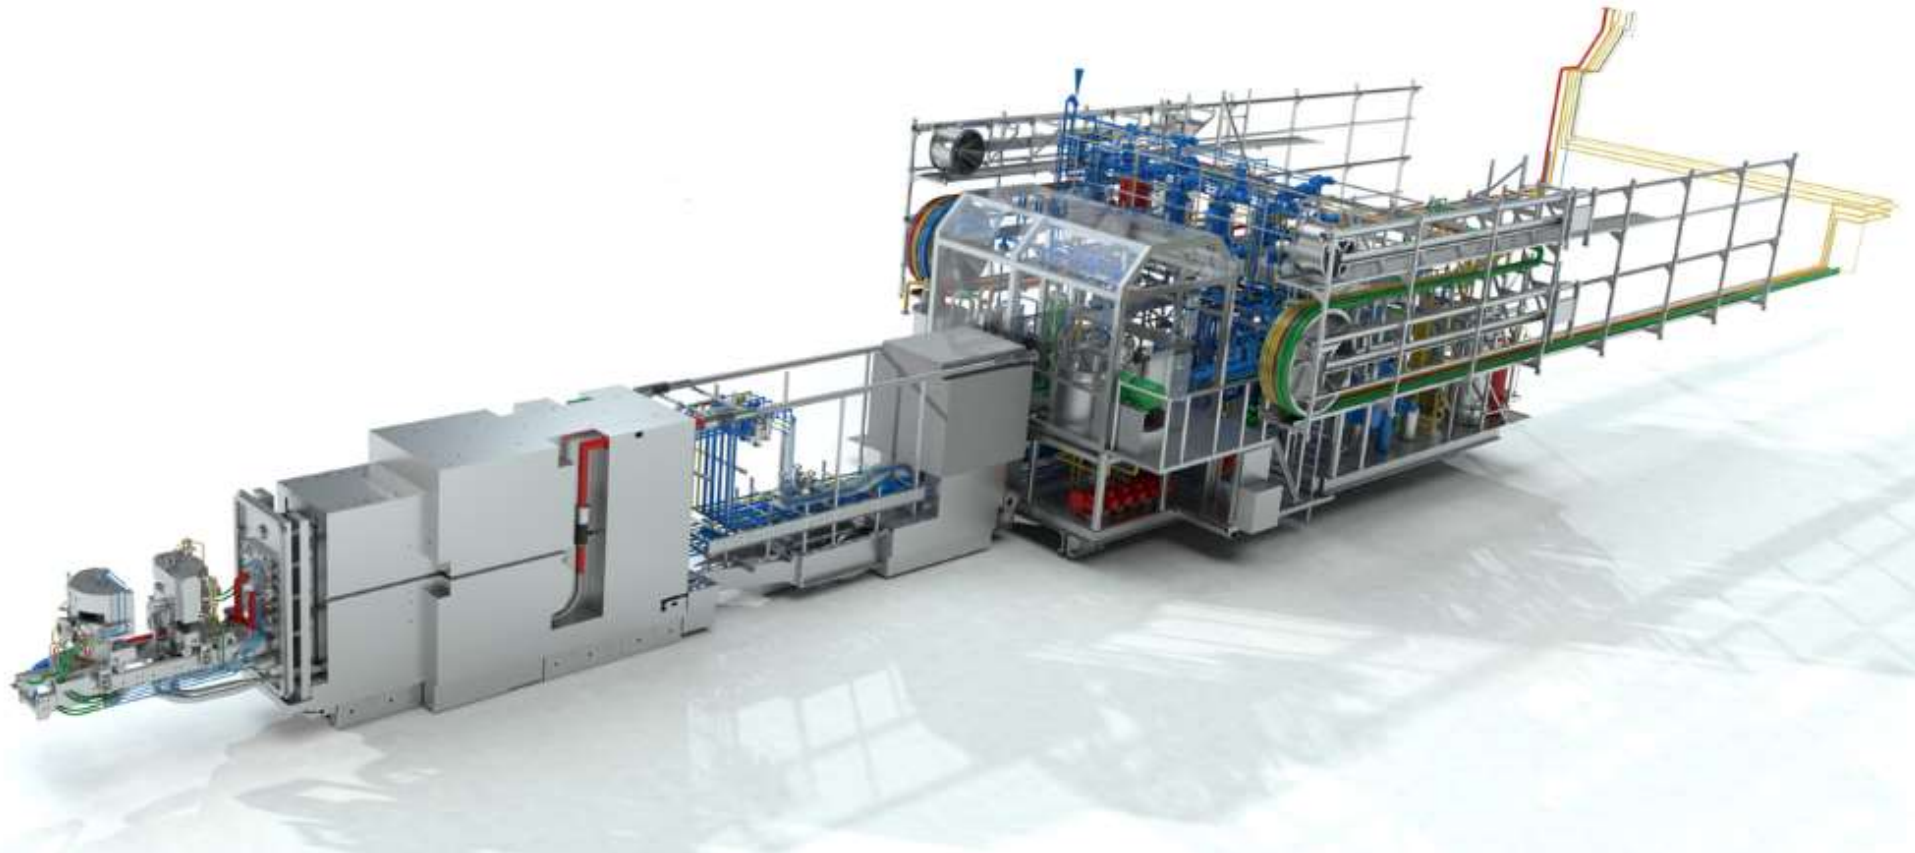
A CAD image of the full TS1 target trolley

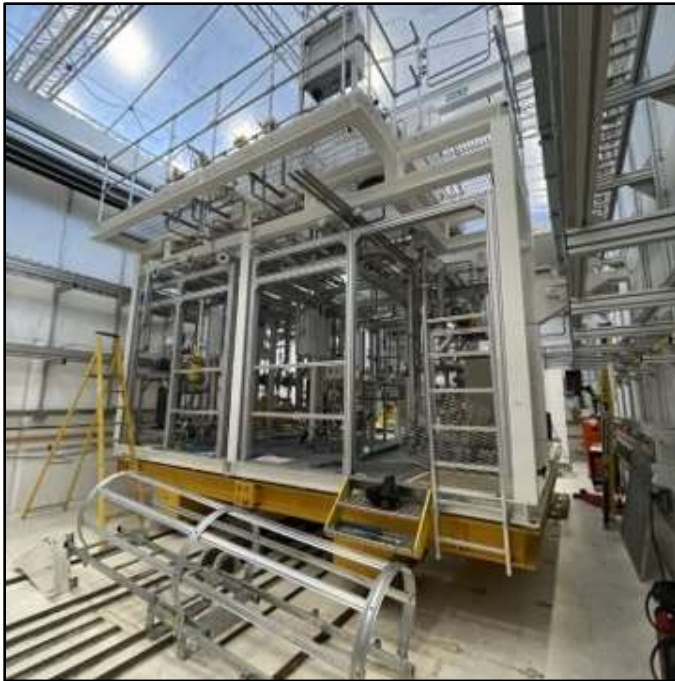
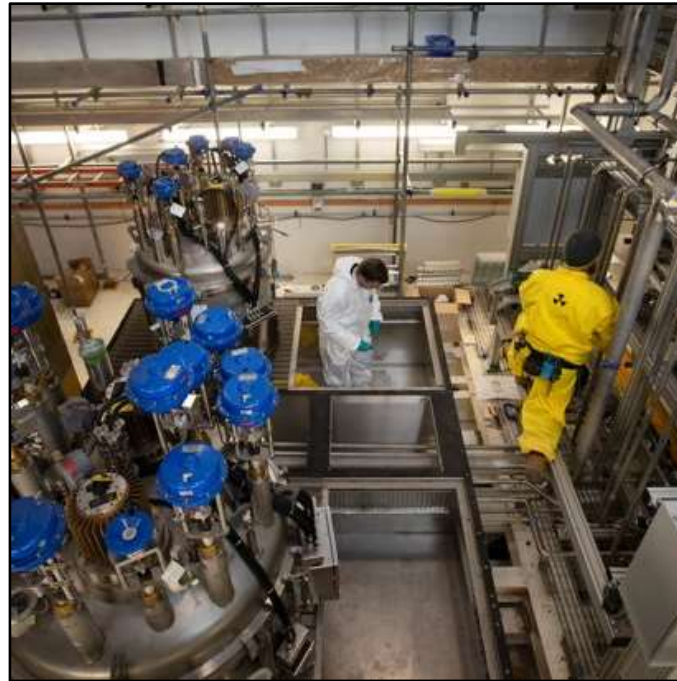
Connection of the modular services 'skids' and installation of the cryogenic cold boxes. Right hand image is the completed services trolley

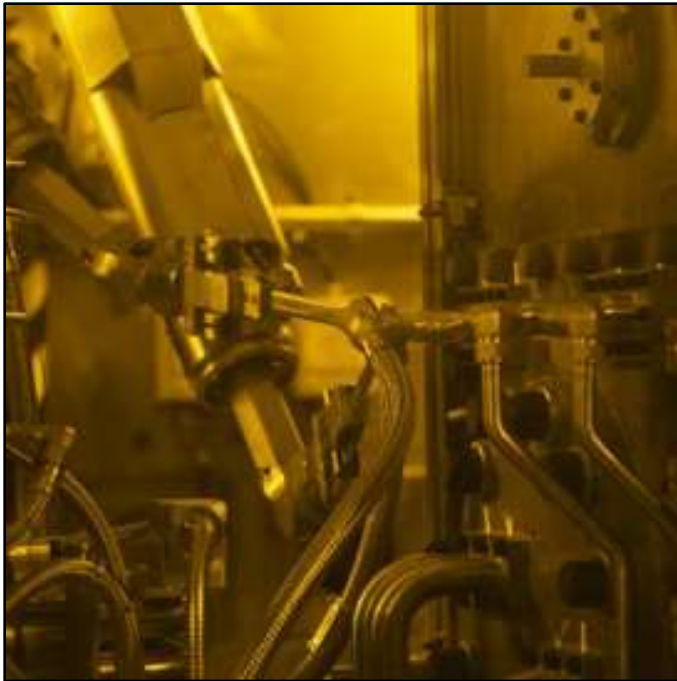
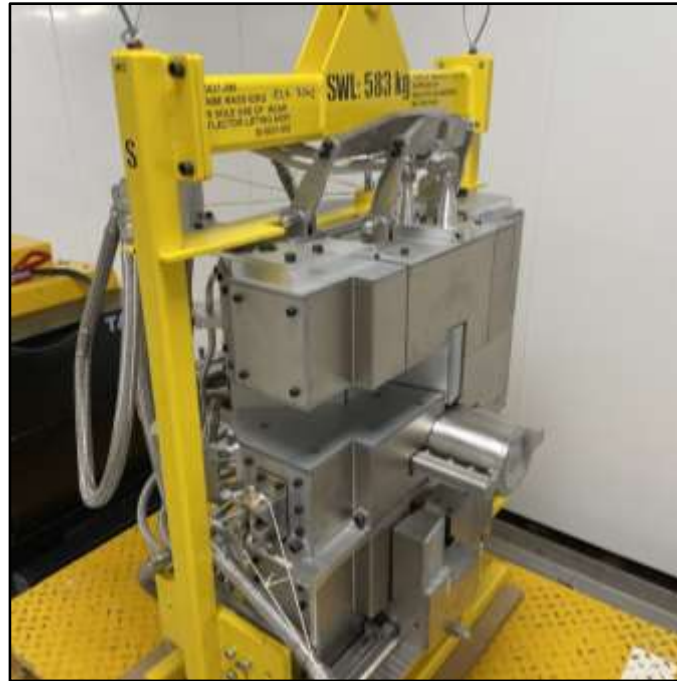
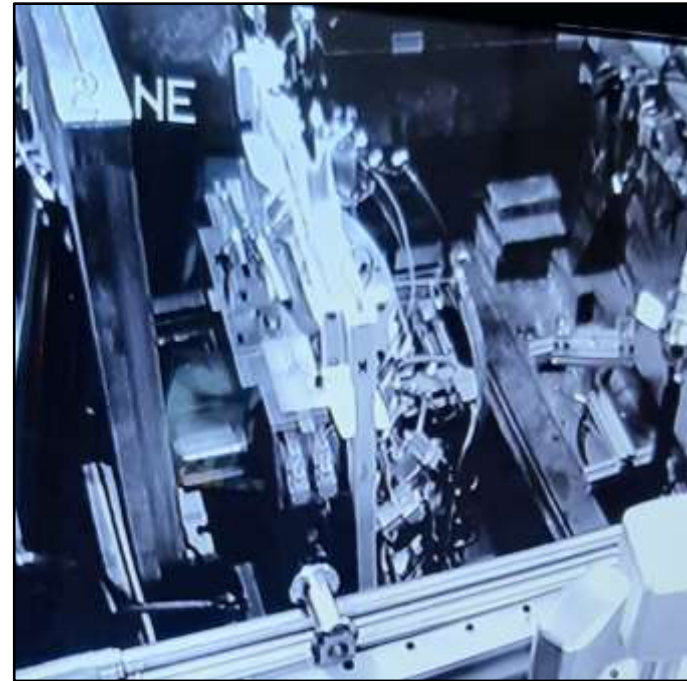
Installation images for the new TRaM installation and connection in the RHC

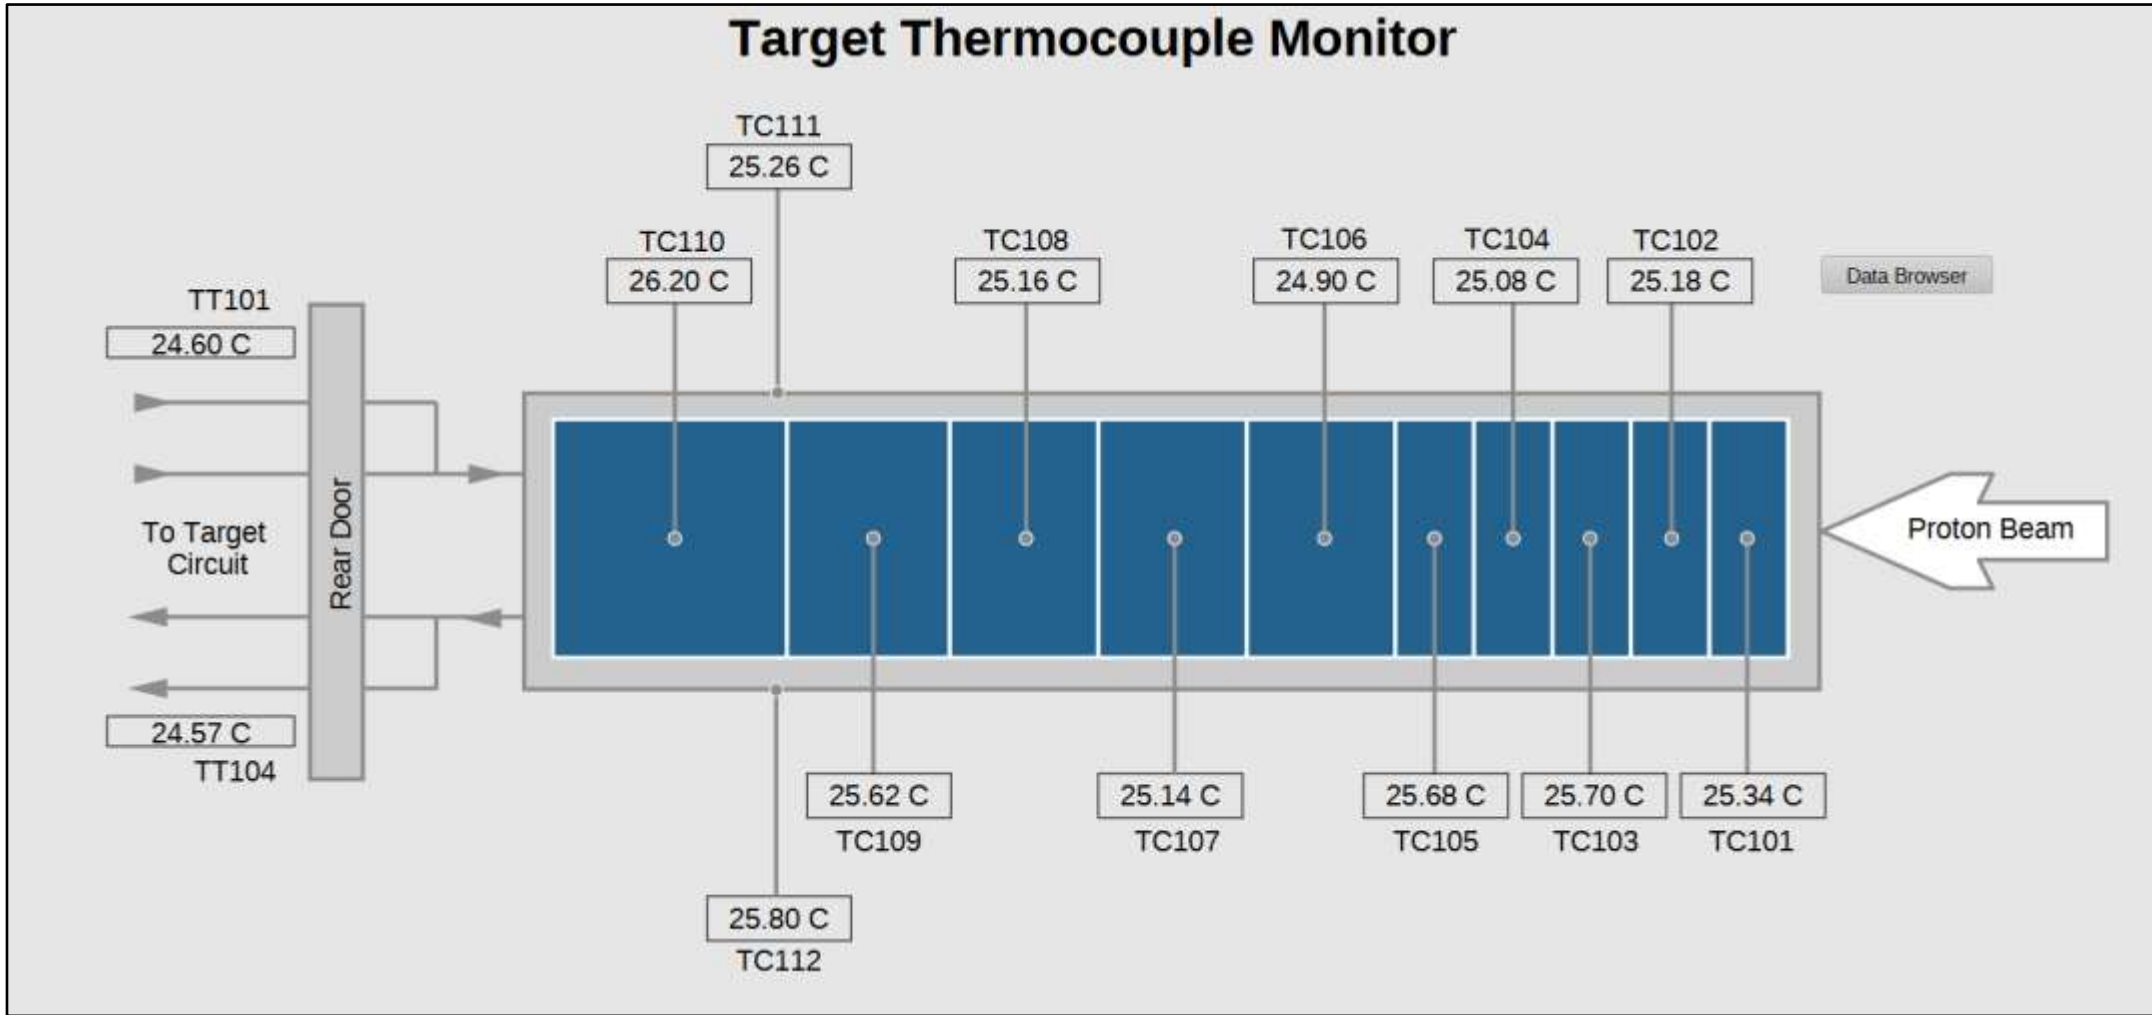
A Schematic layout of the thermocouples on the target

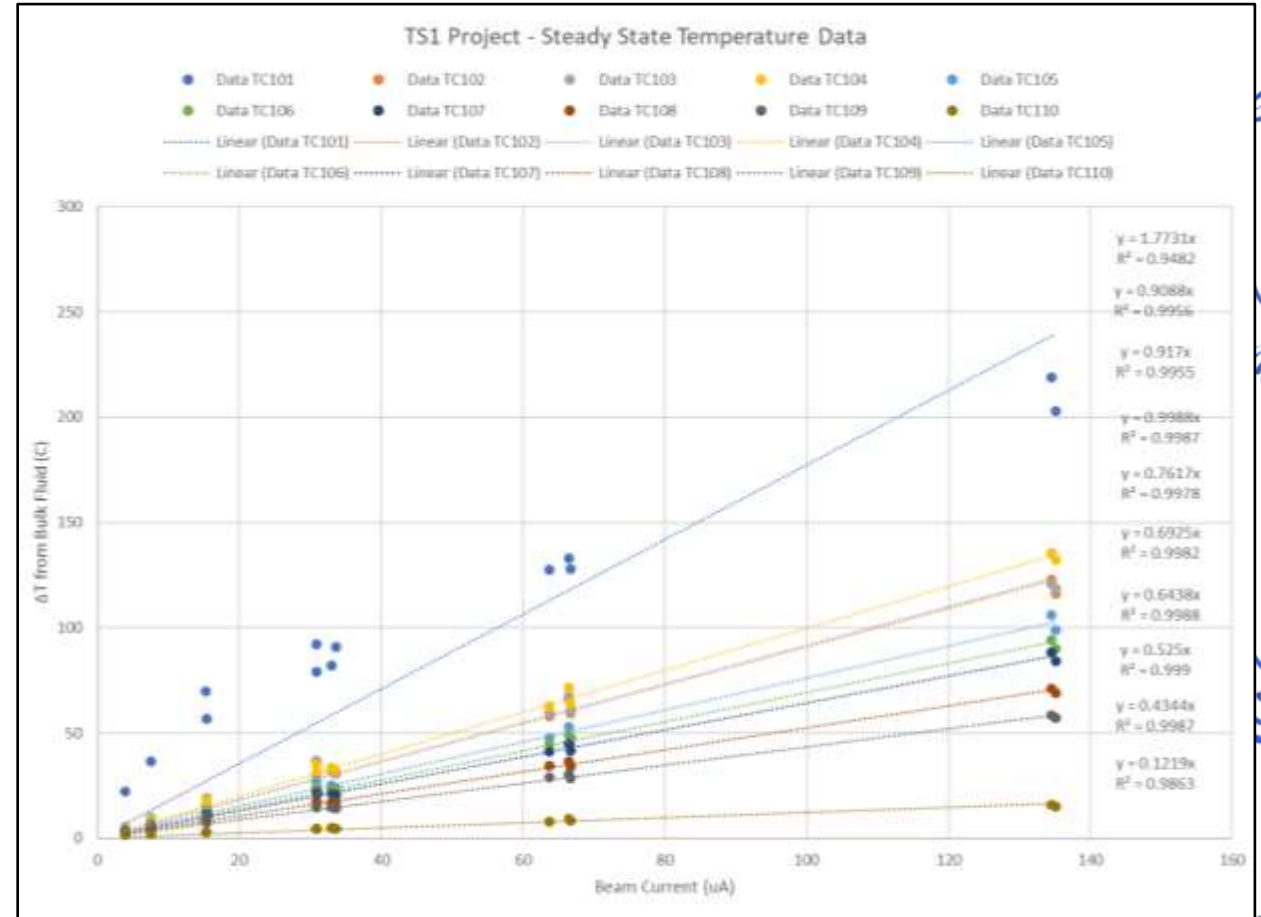
- Worked through the list of possible causes and mitigation for them
- Beam scan H & V across target
- Change of focus
- Went to full power
- Current 'best guess' poor thermal contact(s) – link to Dan W's talk - [Simulated and Measured Performance of ISIS TS1 Project Target – on Wednesday 1st Nov](#)

A graph showing the differing temperature behaviour of plate one compared to other plates and predictions

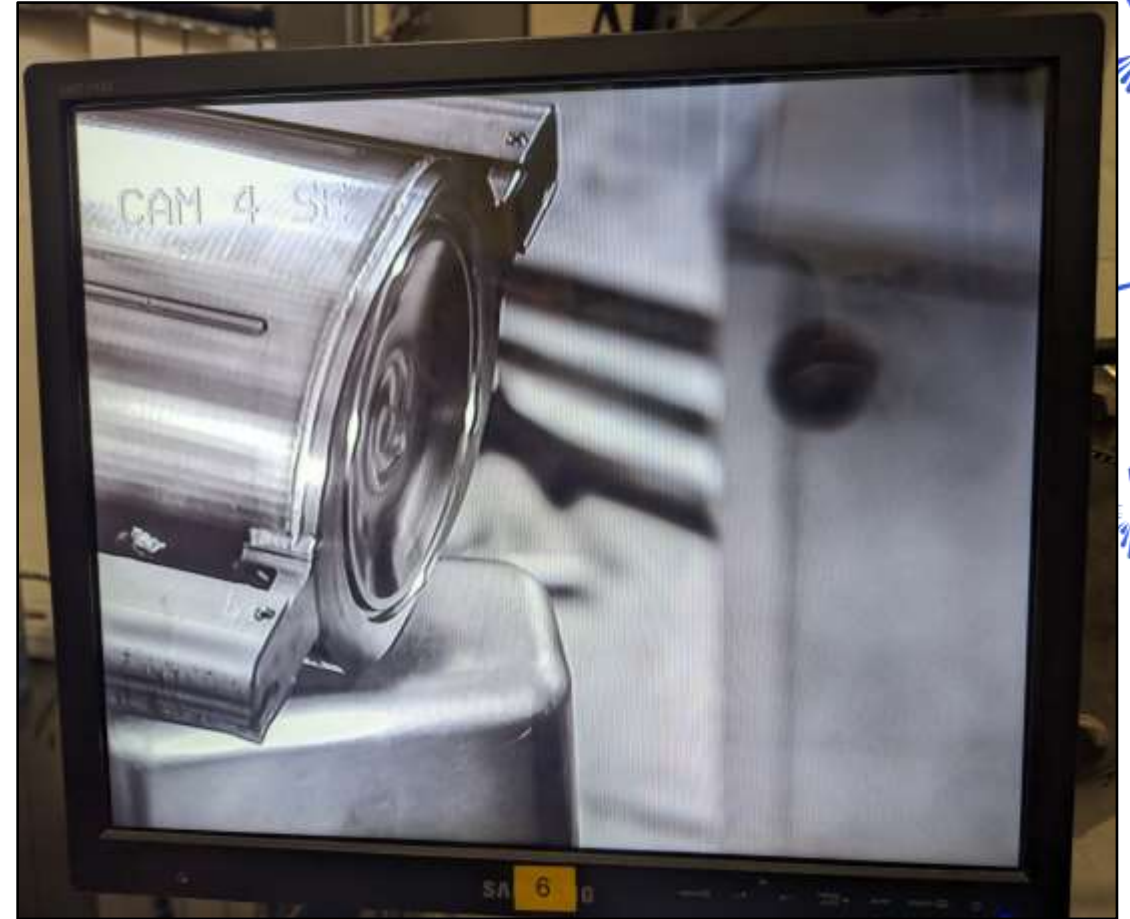
Image from in-cell cameras of the target front face

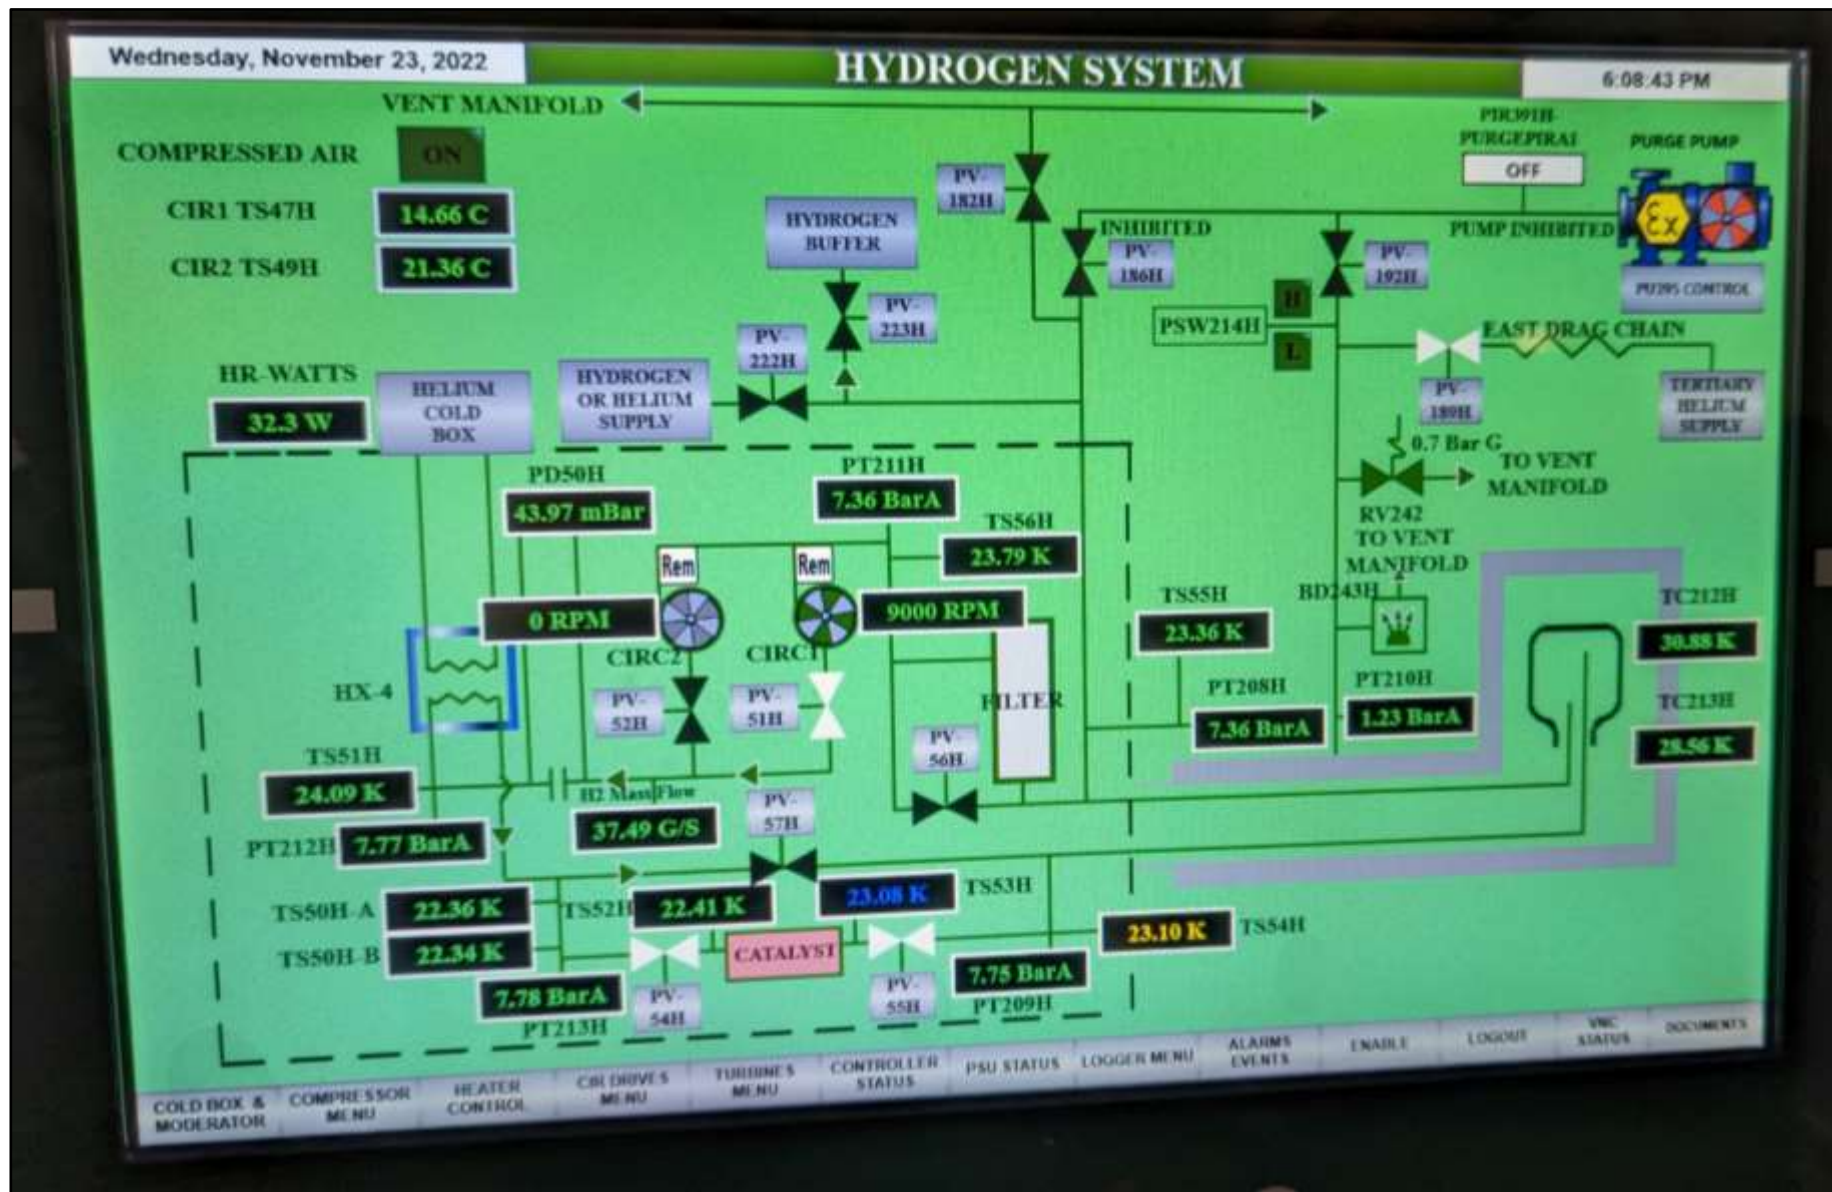
An image of the control screen showing an overview of the cryogenic hydrogen system

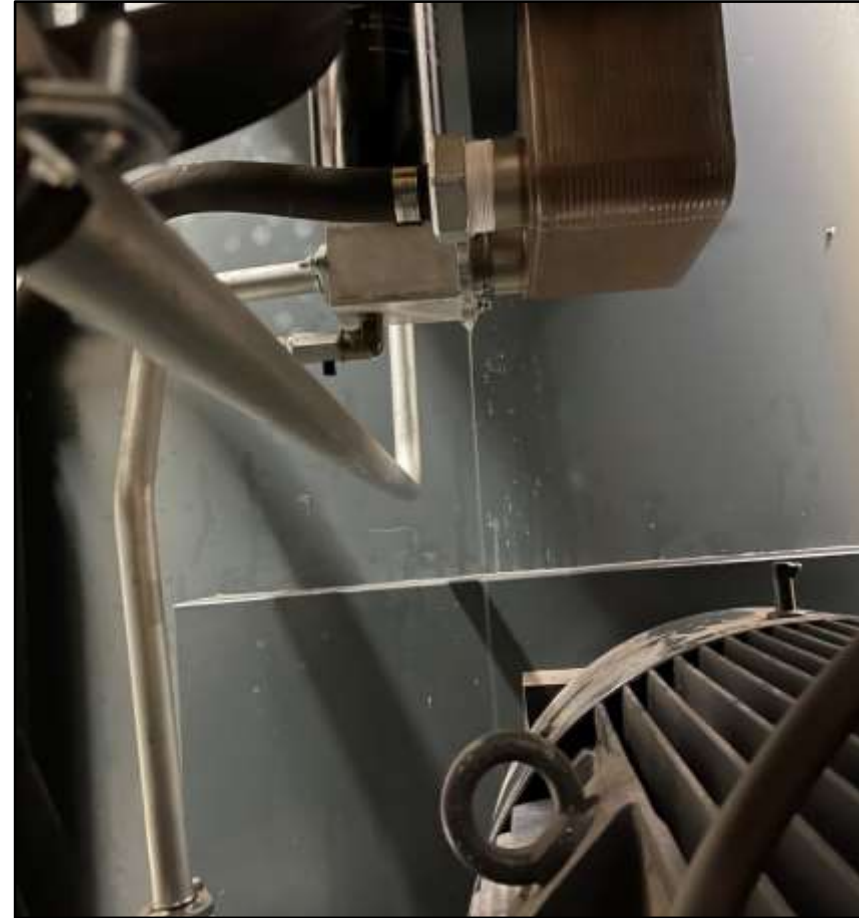
- Initial operation impacted by some issues connected to the compressor:
 - Heat exchanger scaled-up – insufficient cooling caused trips on oil temp
 - Oil leak due to O-ring installation error
- Cold box contamination due to pressure inspection
 - Ran using N₂ cold trap which took extra time
- Once these were overcome, moderator ran well

A leak on the compressor heat exchanger

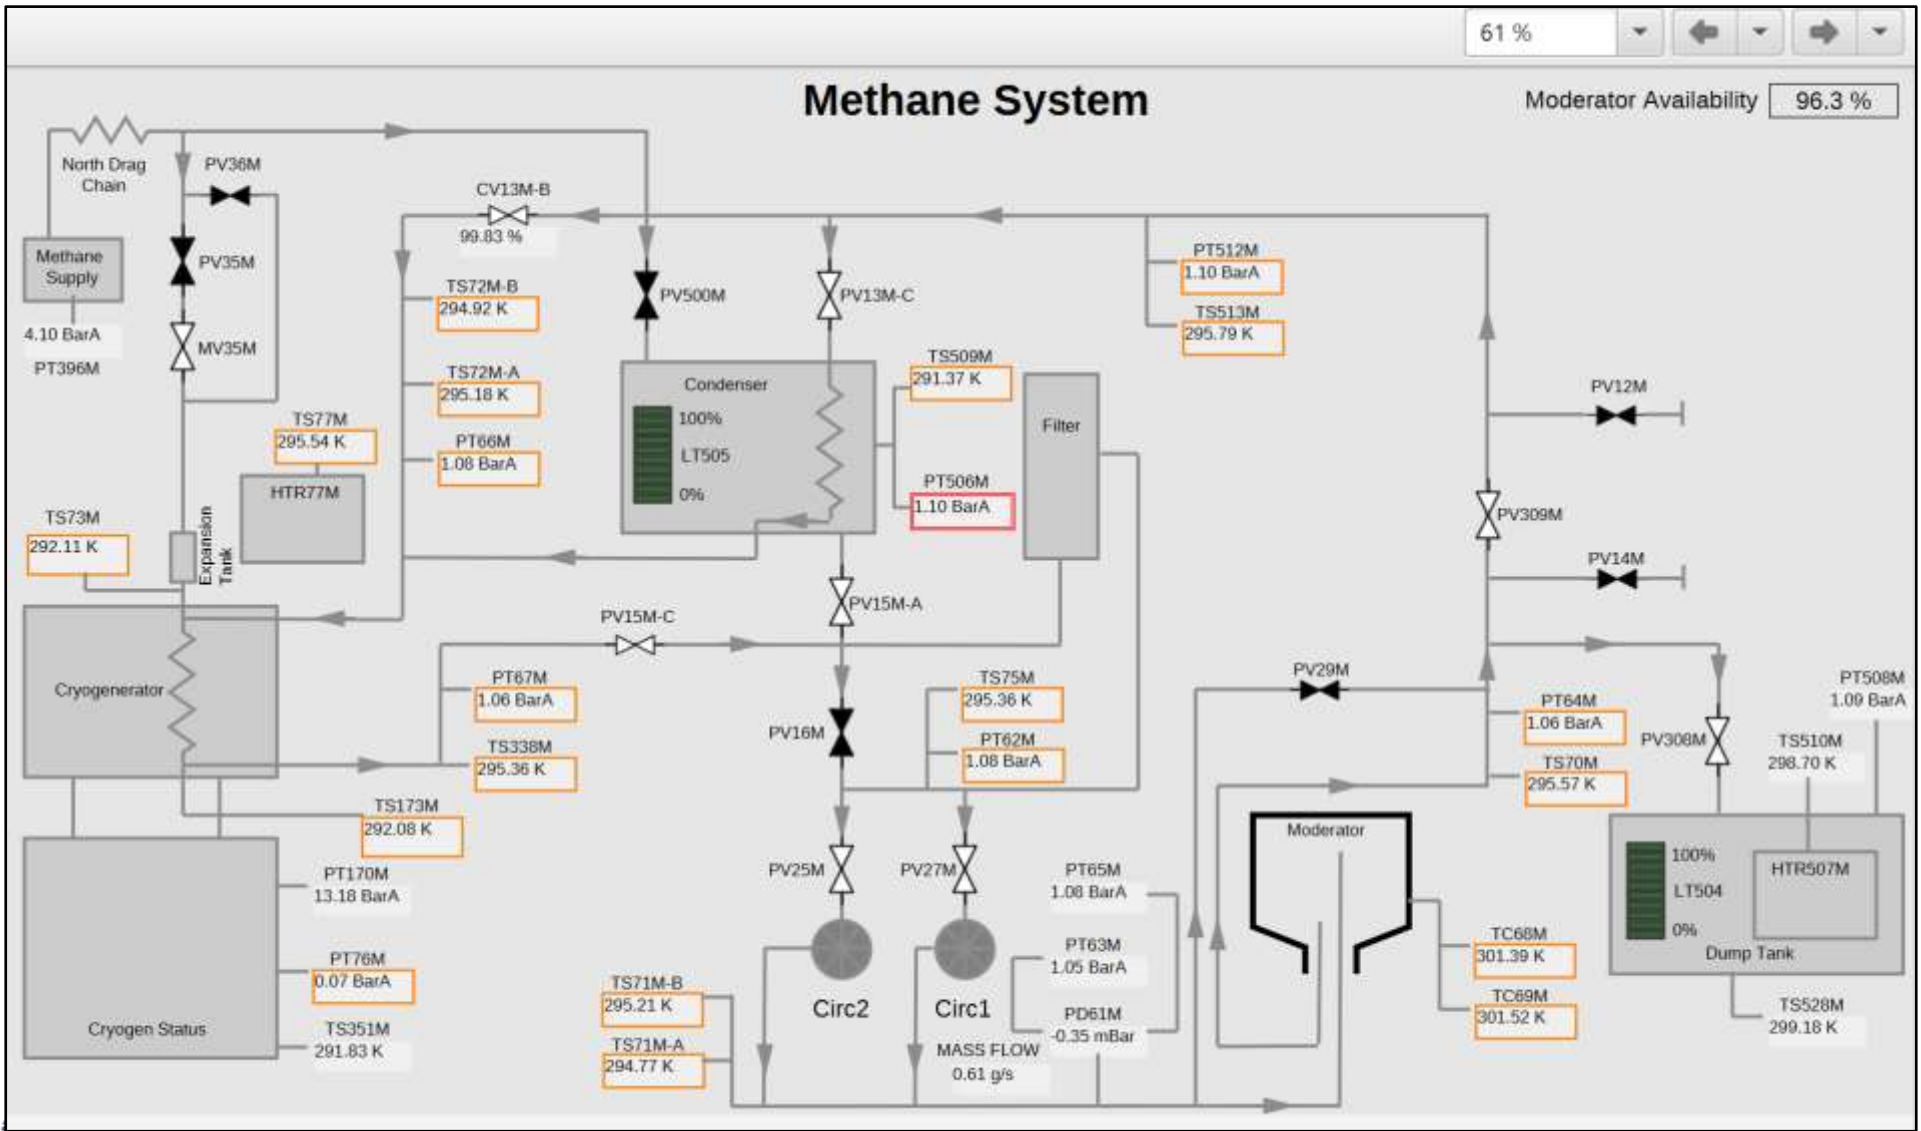
A schematic of the methane cryogenic system

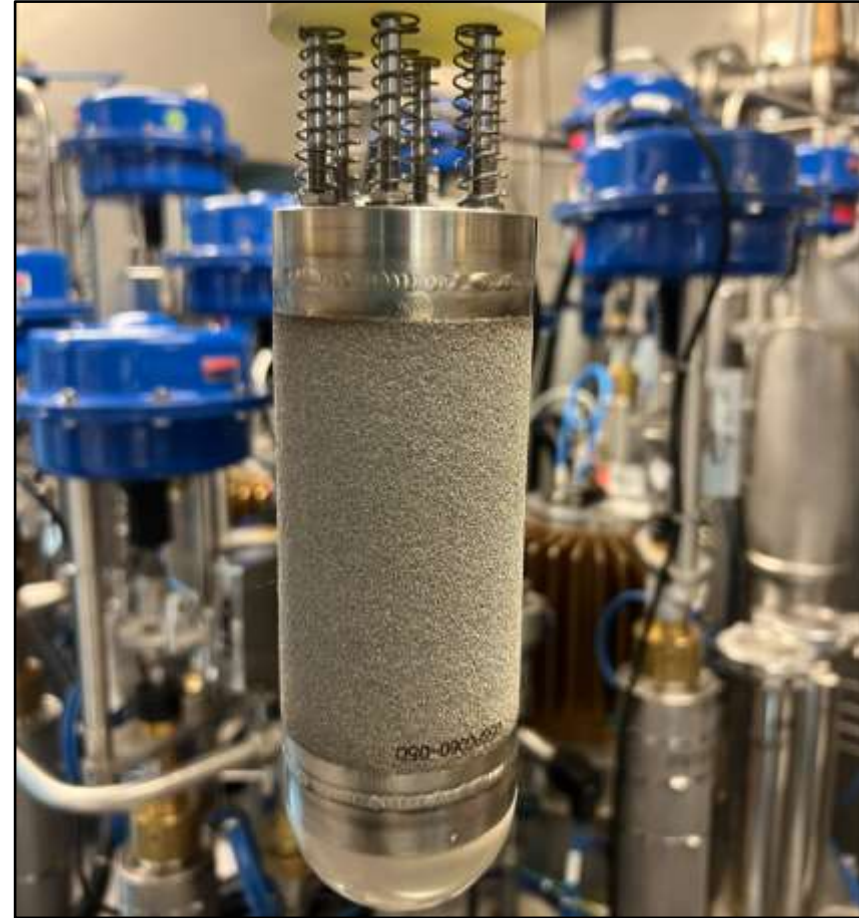
- Initial struggles to get system into liquid – topography
- VSD & vibration leading to bellows leak
- Filter pressure drop and pressure instabilities
- Cryogenerator issues
- Circulator flange temp trips
- Circulator speed adjustments

A photo of the methane system filter unit

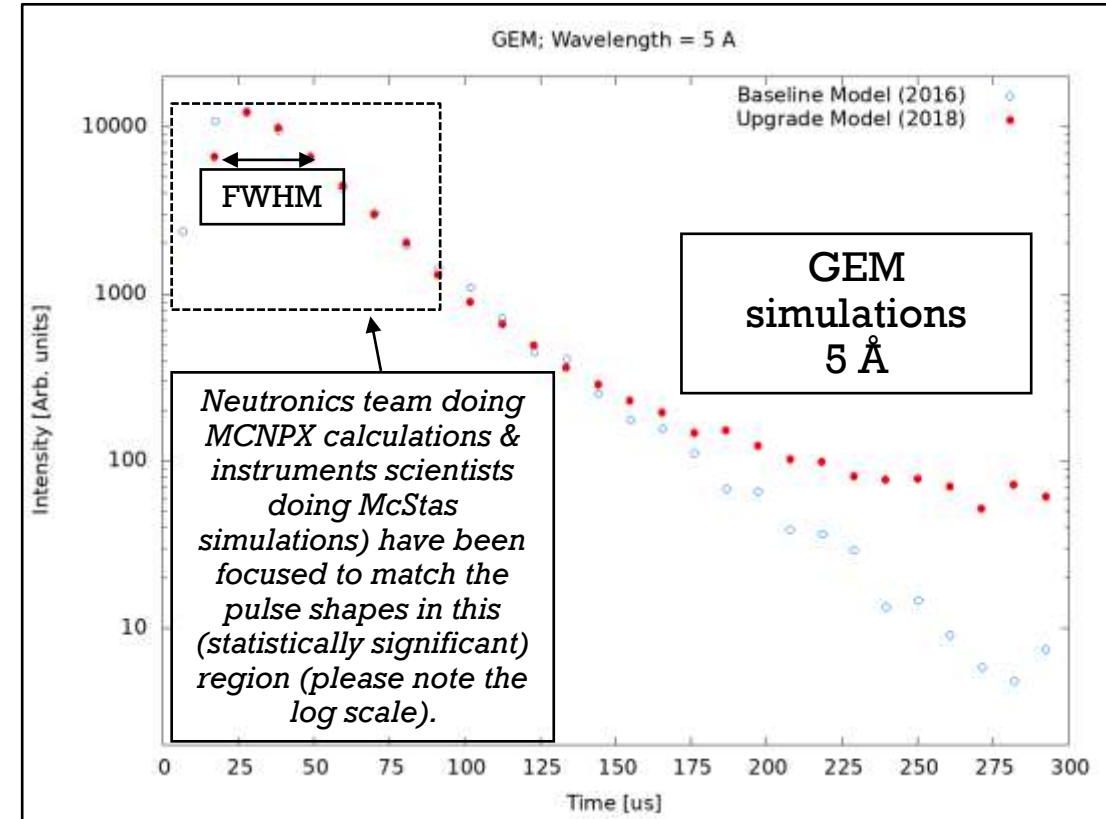
- Build-up to steady ops
- Methane system parameters took several months to optimise
- Unexpected 'tails' on methane pulse:
 - Cd 'beanie hat'
 - Investigated draining pre-mod

A plot of simulations for GEM beamline showing the 'tail'

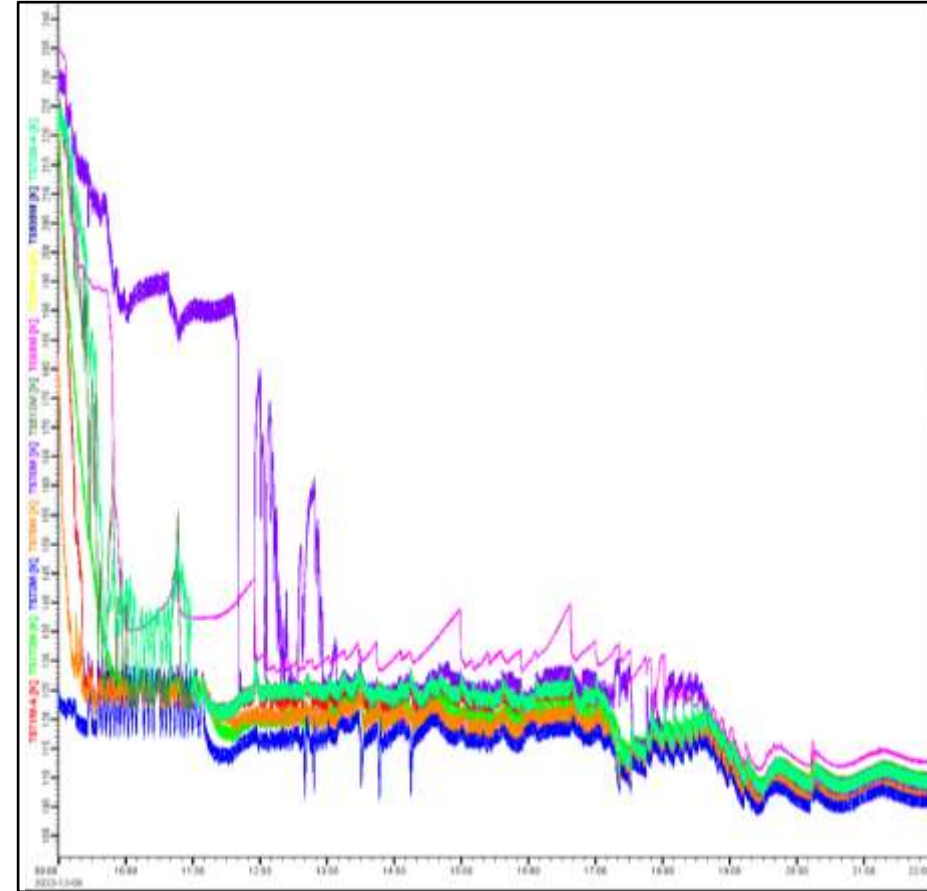
A control screen image for the temperature measurements during a CH₄ system cooldown
