The Operation of CSNS Cryogenic System

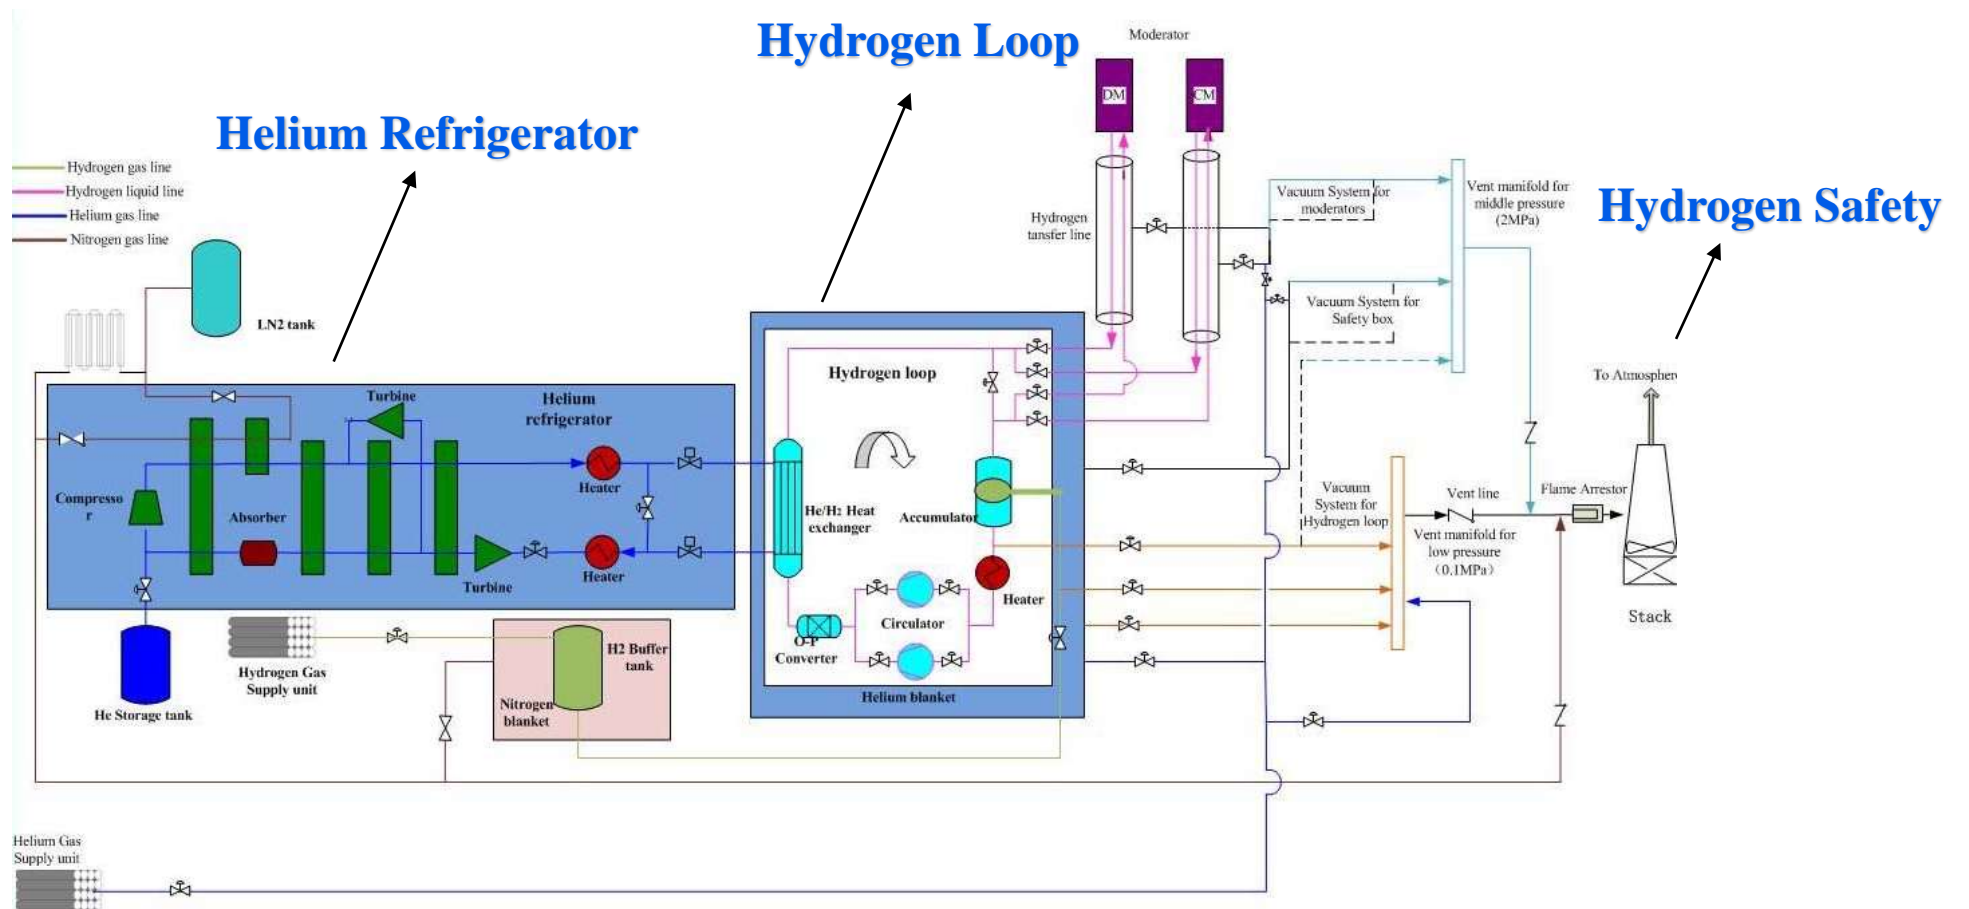
Flow diagram

The cryogenic system's flow diagram comprises three core components: the helium refrigerator, the hydrogen loop, and hydrogen safety system.

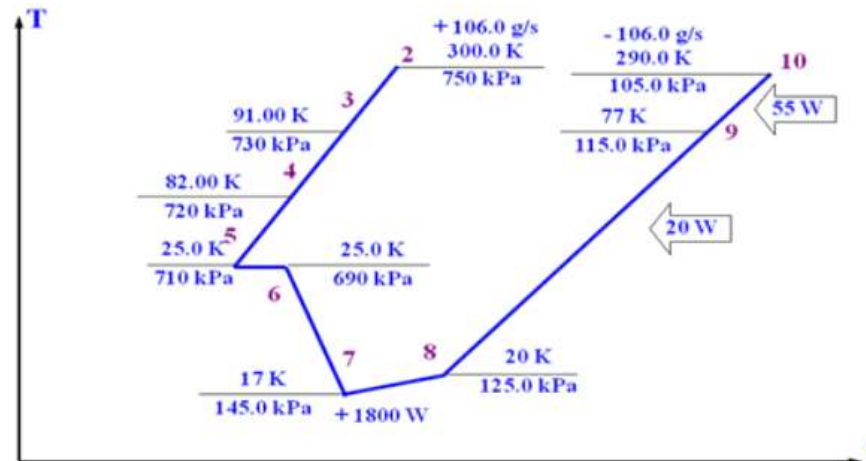
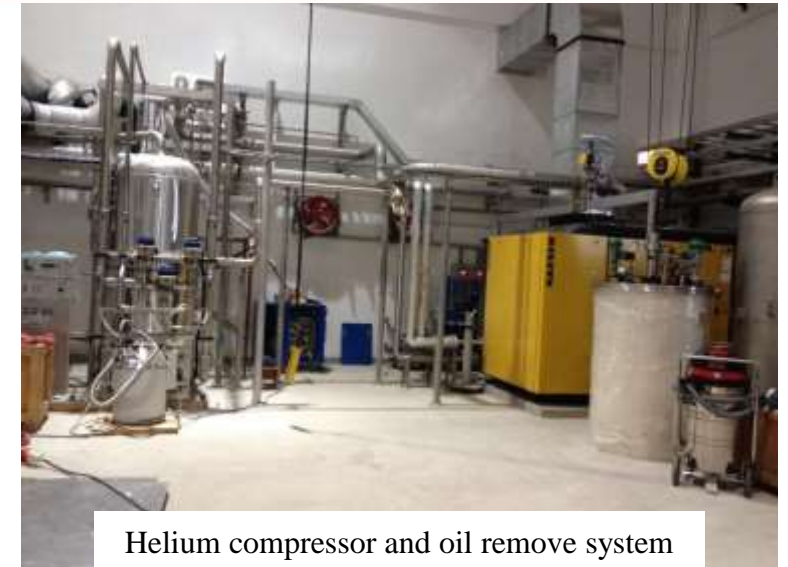
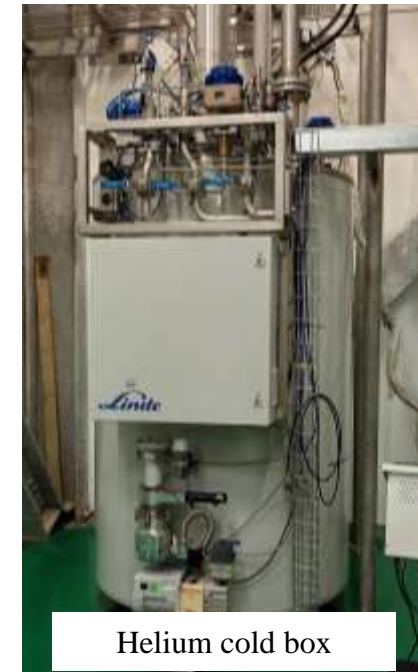
Helium compressor and oil remove system

Parameter	Value
Cooling capacity	2.2 kW@20K
Compressor Power	200 kW
Discharge Pressure	8.0 bar
Suction Pressure	1.5 bar
Inlet temperature of H2/He HEX	16.5 K
Turbo expander efficiency	70%
Mass flowrate	80g/s

Helium cold box

This is the flowchart and photo of the refrigerator, primarily consisting of a compressor, oil separator, and cold box. It employs a modified Claude cycle with a minimum turbine outlet temperature of 16K, achieving cooling down and warming up processes of the hydrogen loop through a hydrogen-helium heat exchanger.

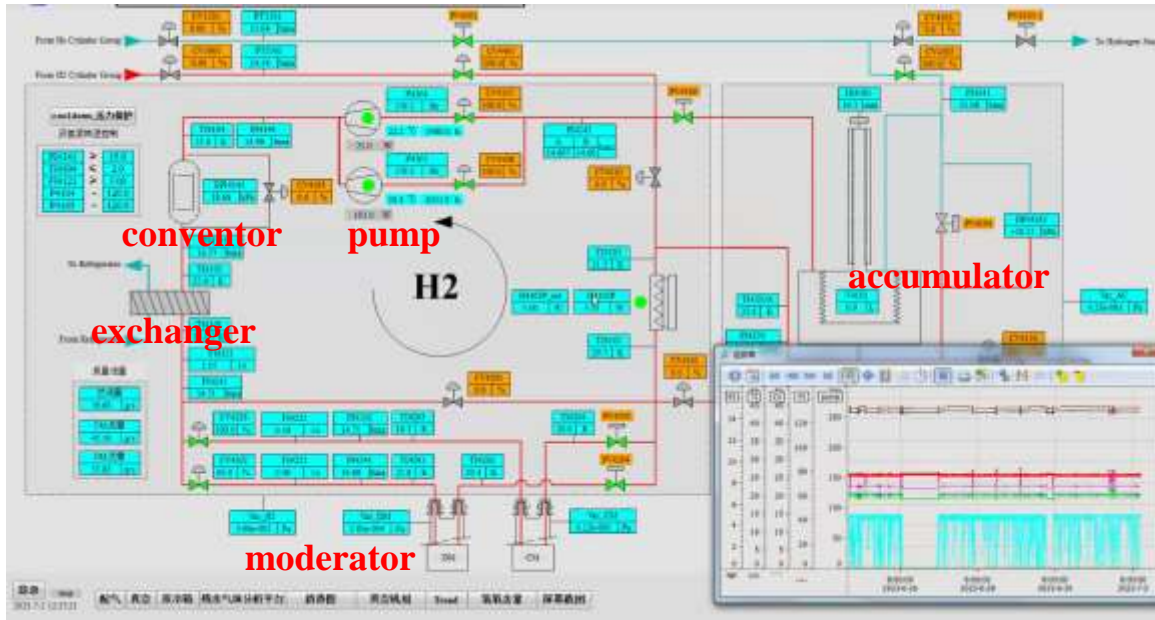
control Interface of hydrogen loop

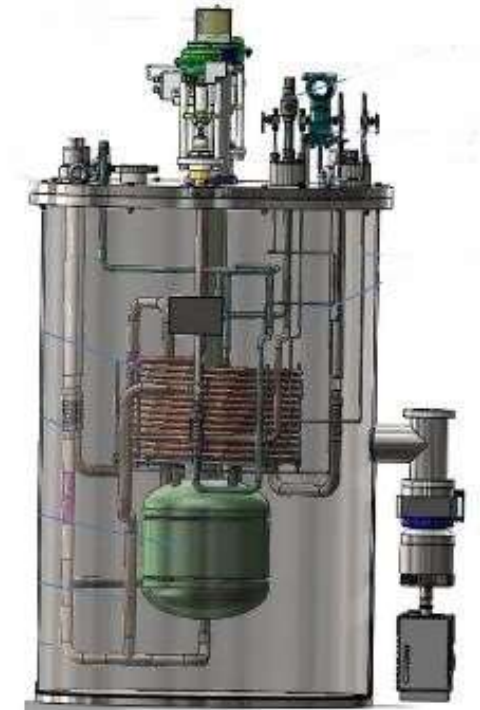
accumulator box

The hydrogen loop consists of a hydrogen cold box and accumulator box. The core principle is : Liquid hydrogen is directed into the ortho-para hydrogen converter via hydrogen pumps. The heat generated during the conversion of ortho-hydrogen to para-hydrogen is rapidly dissipated by the hydrogen-helium heat exchanger, which effectively lowers the overall cycle's average temperature. Moderators are located downstream of the heat exchanger, which is the coldest point within the system. The accumulator, which located upstream of the pump, is used to maintain a stable inlet pressure.

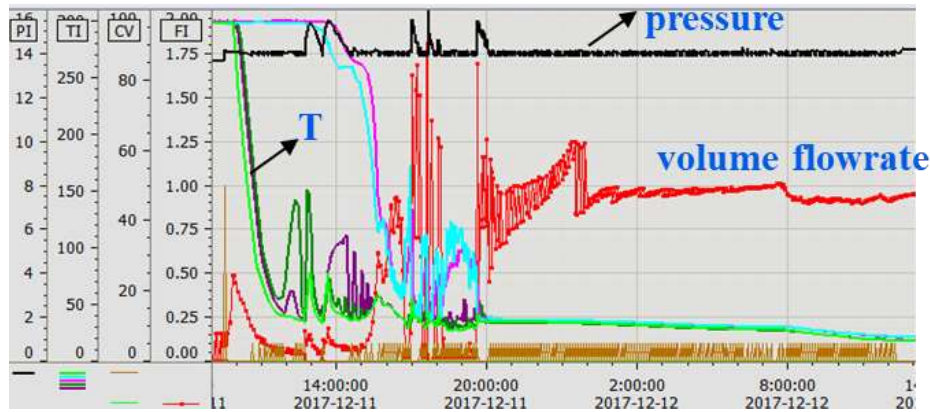
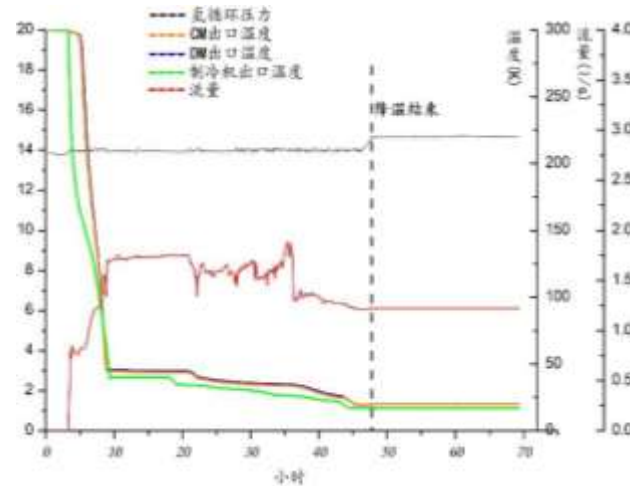
Typically, we perform cooling operations twice a year, following the Spring Festival and summer maintenance. The following chart depicts the annual cooling trends from 2017 to 2022.

2017

2019

2021

- In 2017 and 2018, the cooling down process experienced substantial temperature and pressure fluctuations. However, through adjustments to the cooling down logic, we achieved a consistent temperature drop without further fluctuations during the cooling process in 2019.
- Over the past three years, we have managed to reduce the cooling time gradually from 48 hours to 24 hours, maintaining a high level of stability and repeatability.
- As the cryogenic system's control logic continues to improve, manual interventions have significantly decreased, and we have effectively transitioned to automated cooling procedures.

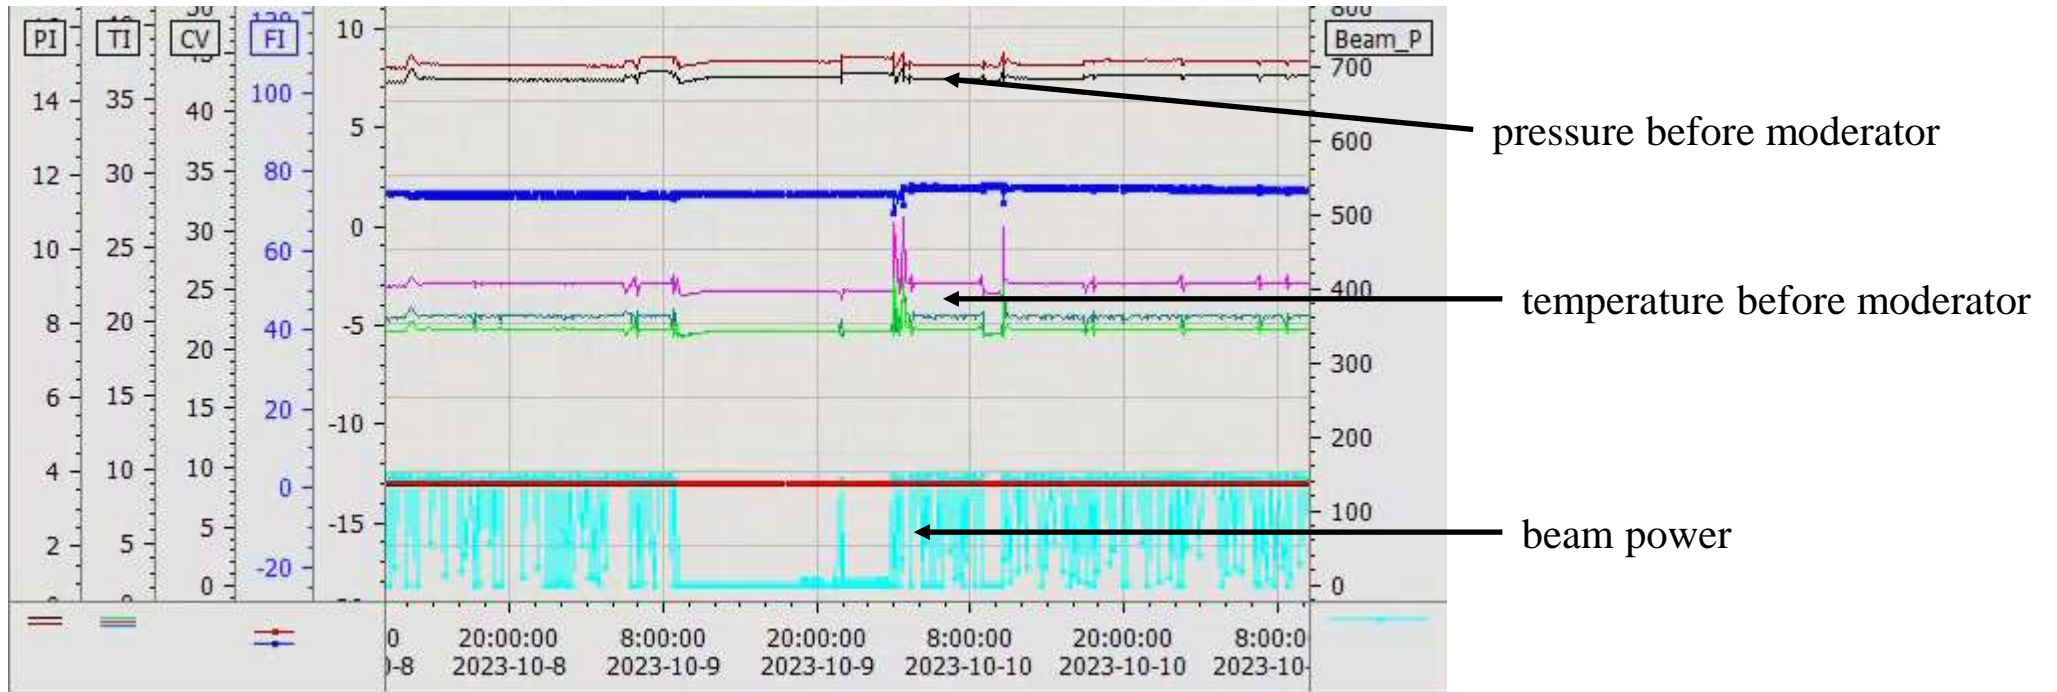
When the beam power is supplied and withdrawn frequently, the cryogenic system experiences significant pressure and temperature fluctuations. To maintain system pressure stability, we employ an accumulator and electric heater. When pressure changes occur, accumulator can additionally supply up to 4 liters of liquid hydrogen to the system. During beam power withdrawal, the electric heater provides a thermal load that equivalent to the beam power, to keep the load stable.

Through these measures, we have maintained the moderator pressure within the range of 14.4-14.8 bara, with a maximum temperature fluctuation of less than 3 K, and the system can return to stability within half an hour.

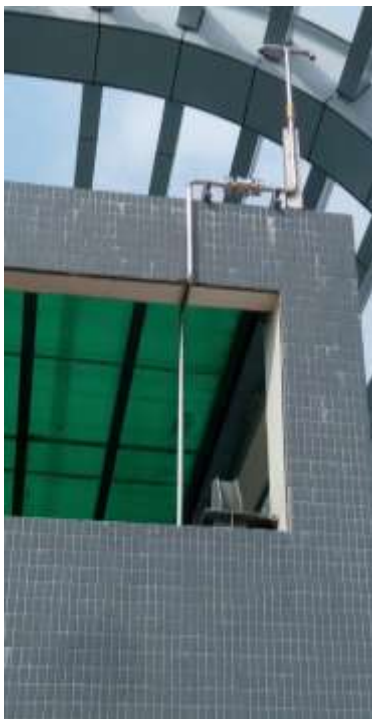
In emergency vent mode, the 20K cryogenic hydrogen is directly discharged into the hydrogen vent pipe.

- At the outlet of the vent pipe, the temperature of the hydrogen must be maintained above the temperature of liquid air (about 81K) to prevent the backflow of liquid air.
- The temperature of the hydrogen should be kept above the freezing point of nitrogen at the point where the vent pipe connects to the nitrogen pipe.

Part of hydrogen vent line

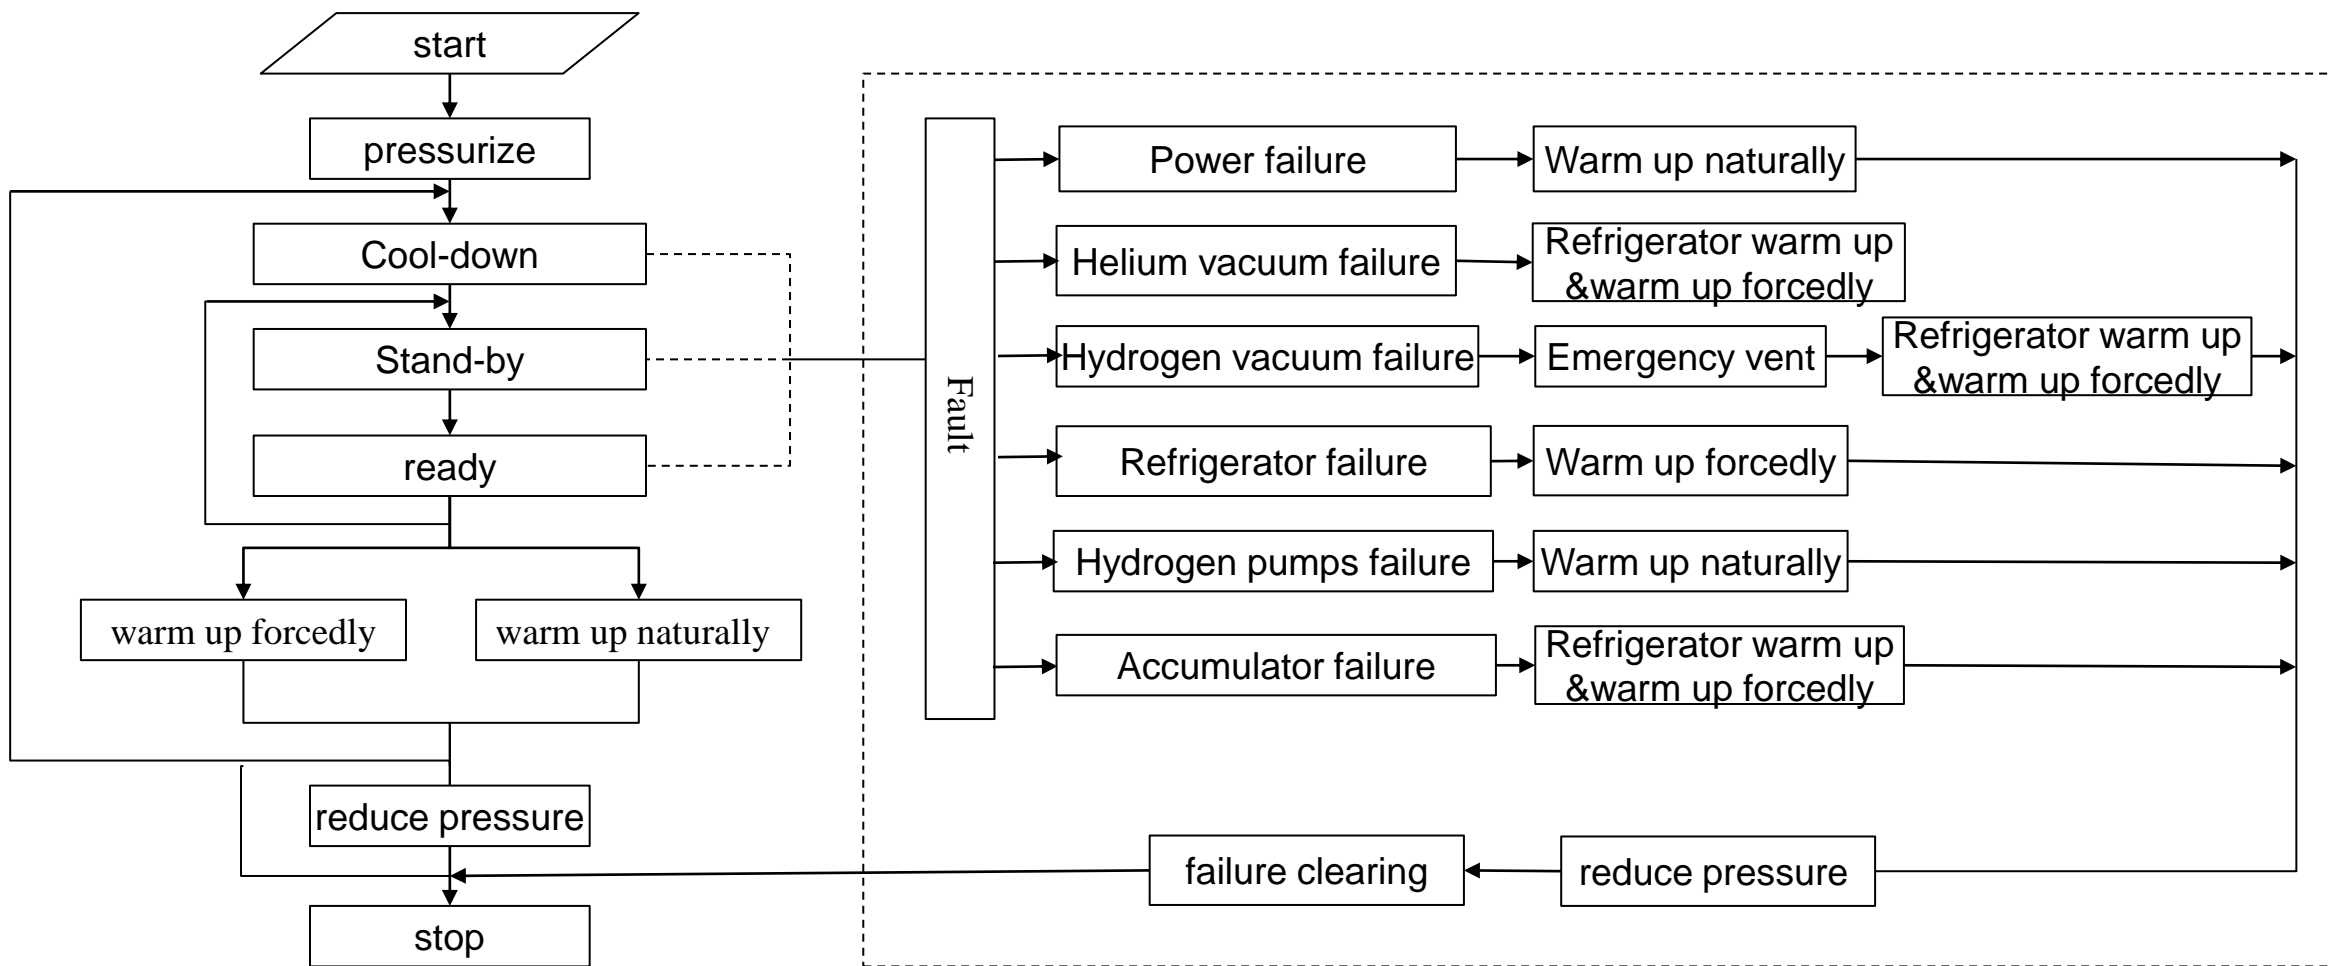
Interlock is the core of the entire system's stability and safe operation. After the system pressurizes and cools down, it goes into a stand-by mode once it's in position. The central control at the target station can supply the beam power upon receiving our 'ready' signal. In case of a malfunction, the system will initiate interlocks based on the type of fault. Beyond forcedly warm up and naturally warm up modes, there is also an emergency vent mode, which rapidly expels hydrogen from the system to ensure safety.

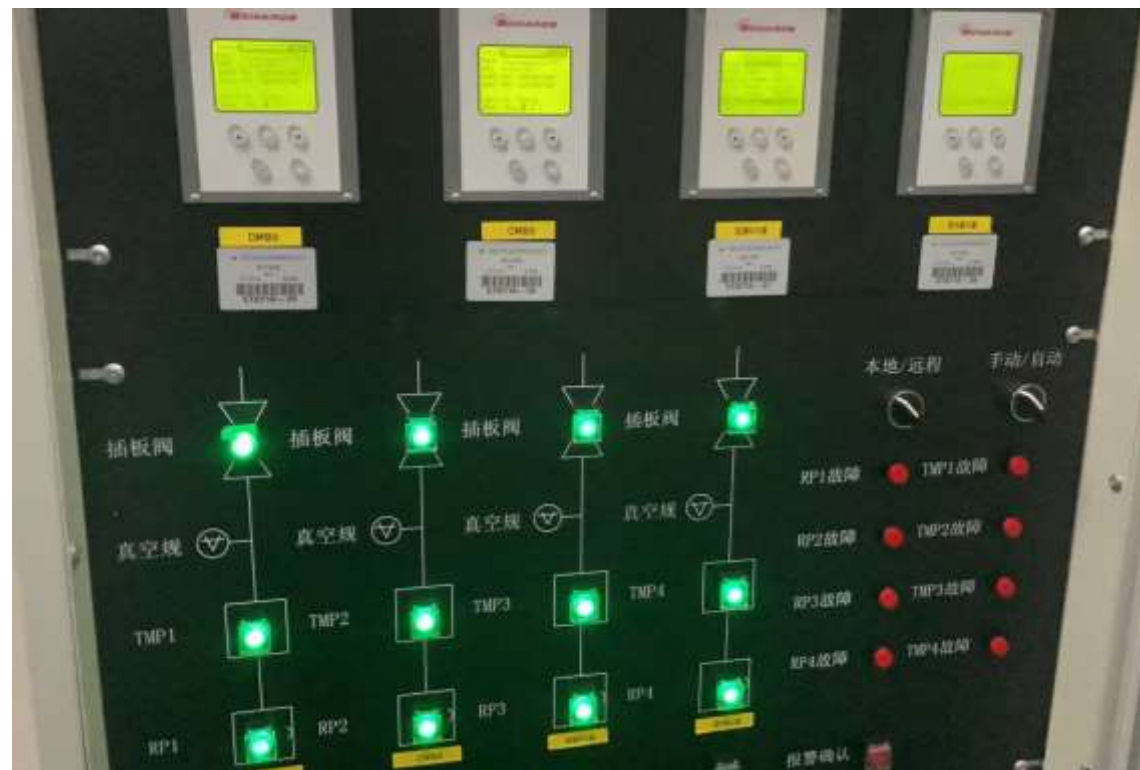
We utilize five sets of molecular pumps in conjunction with mechanical pumps to evacuate the hydrogen cold box, accumulator, refrigerator box, and two cryogenic pipelines. This evacuation process ensures that the pressure within the vacuum interlayer remains below $10\text{e-}3$.

In the event that the pressure exceeds 1Pa , an alarm signal is triggered, and the molecular pump is halted. The duty personnel then conduct an inspection to identify any potential air, helium, or hydrogen leakage. Based on their assessment, they make a determination on whether to initiate a warming-up procedure as necessary.

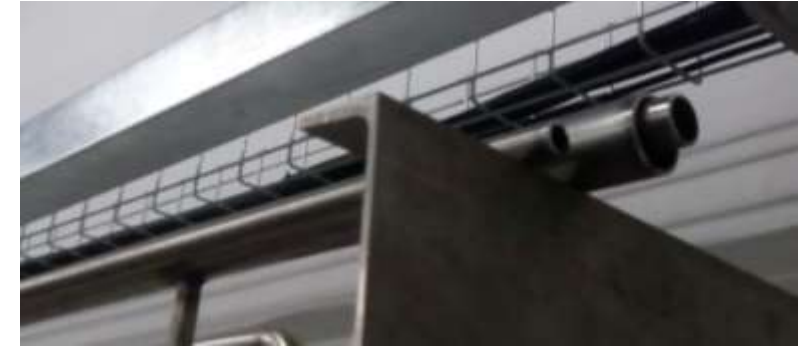
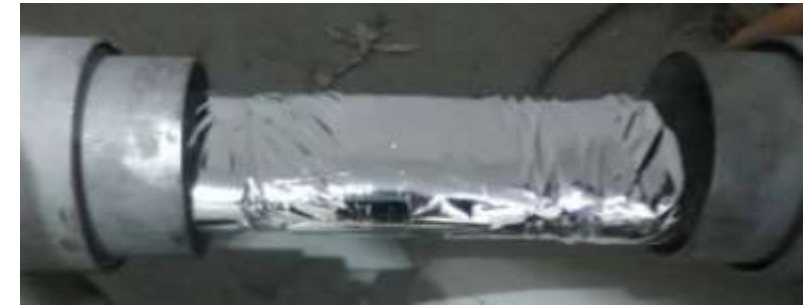
The hydrogen pipeline in the target station hall is designed with a gas protective layer. The room-temperature hydrogen pipeline is safeguarded by N₂, while the cryogenic hydrogen pipeline is protected by He in addition to the vacuum layer.

The pressure of the N₂ and He layers is automatically regulated within the range of 1.2 to 1.5 bara. If the N₂ pressure exceeds this adjustment range, an alarm will be triggered, and the system will undergo a forced warm-up process. However, when the He pressure exceeds the adjustment range, and the vacuum layer pressure remains stable, normal operation can be sustained until a scheduled periodic shutdown.

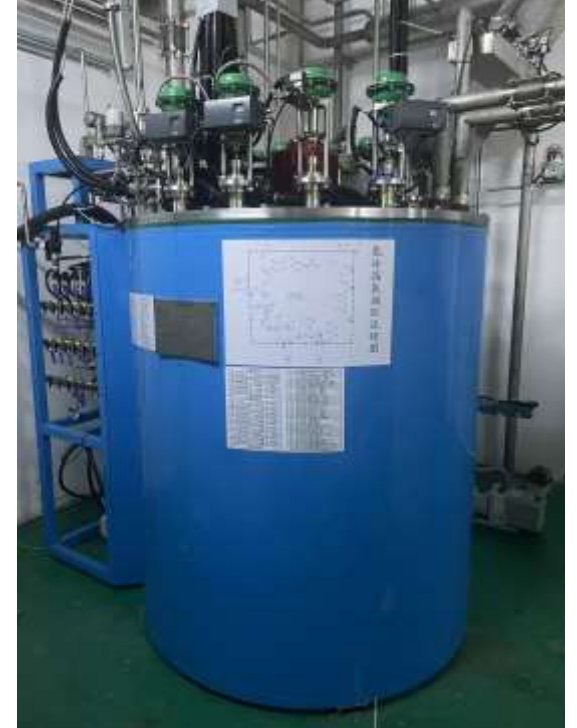
The hydrogen loop is designed to maintain the pressure within the range of 14 to 15 bara. If the pressure cannot be adjusted and continues to rise, safety valves and bursting discs are employed as safety measures.

In addition, when the temperature exceeds 22K, an alarm signal will be activated. The duty personnel will then conduct an inspection to determine if there is any leakage or a failure in the refrigerator.

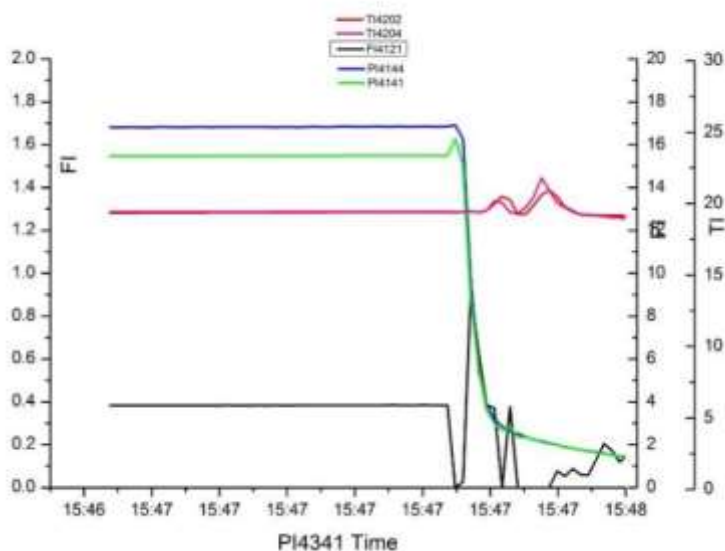
At 14:47, there was a sudden and significant increase in hydrogen loop pressure, exceeding the bursting disc's set value, which led to an emergency discharge of liquid hydrogen.

Cause: The incident was triggered by the need for critical tasks, such as replacing the bursting disc and conducting helium purging. The cryogenic system was re-cooled down at 21:00. Early on the morning of the 11th, during the cooling process, pressure began to rise uncontrollably, necessitating a prolonged deflation. Upon inspection, internal leakage in the hydrogen supply valve CV5001 was discovered.

Pressure and temperature changes during the failure

Solution: To address the issue, the pneumatic ball valve at the front end of CV5001 was synchronized for opening and closing, and the faulty valve was replaced during the summer maintenance period. The fault resolution took a total of 73 hours.

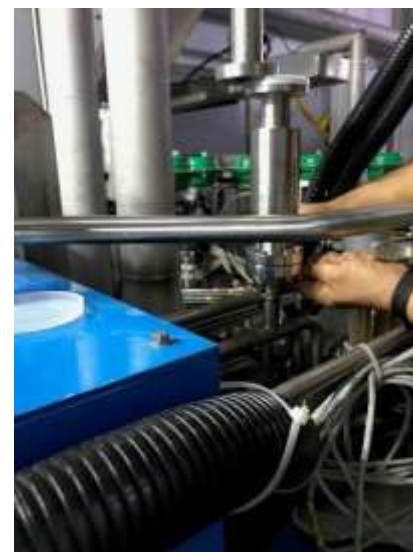
Replace bursting disc

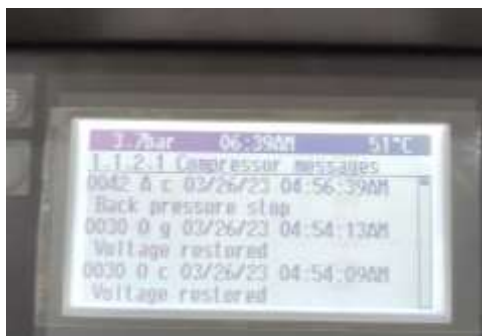
Cause: Upon inspecting the refrigerator room, our attention was drawn to an issue with the Uninterruptible Power Supply (UPS) that had switched to bypass, and the panel indicated that the inverter was OFF. To uncover the root cause of the incident, we reviewed the historical data of the refrigerator and confirmed that the control system lost power for one minute. This confirmed that the UPS was the source of the failure.

Compressor voltage restored

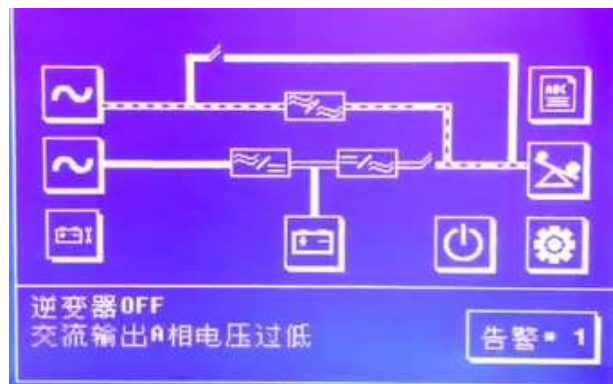
UPS switched to bypass
