Trial of defect finding using machine learning

The 11th IHEP-KEK SCRF Collaboration Meeting

KEK iCASA SRF group

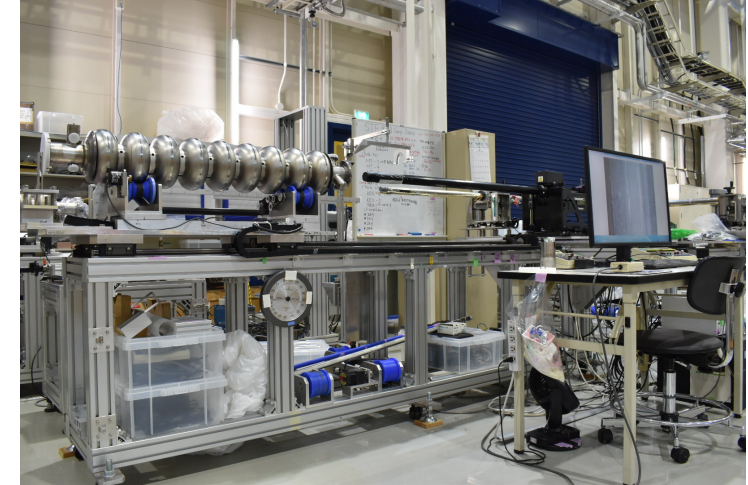
Optical inspection machine in KEK.

- “Defect”
 - Reason of **limiting the acceleration gradient**
 - Impurities: Large surface resistance
 - Bump and dip: Local enhancement
- Optical inspection machine
 - Developed in 2008
 - Resolution: 3418 x 2616
 - Field of view: ~8 x 6 mm²
 - About 3,000 pictures per one 9-cell cavity

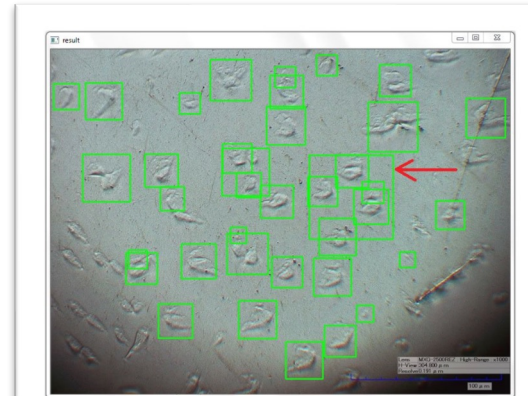
Figure 1: This is the output image for one of the positive test pictures from the Easy folder. One of the false positives is indicated by the arrow. It counted as a false positive for two reasons: more than 50% of contained defect area was contained in other, true positives, and it contained defects separated by more than 10 μm .

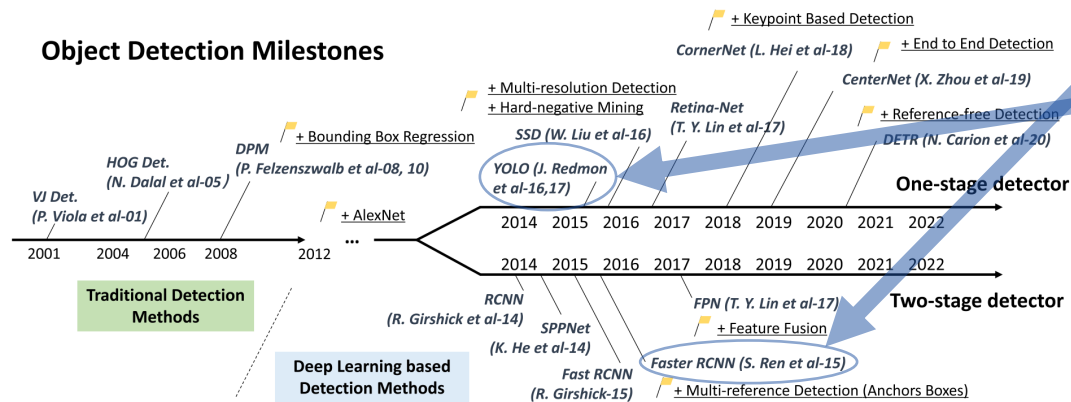
Fig. 2. Road map of object detection. Milestone detectors in this figure: VJ Det. [10], [11], HOG Det. [12], DPM [13], [14], [15], RCNN [16], SPPNet [17], Fast RCNN [18], Faster RCNN [19], YOLO [20], [21], [22], SSD [23], FPN [24], Retina-Net [25], CornerNet [26], CenterNet [27], and DETR [28].

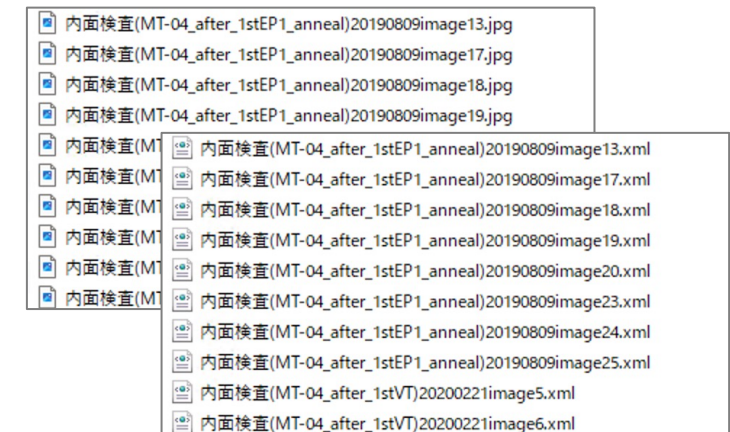
- **3,984** pictures (from 2010 to 2021)
 - Checked by an expert (more than 10 years of experience)
 - Took 3 weeks

Dataset (pairs of .jpg and .xml)

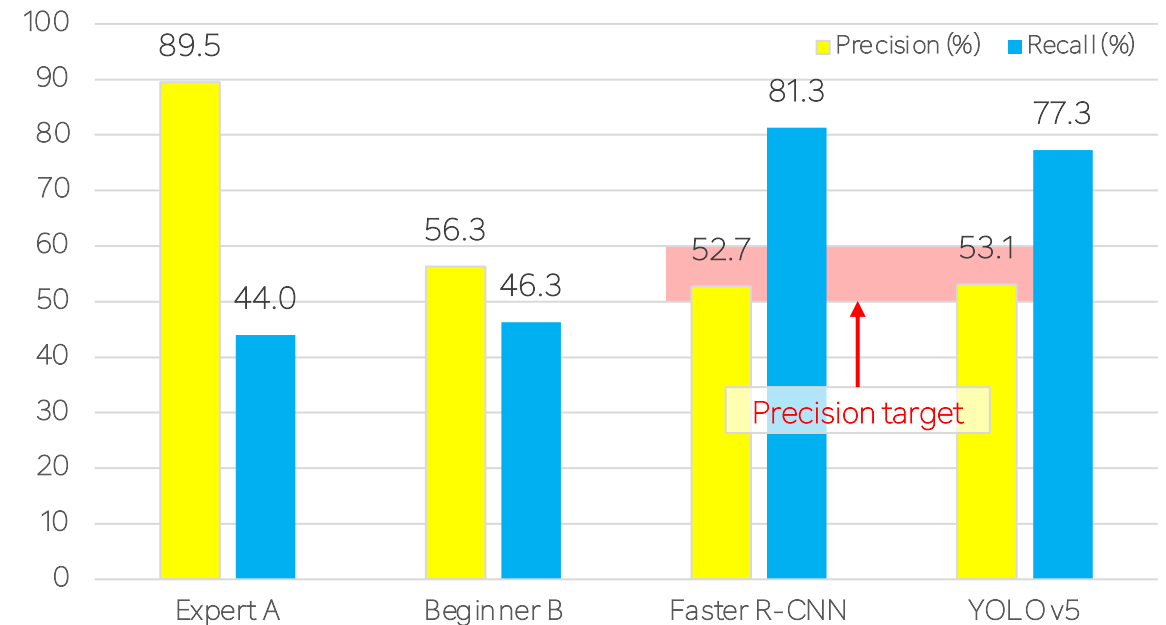
- Auto detection software
 - Threshold was set to achieve **50-60% of precision.** (for screening purpose)
 - Inference: a few seconds
- Manual inspection
 - Expert A: A different person from the dataset creator
 - Beginner B: Received only a brief explanation
- Test data
 - 100 pictures
 - A part of past inspection data in KEK
 - Excluded from the dataset
 - “Correct answers” are defined by the dataset creator.

- Expert A had highest precision.
- Target value of precision was similar level of Beginner B.
- Both architectures had much **higher recall** than manual inspection.
- No large difference between architectures.

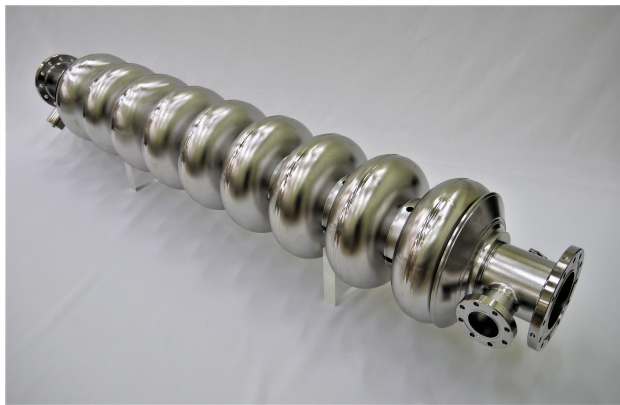
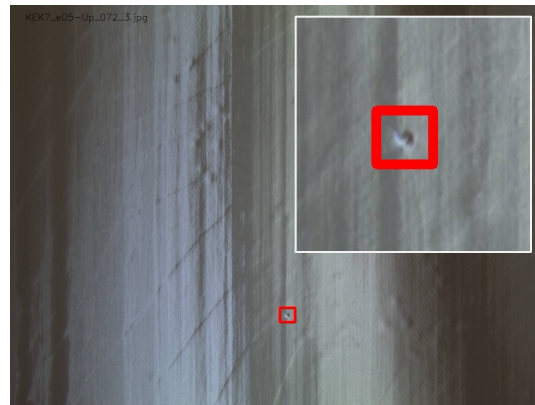
- New cavity KEK-7
 - Fabrication finished in March 2022.
 - Completely excluded from the dataset.
 - Newest cavity in KEK
→ Expected most advanced welding technique
- Test data: inspection after EP-1
 - Total 2,694 pictures
 - **One defect (three pictures)** including the defect)
 - Features specific to this cavity:
 - Noticeable grain boundaries
 - Bubble marks of EP acid

- Software setup
 - Same model/parameter as Benchmark 1.
 - Inference: ~90 seconds
- Result
 - Number of pictures detected to contain defects:
 - Faster R-CNN: 246
 - YOLO: 618
 - Both architectures **successfully detected all the defects** in 3 pictures.
 - Faster R-CNN had higher precision (the threshold seemed too low for YOLO).
 - Other detected objects were mainly small scratches on irises.
