# COFFEE3 test beam at SPS

# Beam information:

SPS H8 PPE138, Mixed hadron beam, 180 GeV/c, approximately  $2 \times 10^6$  particles/spill

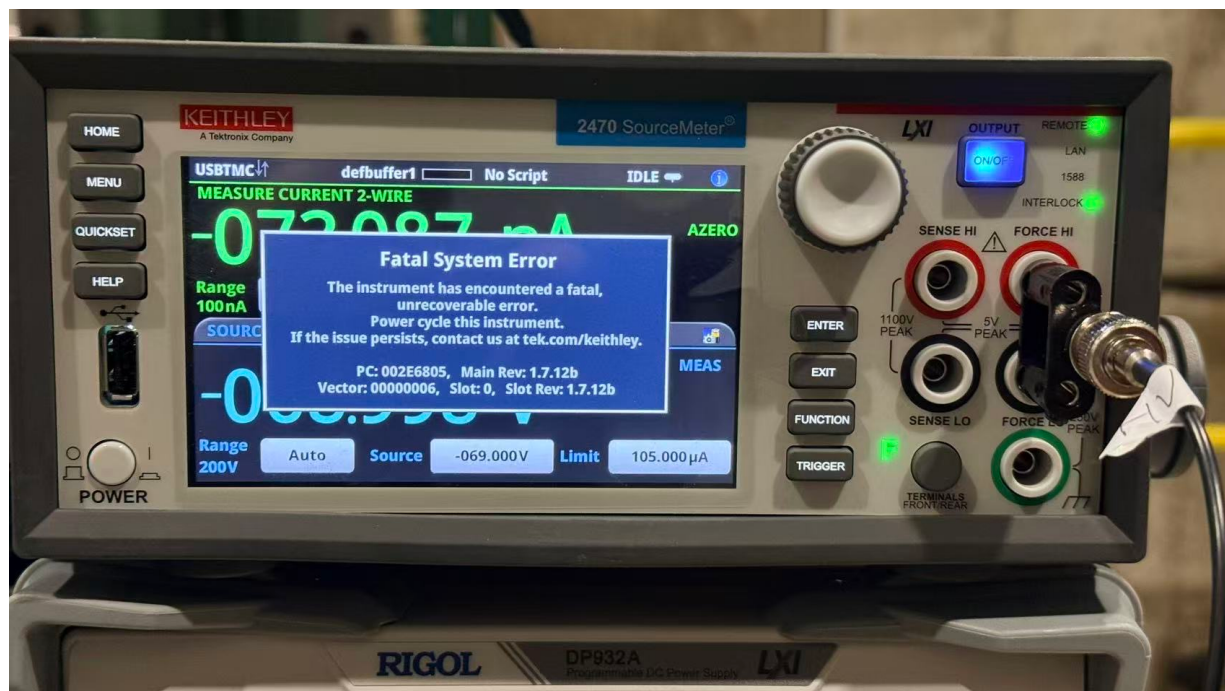
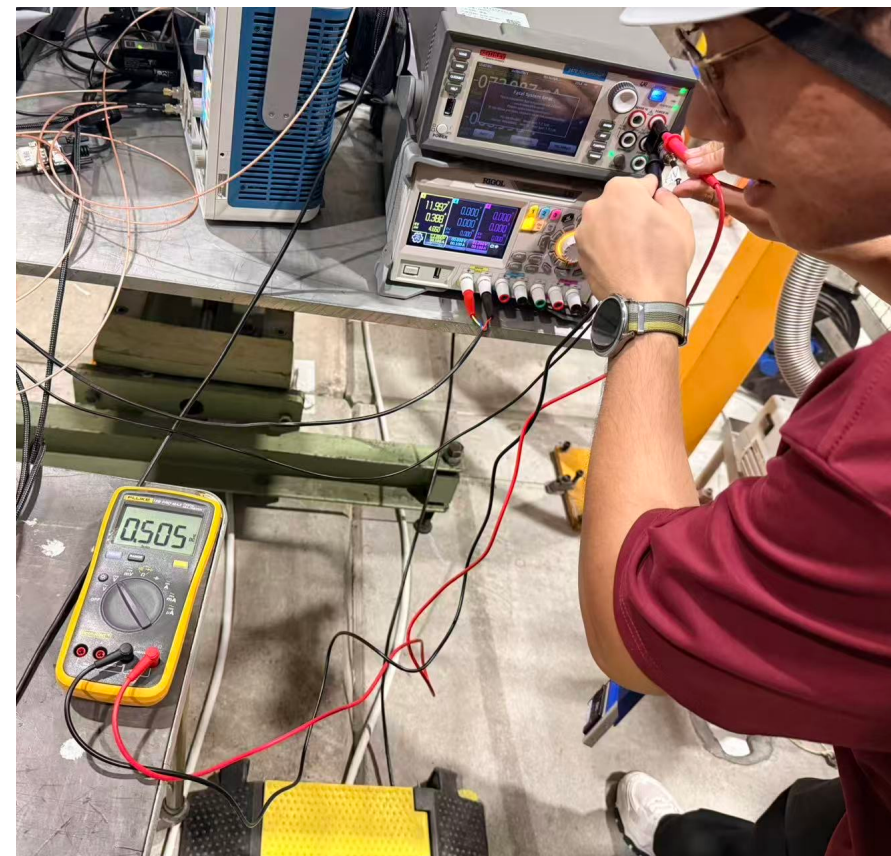
## 2470 fatal system error

12 July 发现2470 fatal error, 但当时从取数结果看没有看到明显的高压lost。说明书提到这种情况会保持最后设定的输出电压, 遂决定继续取数。

14 July 测量2470的输出端只有 - 0.5 V 电压。
