# Large-diameter carbon nanotube fiber for H-/proton beam diagnostics: fabrication, test and implementation at CSNS accelerator

Zhijun Lu, **Chunjie Xie**, Biao Zhang, Fang Li, Renjun Yang, Huachang Liu, Xiao Li, Xin Qi, Sheng Wang, CSNS/IHEP, Dongguan, China

# New Materials for high-intensity beam monitor

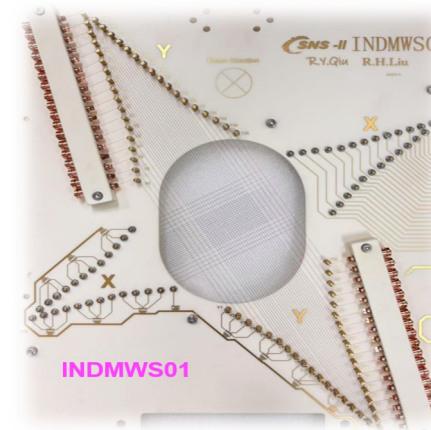
- RCS SEM-Grid uses 100  $\mu\text{m}$  carbon nanotube (CNTF) material, total of 136 wires, minimum wire spacing 1.55 mm
- Injection region  $\text{H}^-$  beam horizontal/vertical fitting rms values 2.96/1.96 mm, same as expect
