# Radiation damage studies in LHCb vertex detector

**Shanzhen Chen (陈缮真)**

IHEP seminar  
8 January 2019

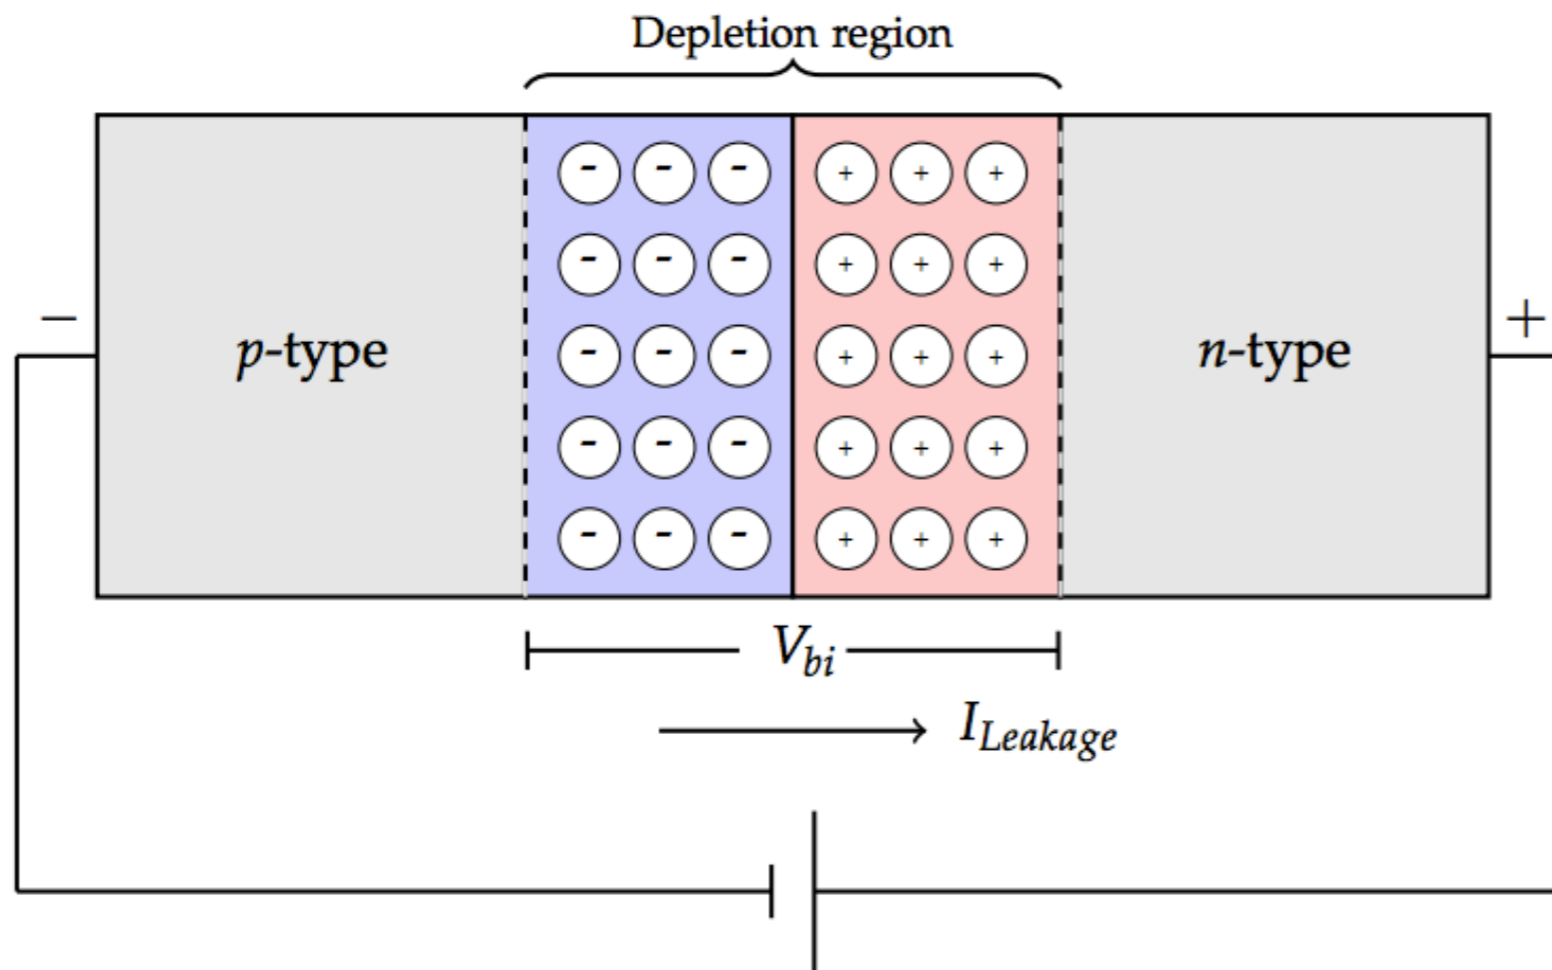
# p-n junction in a silicon sensor

- Silicon doped with group 13 elements (p-type) or group 15 elements (n-type)
- Bias voltage applied on p-n junction can increase the depletion region to the whole junction
- Charged particle traversing silicon will create electron-hole pairs and deposit energy
- Energy deposit within depletion region will be collected at the edge of the silicon

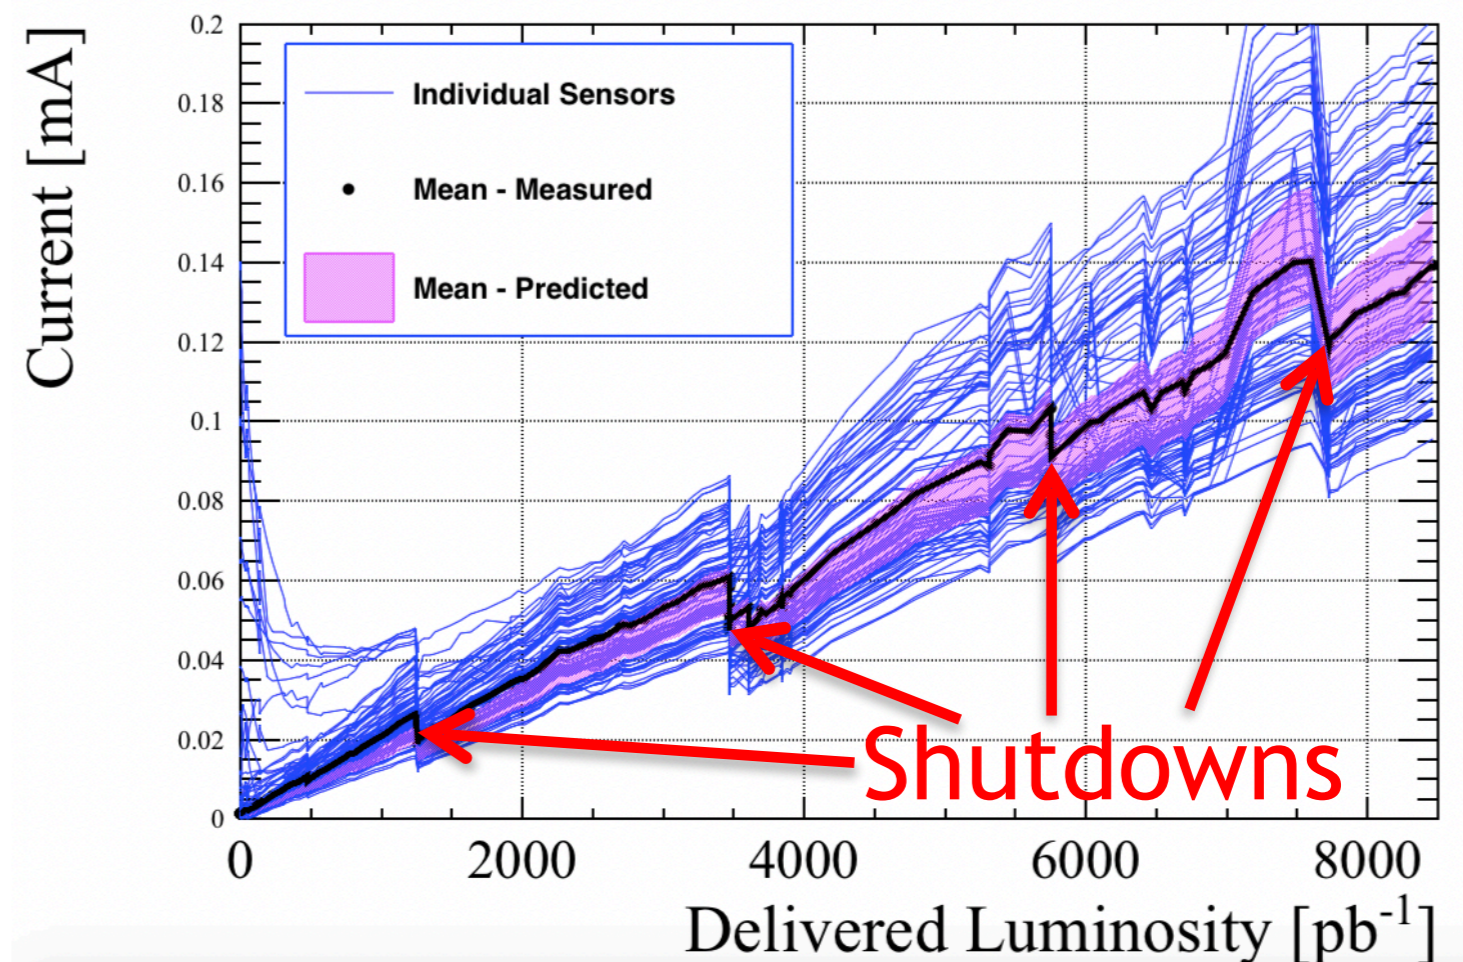
LHCb VELO preliminary

- Continue to observe the linear increase in bulk leakage currents with delivered luminosity
  - Different slopes reflect particle densities in different parts of detector
- As expected, significant decrease after shut downs due to annealing of radiation damage

IV curves are taken semi-automatically at the end of fills

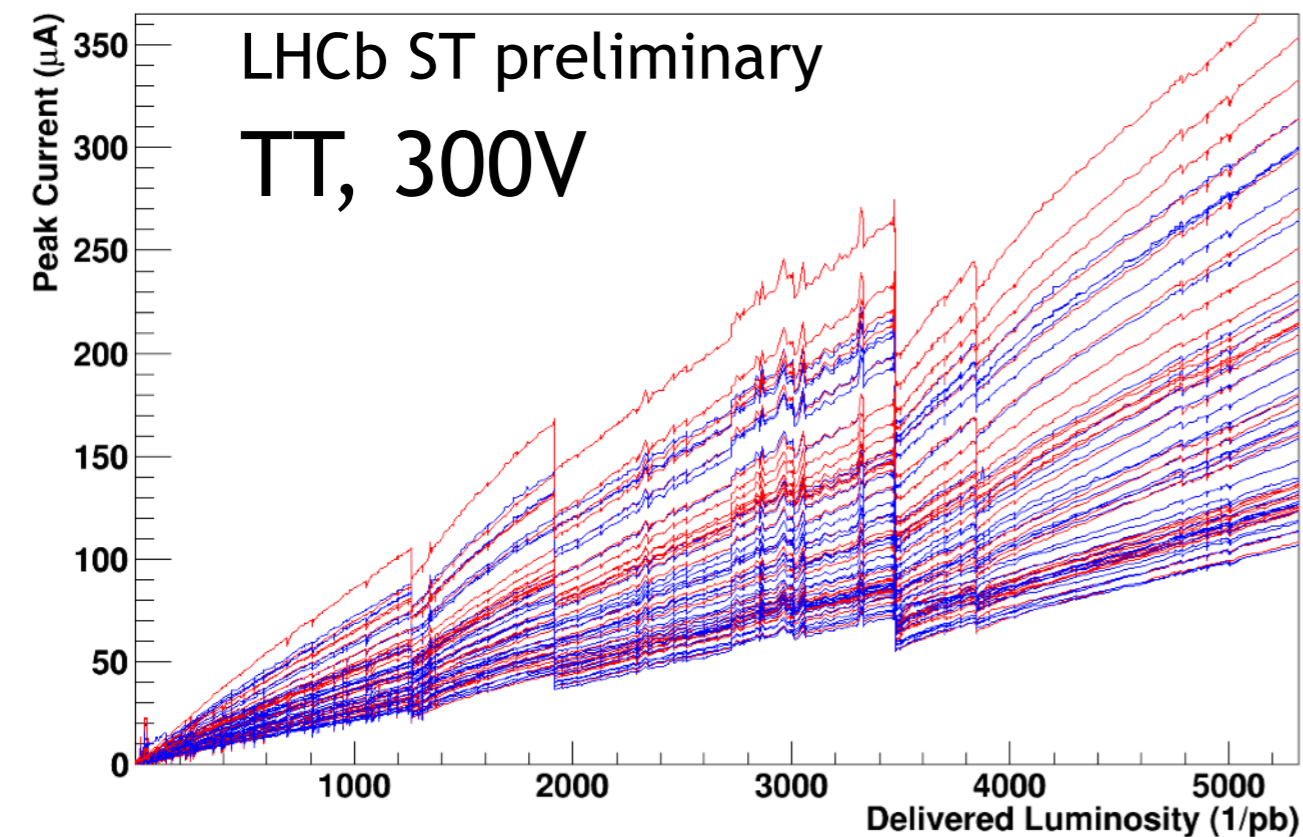
# Leakage currents (ST)

- Similar trend for silicon trackers
- Linear increase of leakage currents as function of delivered luminosity, with drops during shutdowns

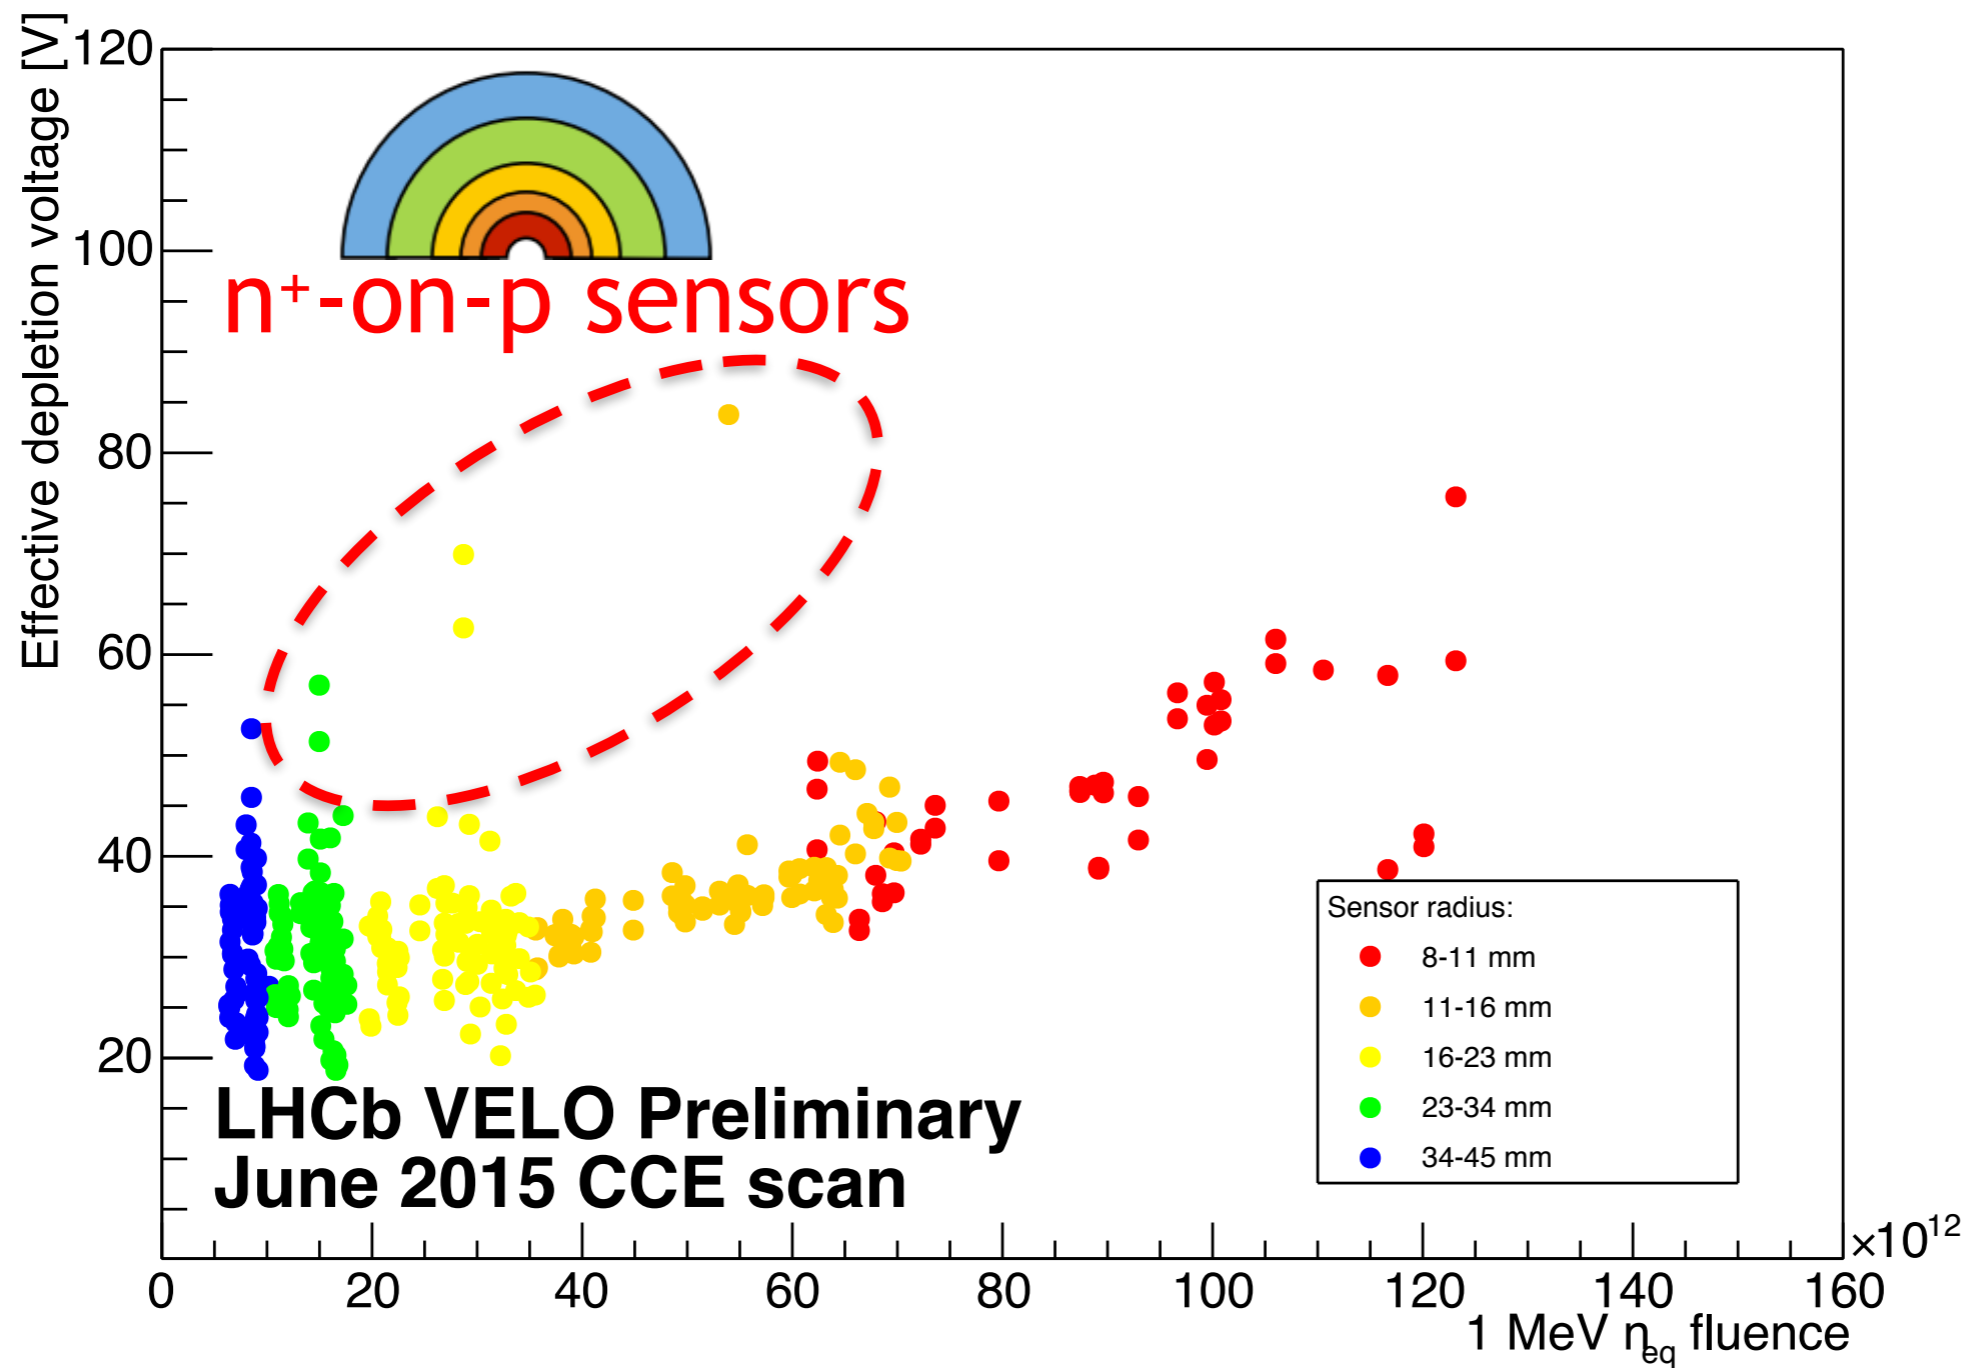
## First CCE scan from Run 2

- Define effective depletion voltage (EDV) as the voltage where MPV is 80% of maximum

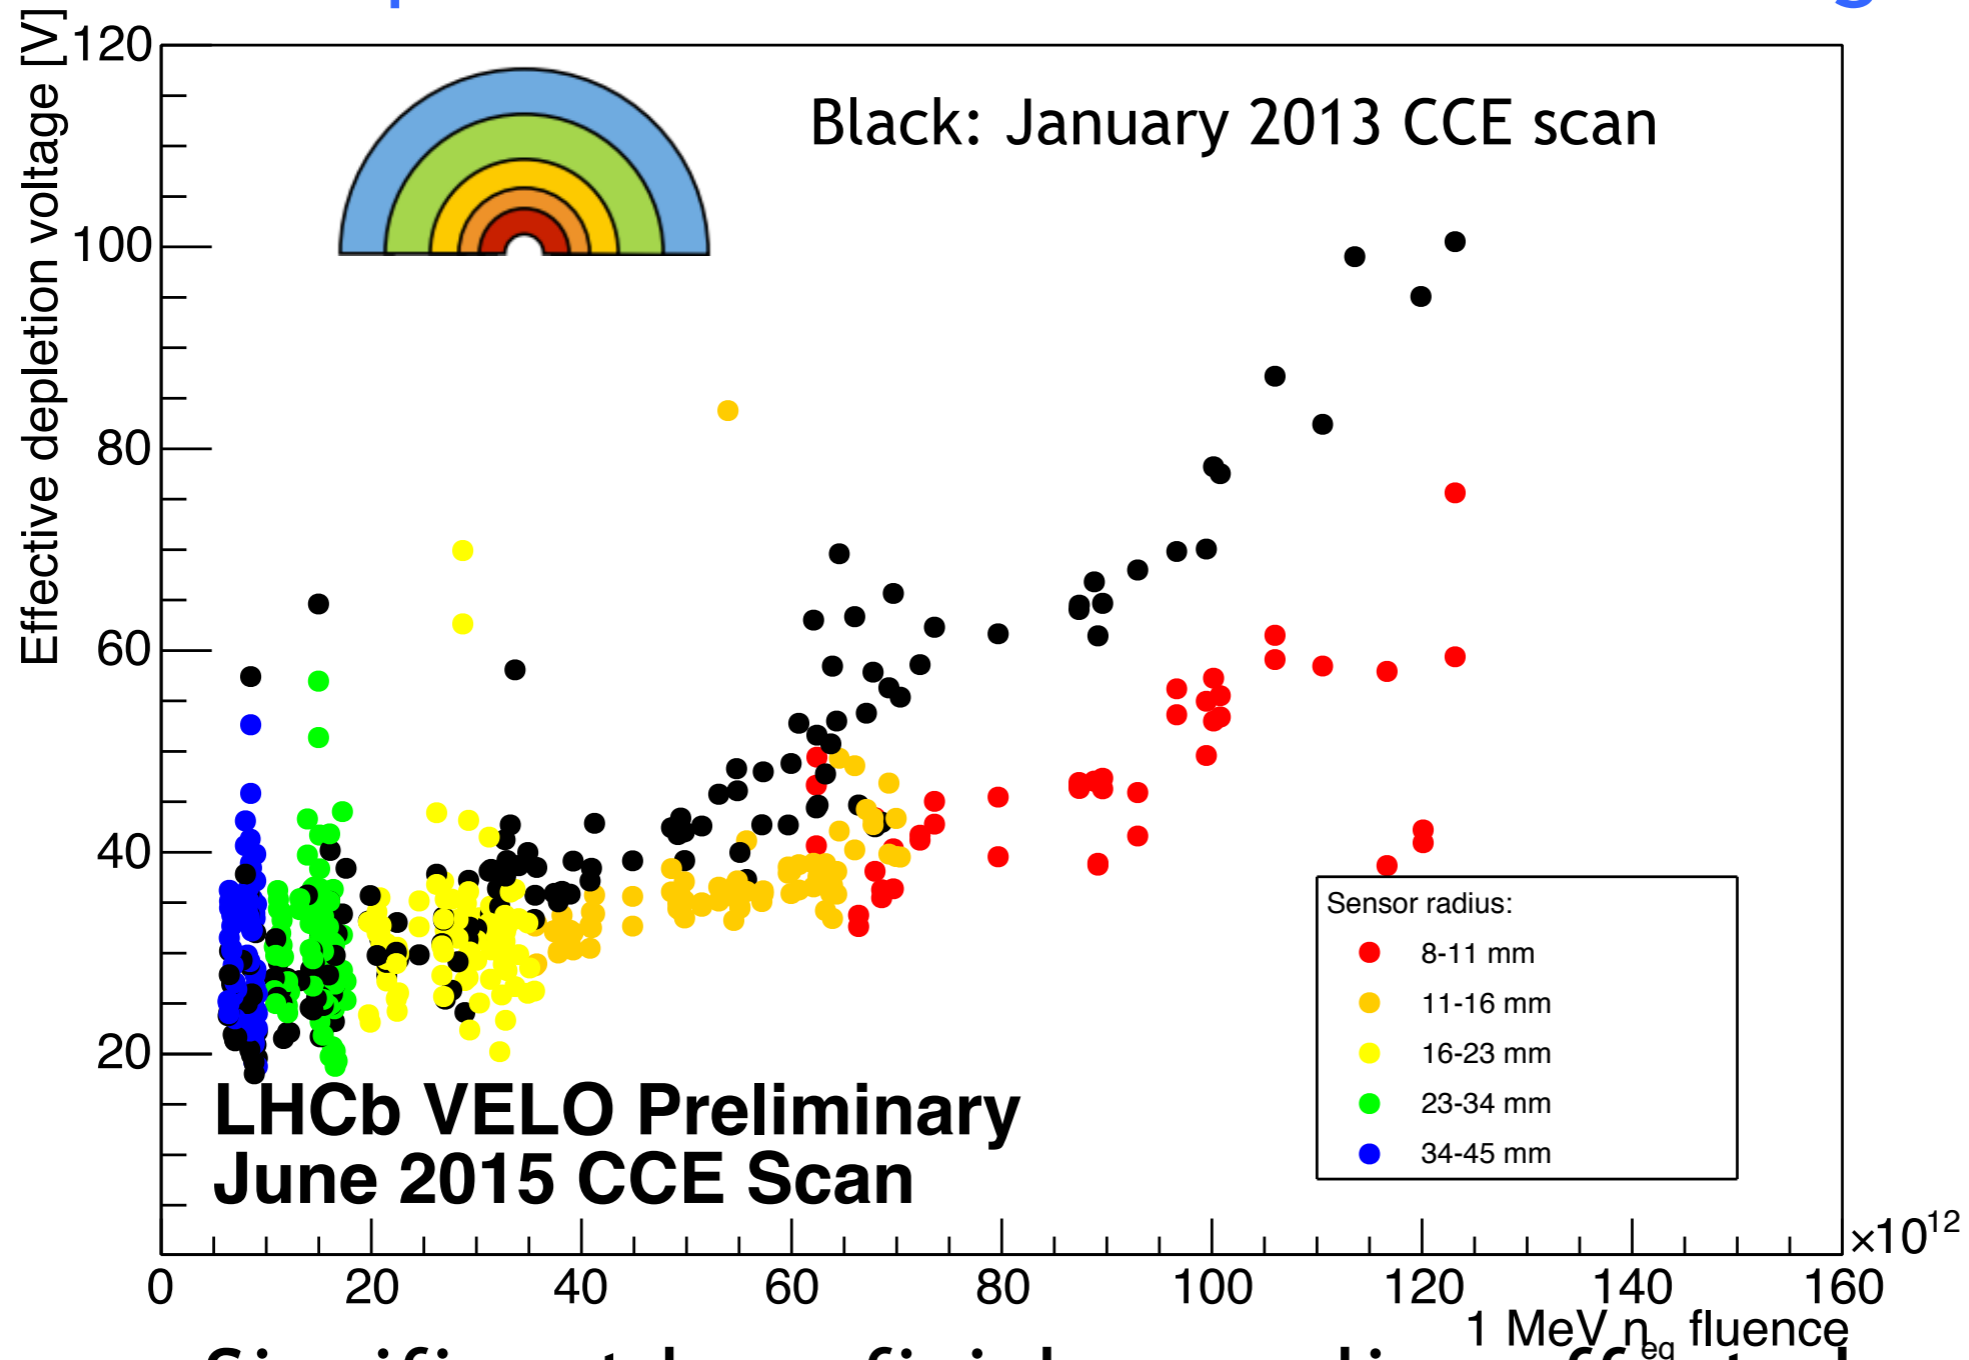
Compare it with the last CCE before long shutdown-I

Significant beneficial annealing effect observed

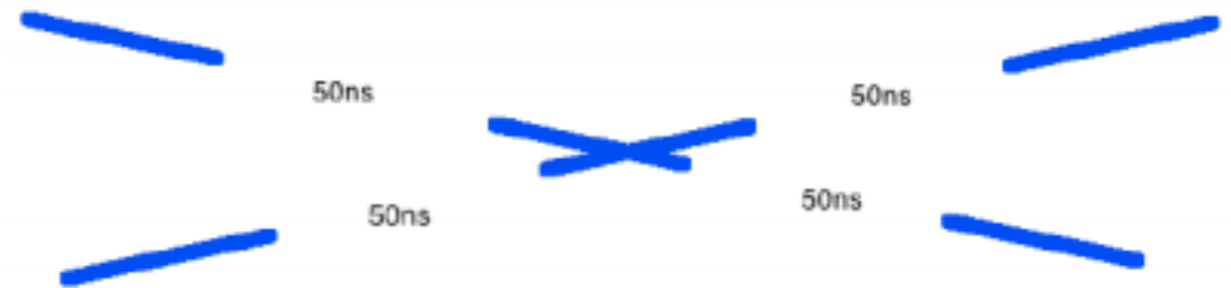
Number of Tracks (50ns)

- The 25 ns bunch spacing could introduce spill-over tracks.
- Using 50 ns bunches to study the number of tracks in the empty bunches and collision bunches

- Less than one spill over track in the empty-empty crossings on average, the number of spurious tracks “spilling over” bunch crossings is negligible.

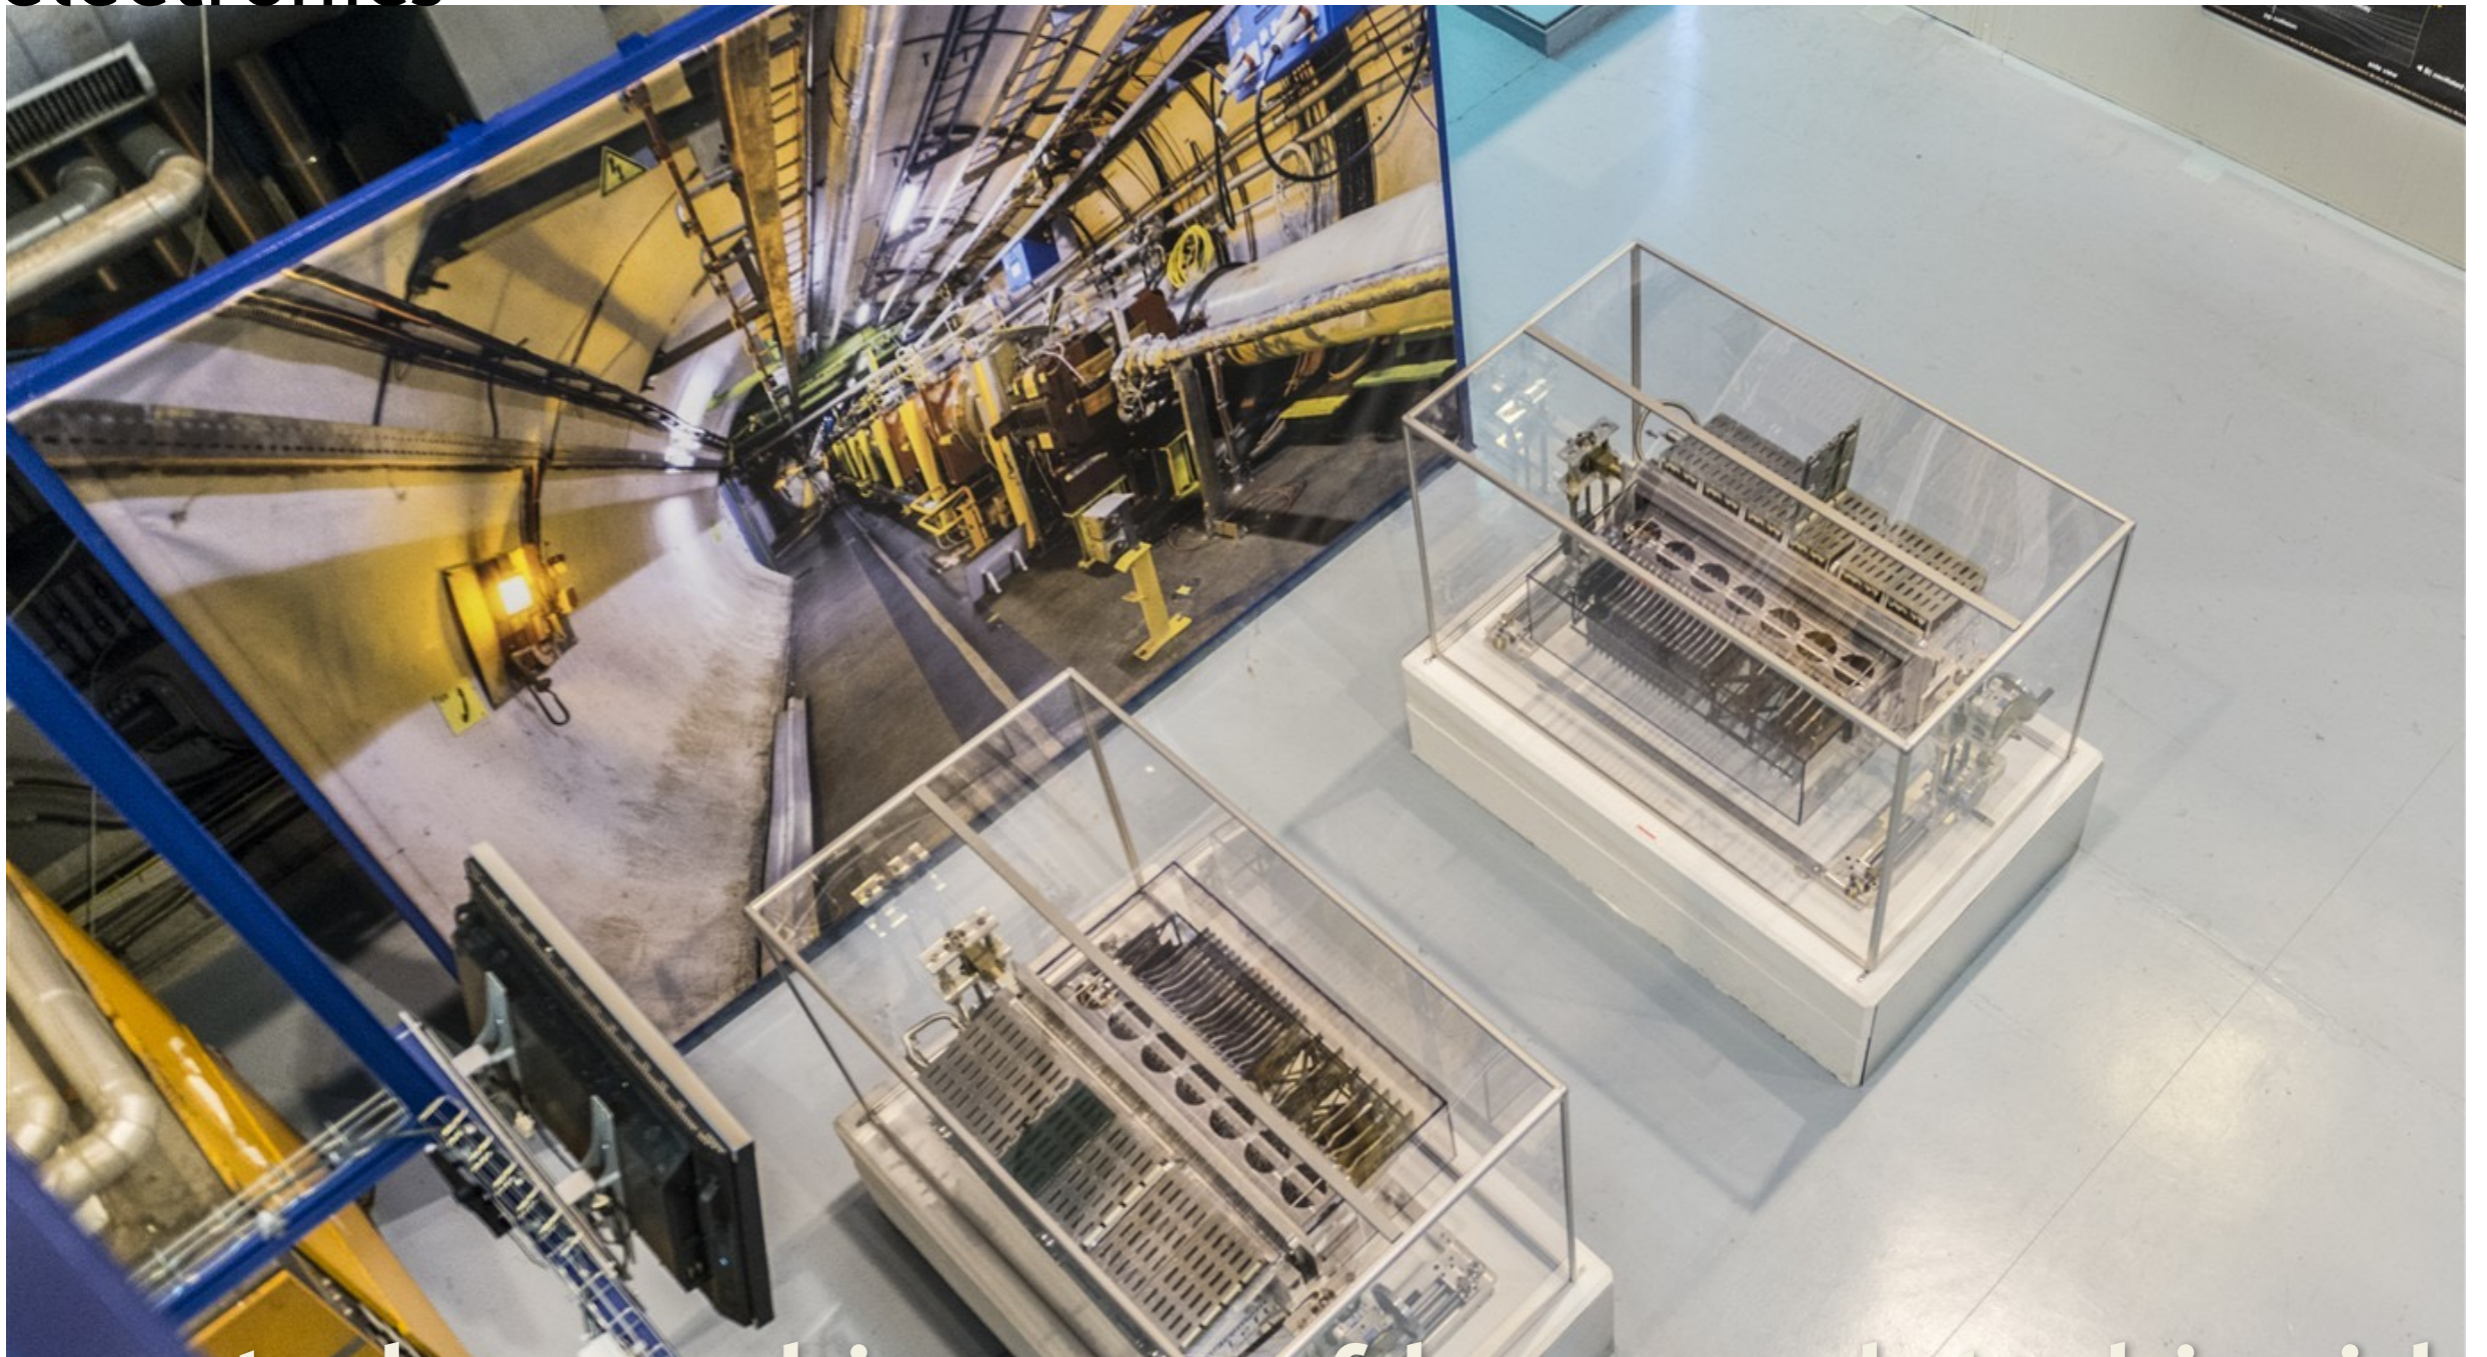
## Fully Functional and Tested spare sensors and frontend electronics

Spare to be used in case of beam related incident
