# The operation status of neutron chopper system at CSNS

**Weiliang Cai**

Dongguan branch, Institute of High Energy Physics, Chinese Academy of Sciences (CAS)

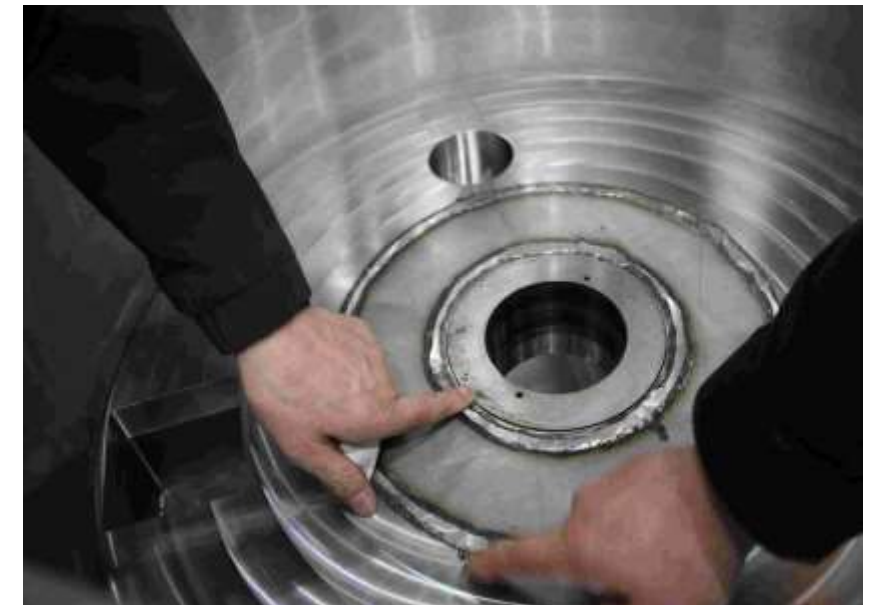
# Failure 2 - Cooling & Leakage

- Water-cooling pipe was plug by alumina particles which come from motor stator shell.
- Leakage of internal weld seam.
