Noise issues of MDC after installation of CGEM IT

2024.12.02

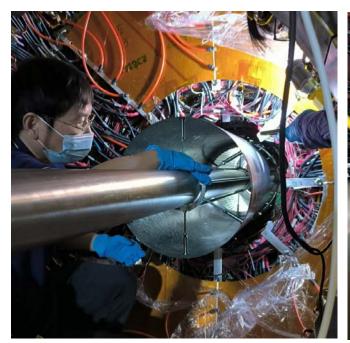
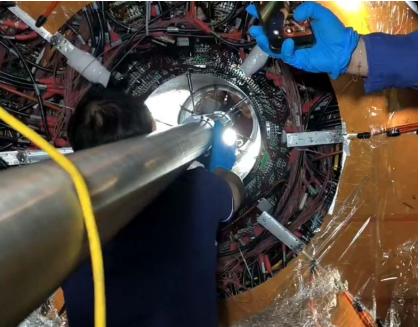
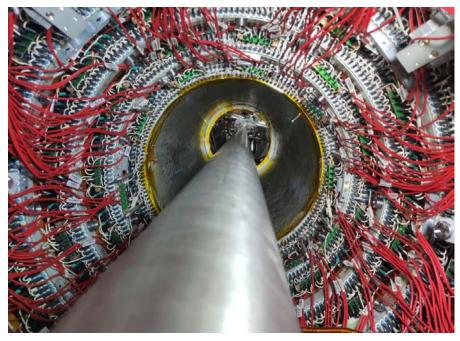
Installation of new inner CF cylinder

- After extraction of the inner chamber, new inner CF cylinder was installed as the inner wall of MDC
- Aluminum foils are coated on both sides of inner CF cylinder for shielding

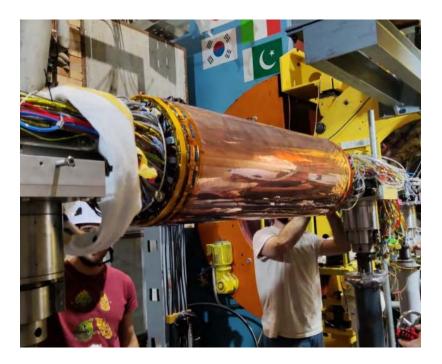
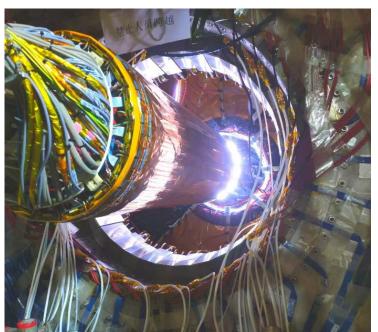
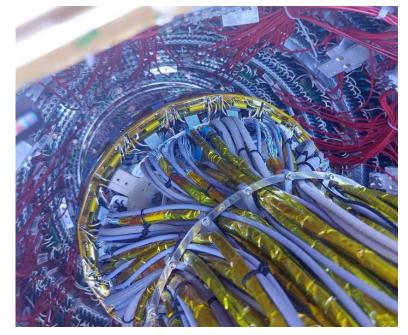
Installation of CGEM

- CGEM was inserted into the BESIII successfully on Oct.5
- It is fixed on MDC flange2 through FR4 flanges on both sides
- Grounding was separated from MDC physically

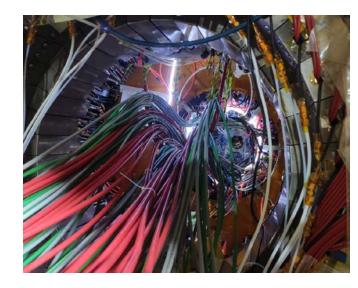
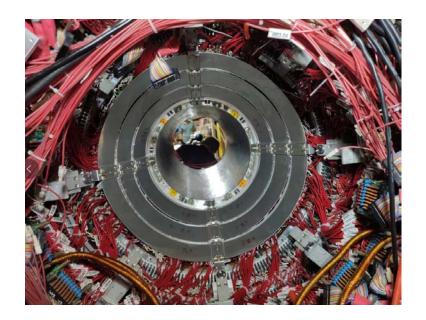
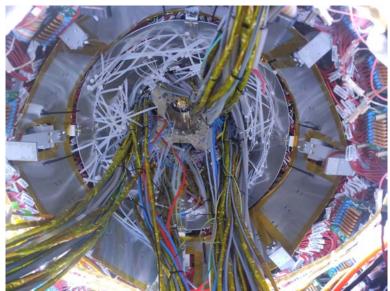
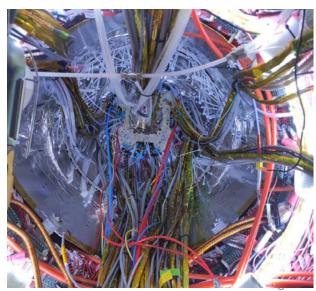
Installation of CGEM

- A aluminum shielding layer was installed to separate MDC cables and CGEM cables
- CGEM patch cards are fixed on the "tower" of the MDC preamplifier boards
- Due to the limited space, there is no shielding layer between MDC preamplifier boards and CGEM patch cards

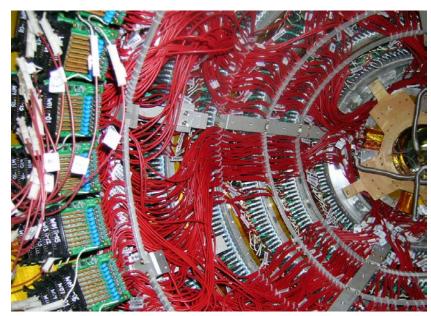
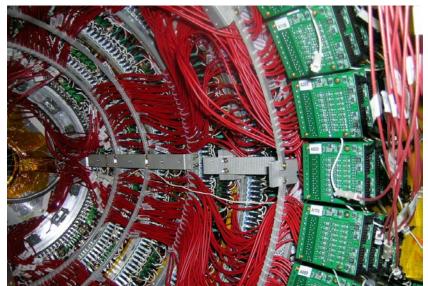
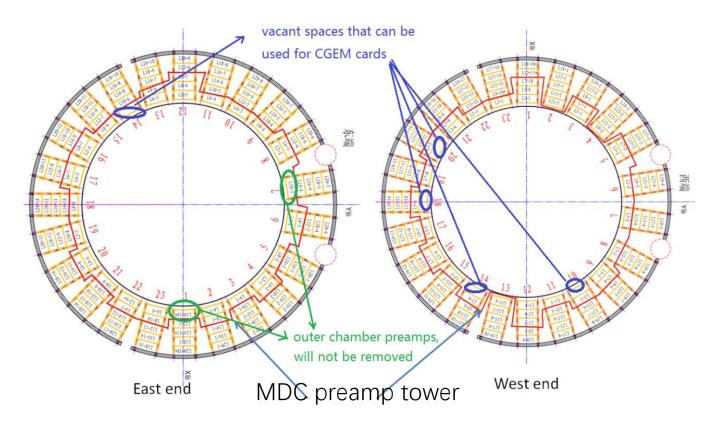
CGEM Patch cards installation

- The preamplifier boards of inner chamber were removed, and the space was used to install CGEM patch cards
- Insulated screws are used to separate the grounding of CGEM and MDC

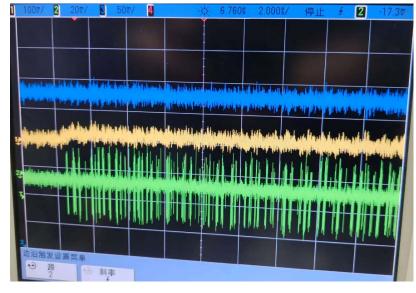
Testing for noise issues

- Lots of tests have been done in the last two weeks
 - Grounding tests:
 - Different grounding connections of CGEM
 - Different grounding connections between CGEM and MDC
 - Disconnecting the preamplifier of MDC from the "tower" ground
 - Shielding tests:
 - Adding shielding boxes for MDC preamplifier boards
 - Adding shielding layers for the end of CGEM signal cables
 - Installation the final shielding plates for CGEM and MDC
 - Noise waveform tests:
 - Testing the signals from daughter board of MDC MQT with a oscilloscope (good channel and noisy channels)
 - Threshold scan:
 - Measuring the noise count rate with different MDC time threshold

- Grounding and shielding have no significant effect on reducing noise
- The ground the CGEM is separated from MDC at the front end (the resistance between them is about 350 k Ω when the crates of the CGEM is disconnected from the ground)
- As each device in the CGEM system is powered off and disconnected from the ground one by one, the noise of MDC becomes smaller and smaller
- Compared to the case before CGEM installation, there is baseline noise because even if CGEM is powered off, there are still some channels with noise present
