Irradiation test of COFFEE2 @ CSNS

CEPC reference TDR tracker meeting

26 Apr 2024

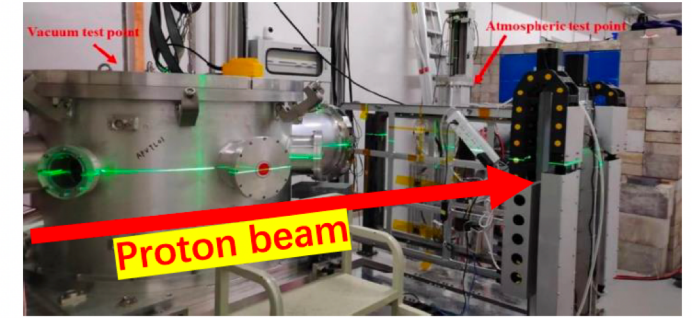
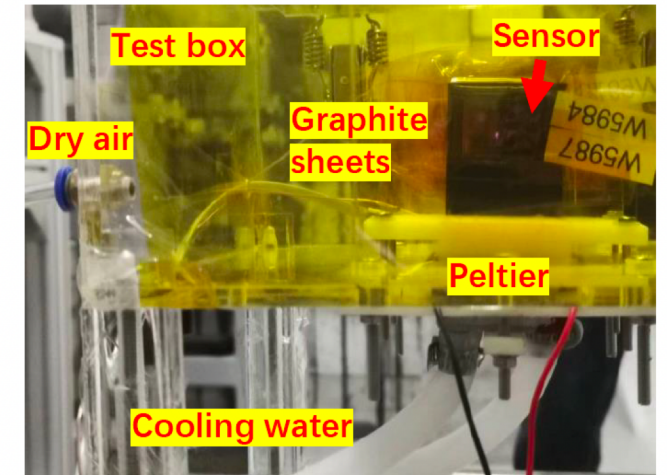
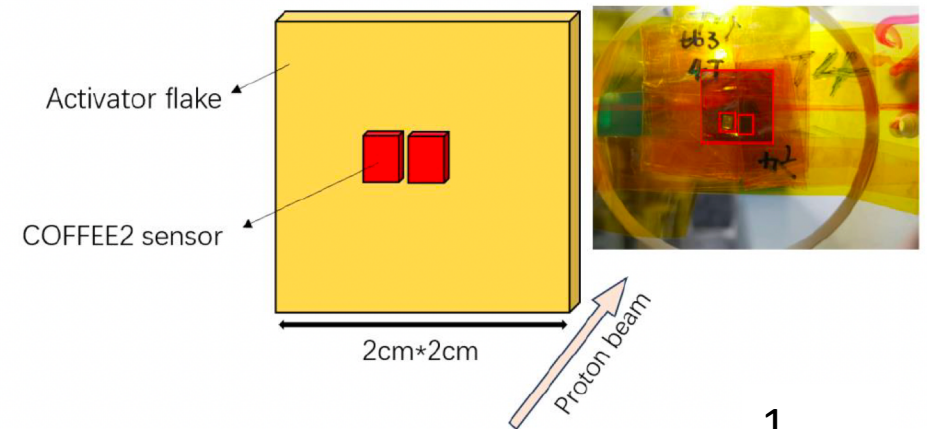
Setup

- Low temperature (1 test point, beam spot $2 \times 2 \text{cm}^2$)
 - -28°C (cooling water + Peltier), dry air prevents freezing
 - Stacked with other samples (Si strip sensor), isolate with Kapton tape, estimated loss of flux $<10\%$
 - Irradiation flux: $7 \times 10^{14} \text{ n}_{\text{eq}}/\text{cm}^2$
 - Annealing condition: 80 min at 60°C
- Room temperature (4 test points, beam spot $3 \times 3 \text{cm}^2$)
 - Irradiation flux: 2×10^{11} , 3×10^{12} , 3.5×10^{13} , $1 \times 10^{14} \text{ n}_{\text{eq}}/\text{cm}^2$
- 2 sensors placed at each test point
 - 1 IV/CV tested + 1 new
- Activator flake were placed at each point to calibrate irradiation flux

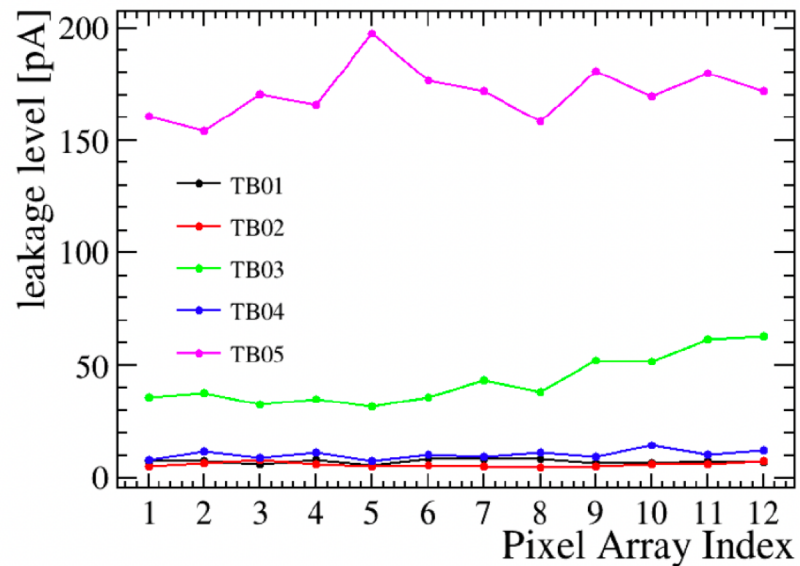
Test Plan (IV, CV, CCE)

- After sensors back (2 weeks later), compare IV/CV change
 - For the 5 sensors tested, IV/CV results were consistent in general
 - Large leakage found for 1 sensor (placed at test point with lowest flux)
- Meanwhile, preparing for test setup of charge collection efficiency
 - Take IDE1140 as readout system
 - Verify the signal response with laser first, further test for radioactive source (α , β)
