Digital Pixel Measurement of TaichuPix1

Tianya Wu **CEPC MOST2 Meeting** twu@ifae.es 17-08-2020

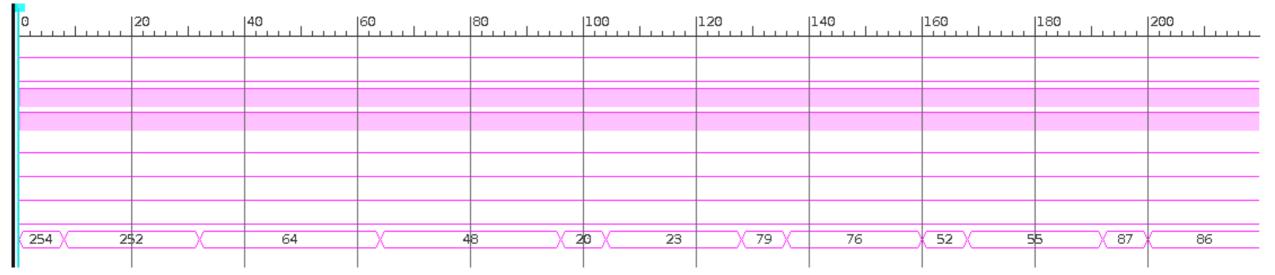
The last line is the serial to parallel conversion output, this is the result of DSEL=1, data is from the internal generator, but it mismatch the PRBS-2^7 pattern? And the time period of each data is different.
