Updates on C-V measurements

Liaoshan Shi

Jan. 24, 2019

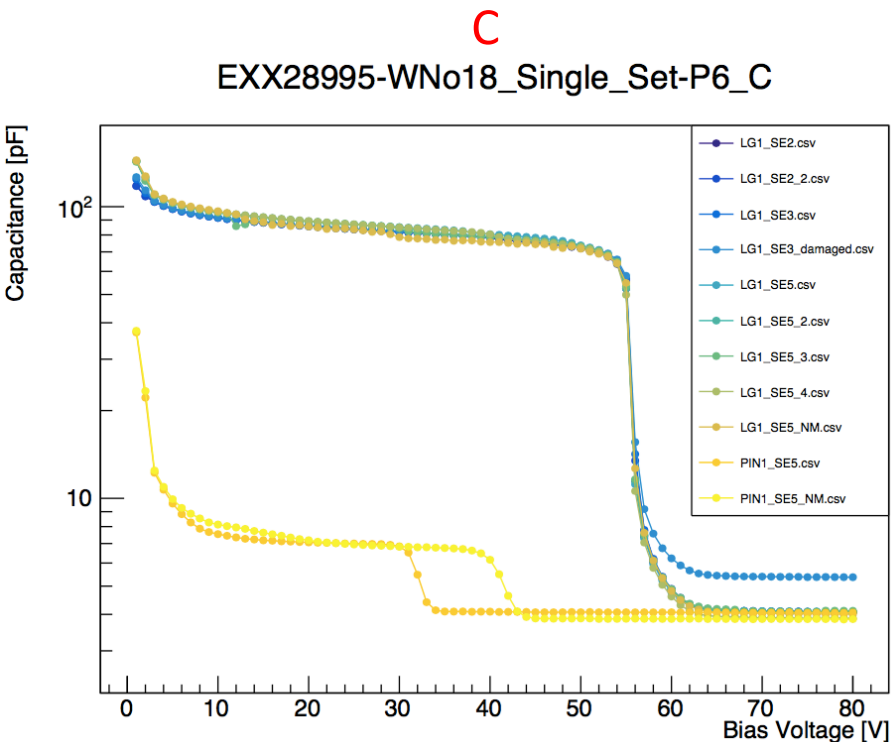
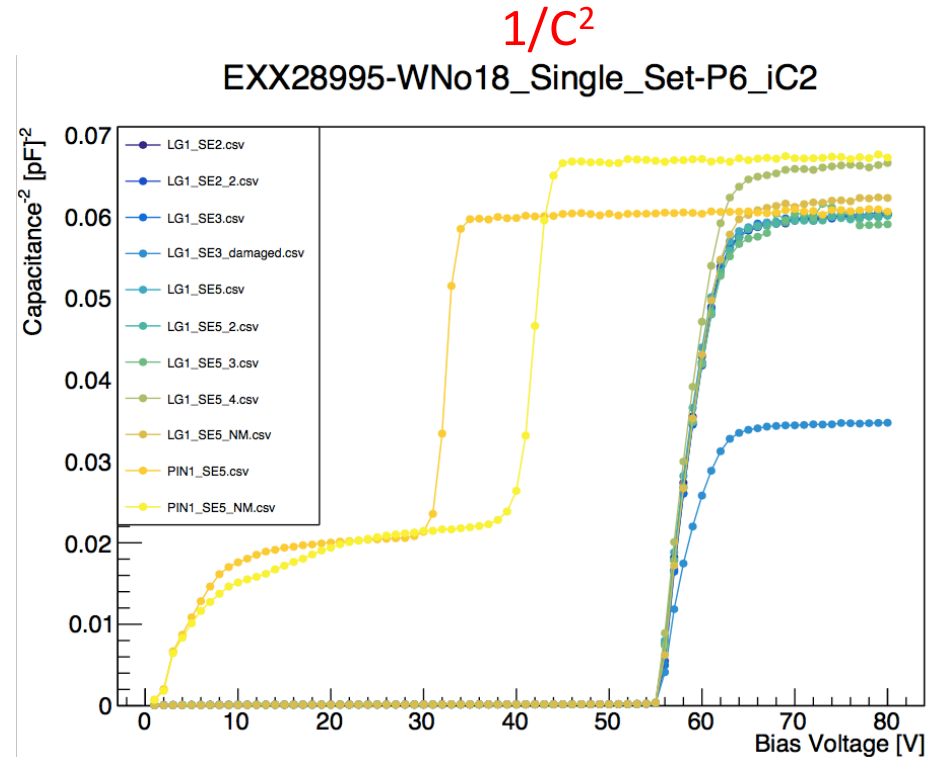
C-V results: HPK-SMPL-3.2-W18_Single_Set-P6

- Full depletion ~60V for LGADs. PINs depleted before LGADs.
- Capacitance at full depletion: 4.0μF
- One of the LG1_SE3 sensors is damaged, showing higher capacitance (5.4μF) after full depletion.

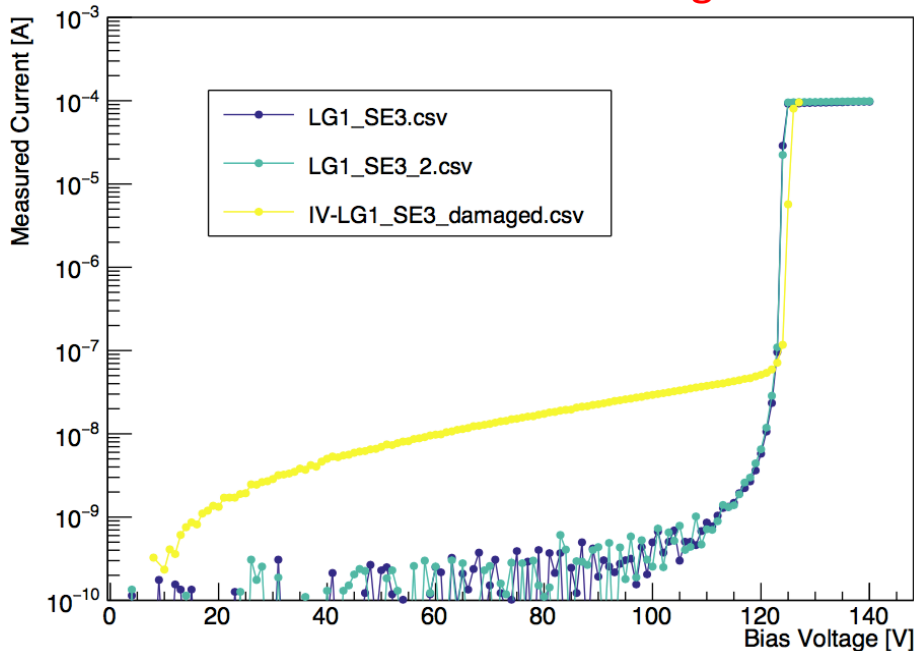
I-V before and after damage

- An LG1_SE3 sensor was damaged after I-V test in December due to improper handling.
- After the damage:
 - Higher leakage current.
 - Breakdown voltage is the same.
 - Higher capacitance after full depletion.
 - Full depletion voltage is the same.
