Commissioning of the Phase-1 Upgrade of the CMS Pixel Detector

Benedikt Vormwald

University of Hamburg on behalf of the CMS collaboration

TIPP 2017 Beijing, 22-26/05/2017

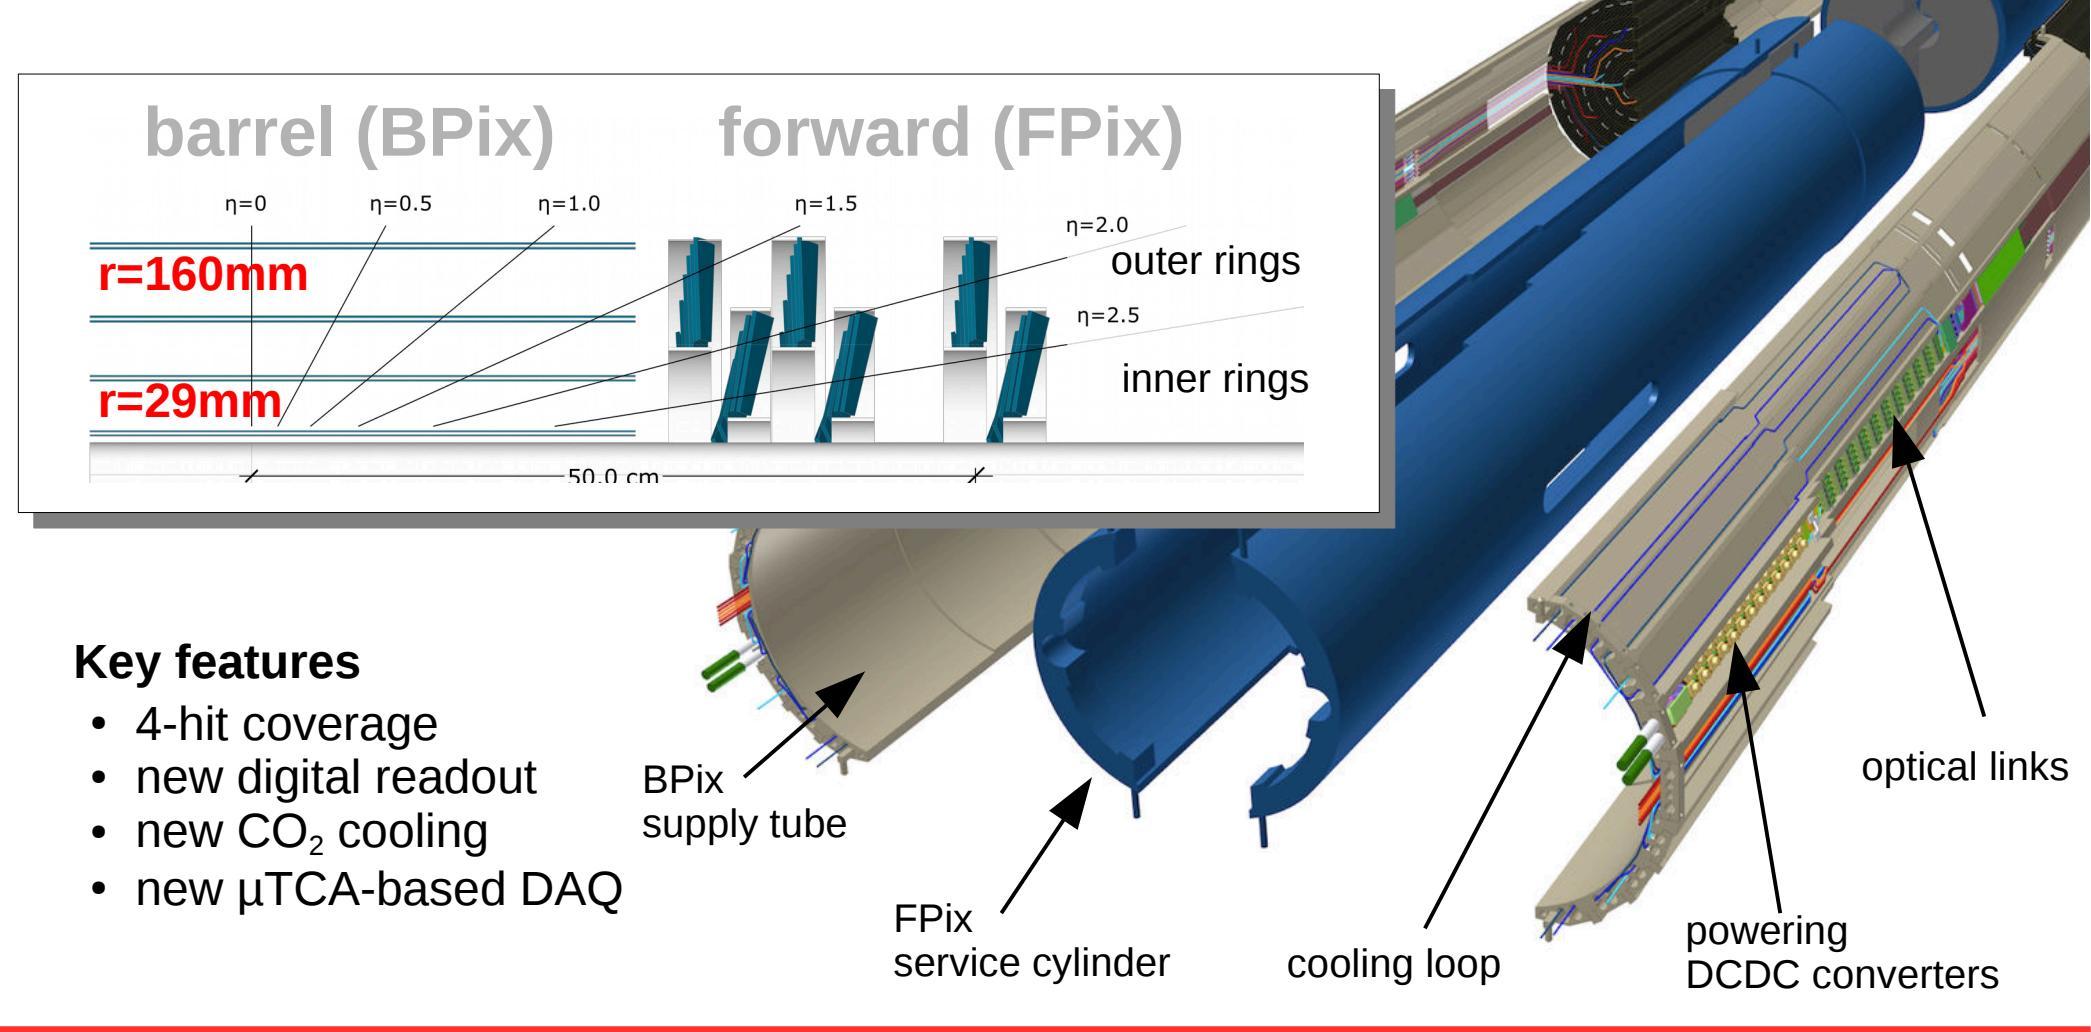
FPix (3 disks on each side)

BPix (4 layers)

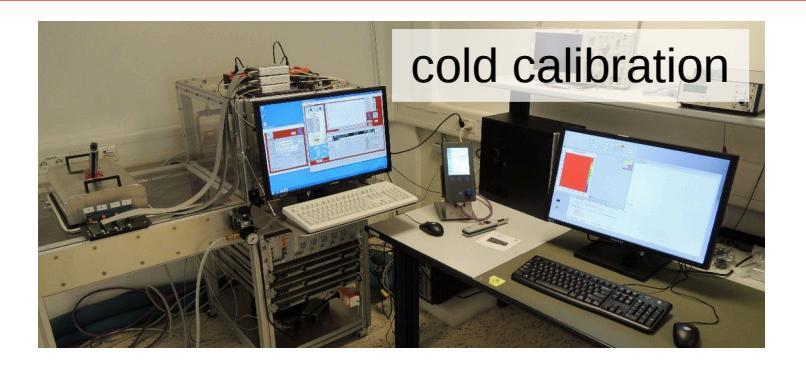
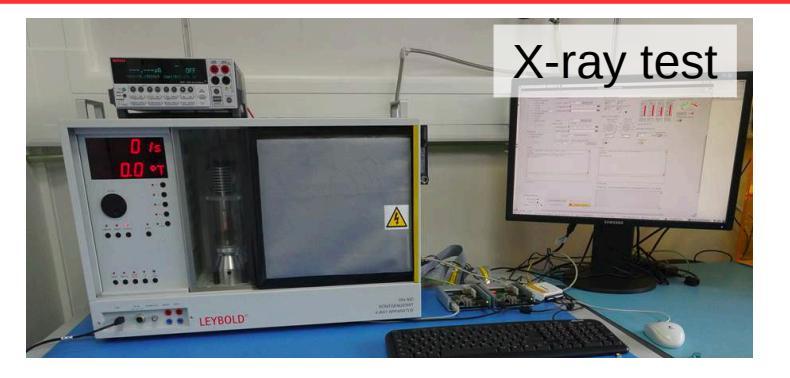
FPIX bad bumps [O(1/1000)] (sum of all modules)

standardized test and qualification procedure following the module production chain:

- → bare modules: bump-bonds, IV curves
- full modules: ROC/TBM/pixel functionality, thermal cycling, IV curves
- X-ray tests: high rate, pulse-hight calibration

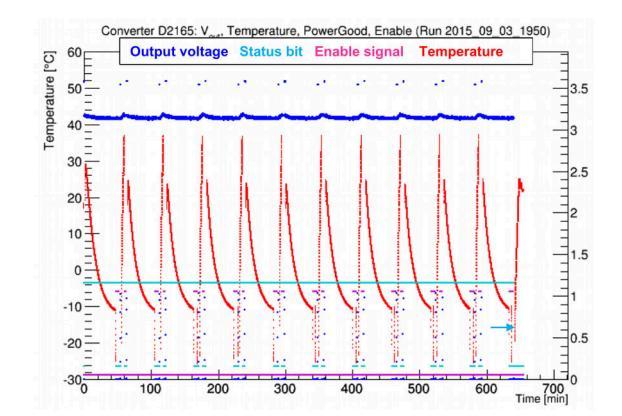
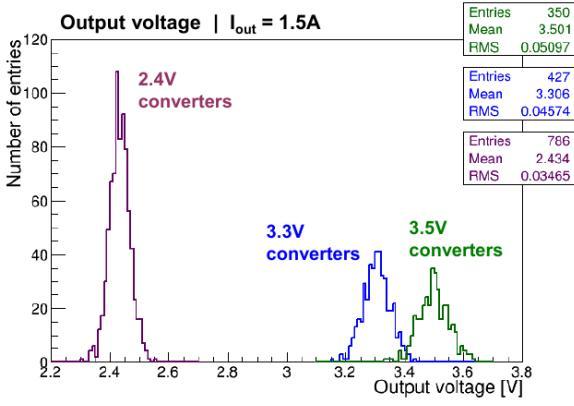
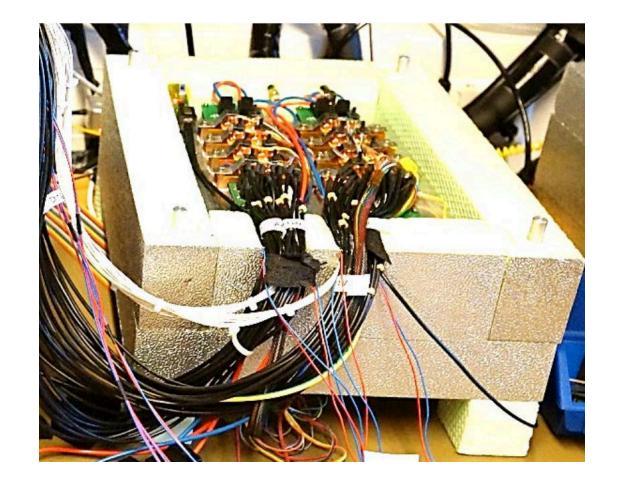
DCDC converters

- 1.9 times more channels
- same power cables
- DC-DC conversion near the detector 11V to 2.4V/3.0V
- 1184 converters needed
- intense testing:
 - thermal cycling (10 times from +20°C to -28°C)
 - monitoring of status&enable bits
 - output stability
- classification according to the output voltage

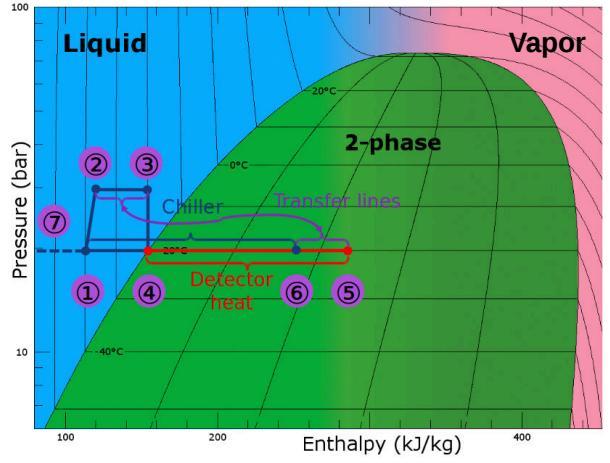
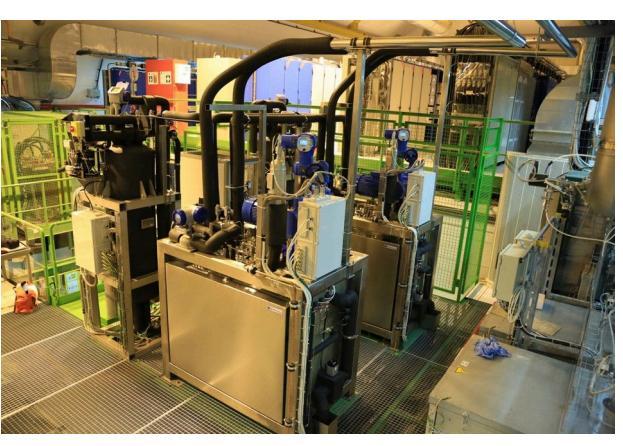
2-phase CO₂ cooling

- → very lightweight
- → very efficient
- stainless steel cooling loops: diameter 1.6mm, wall thickness 50µm

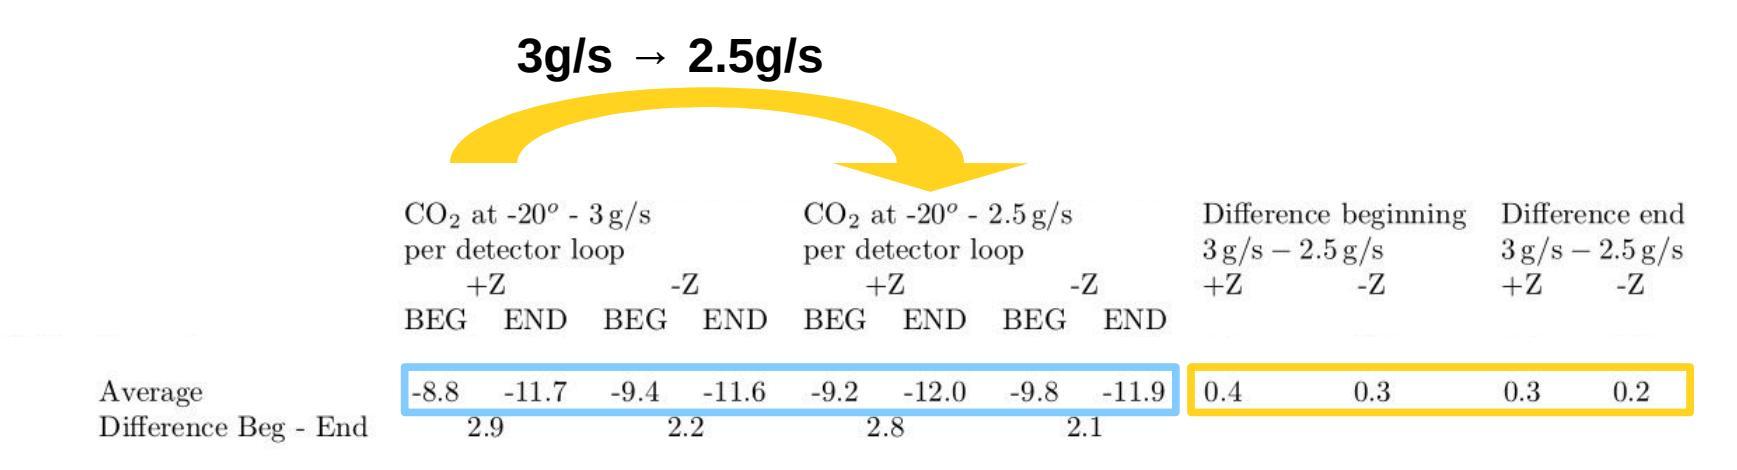
After first successful commissioning: adjustments of CO₂ flows between FPix and BPix:

- reduced flow: even better cooling performance due to improved vapor quality
- pixel detector modules now operated at about -10°C

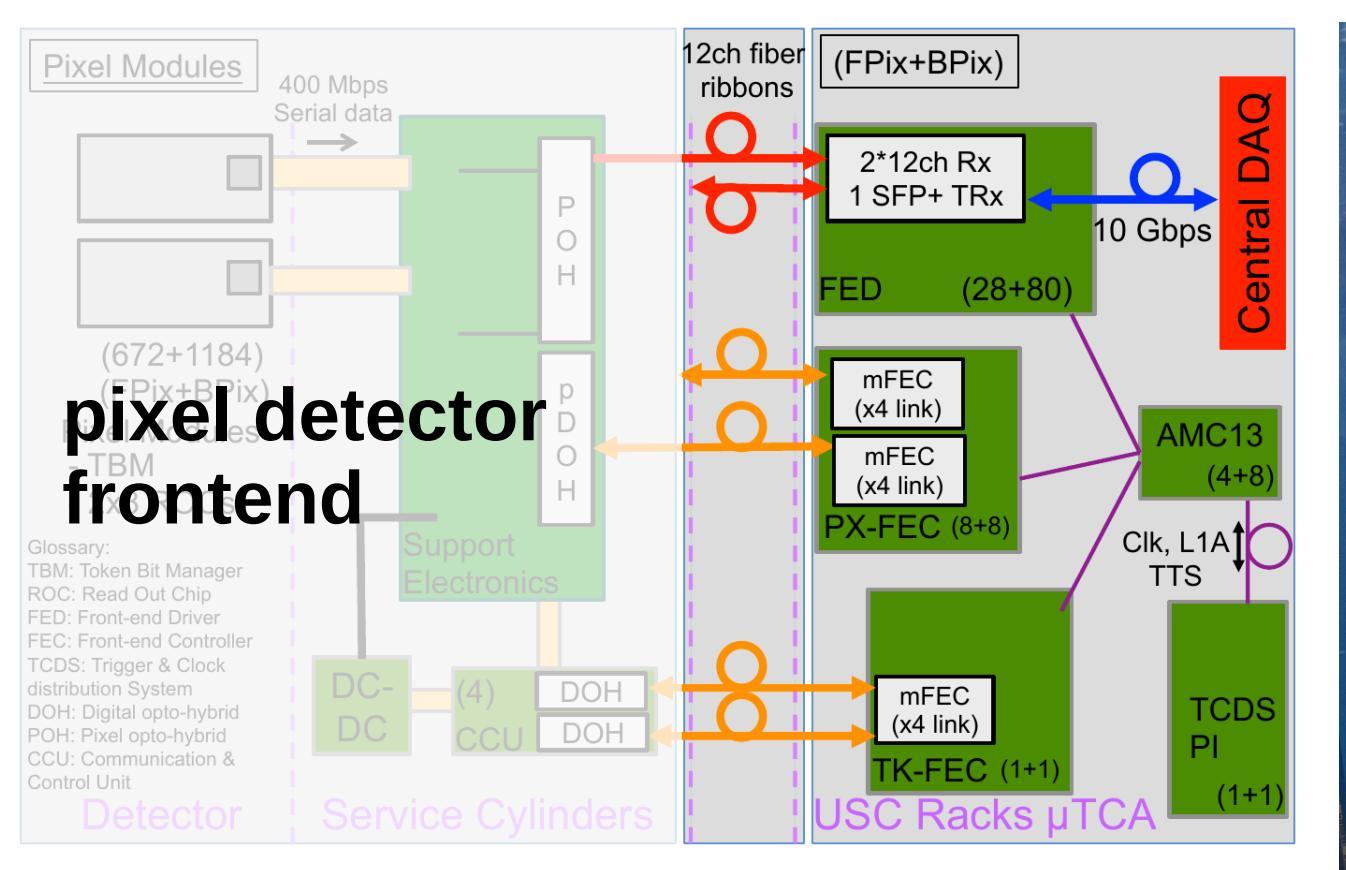
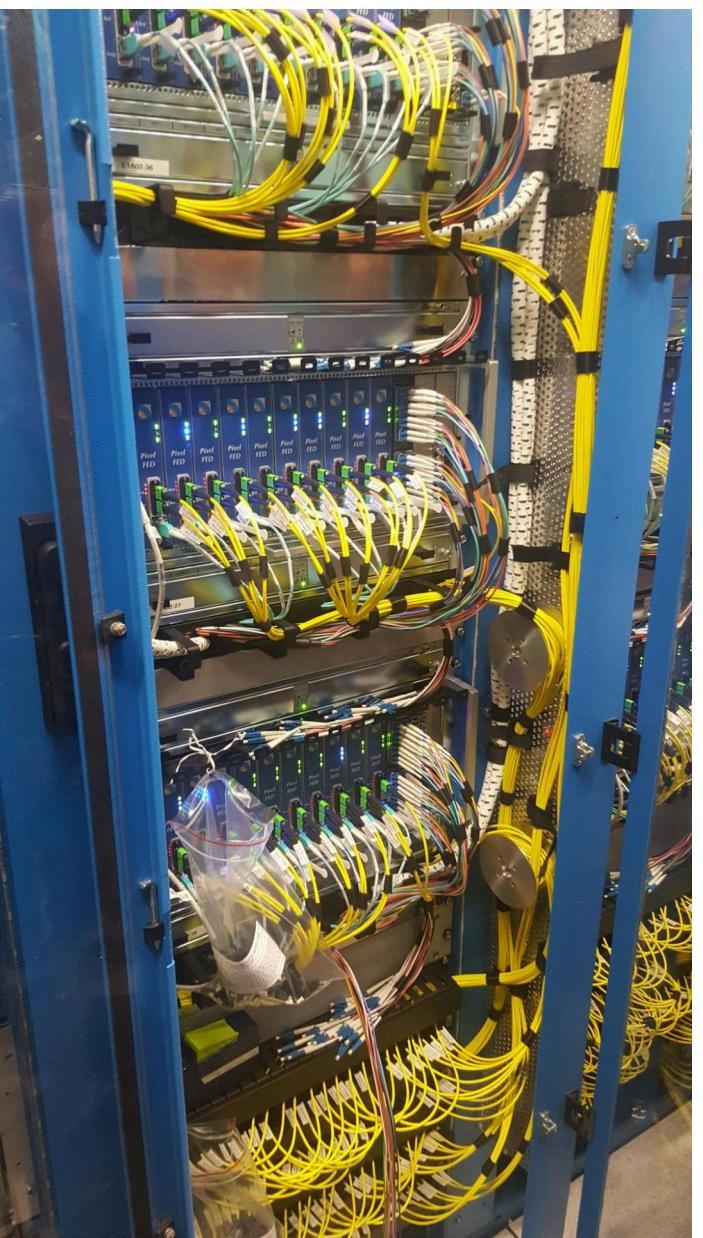
- replacement of VME front-end boards
 - 108 FrontEndDrivers (FED) → detector readout
 - 16+3 FrontEndController (FEC) → detector control
- new CMS-wide crate standard: µTCA
 - all based on generic AMC card (FC7) built around Xilinx Kintex 7 FPGA and 4GB DDR3 RAM
 - different flavors realized with FPGA mezzanine cards/ firmware
- capable to drive/receive links of **up to 10Gb/s**

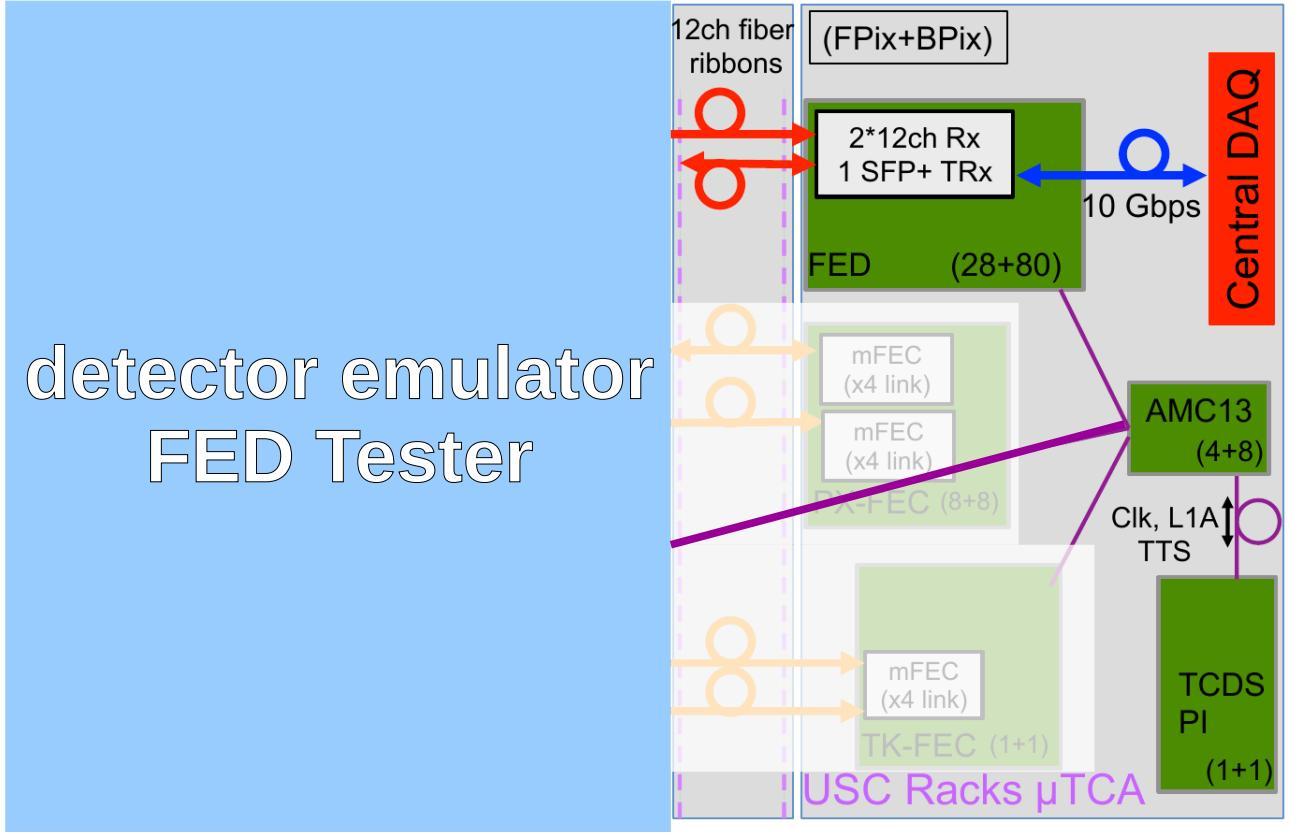
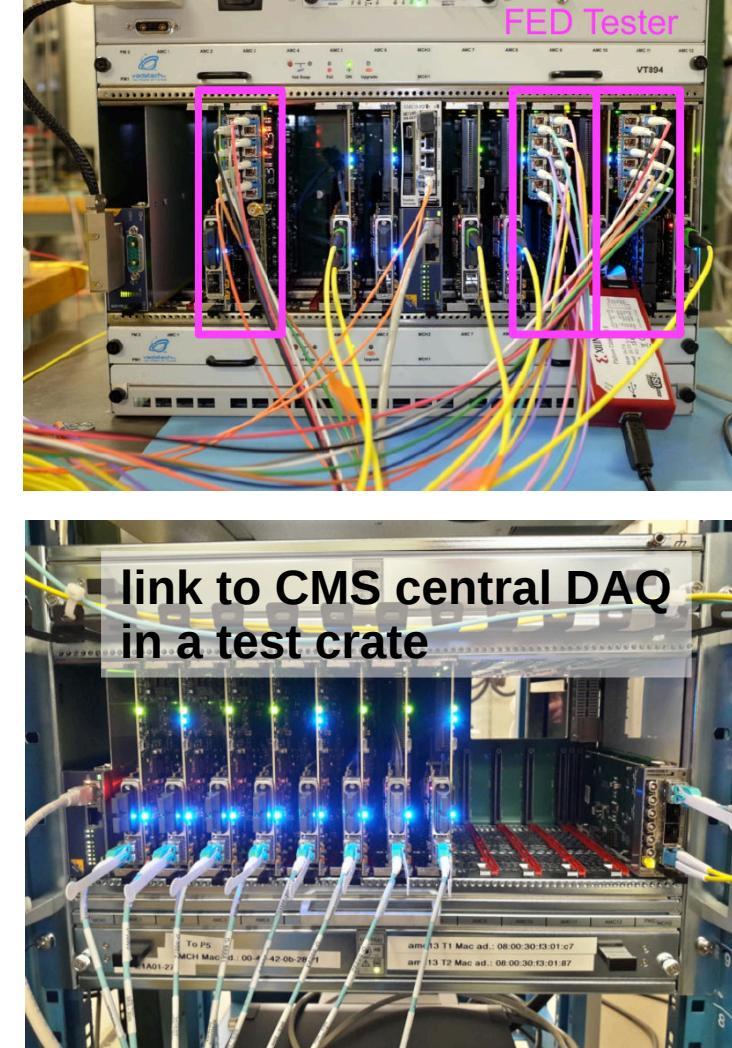
- FED tester: full emulator of pixel module optical output
- GLIB based µTCA board connected to CMS trigger system
- essential tool to test and validate the FED firmware using specific data pattern
- used to exercise and validate the throughput of FED to CMS central DAQ

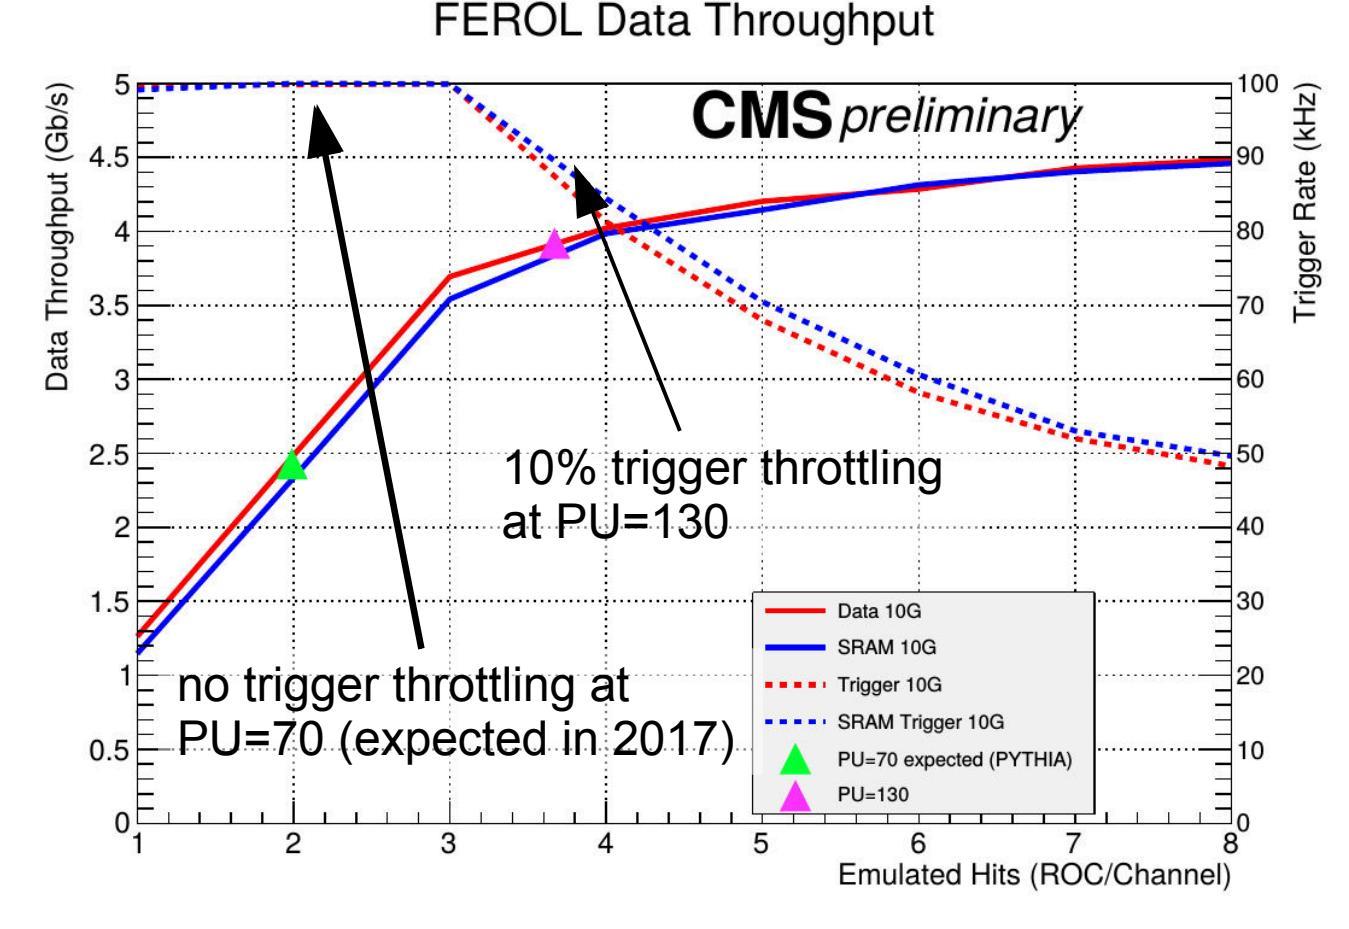
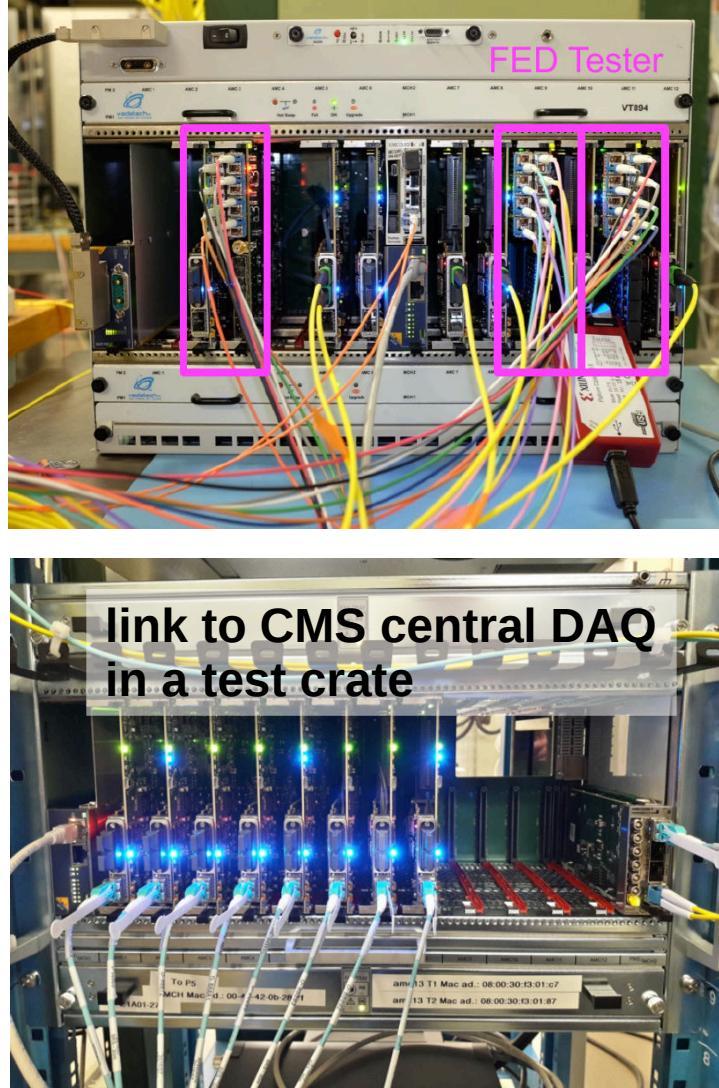
Test of FED Data Throughput

- send 100kHz random triggers (L1A rate at CMS)
- load FED with emulated hits
- read out through 10G link of FEROL (FED Readout Link → CMS central DAQ)
- trigger rate gets throttled according to the FED status

Sufficient headroom for 2017 Work continues on parallel architecture

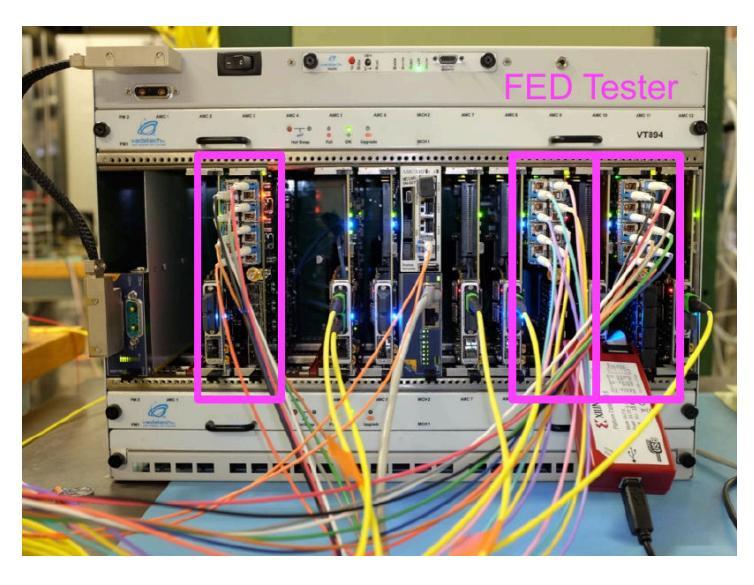
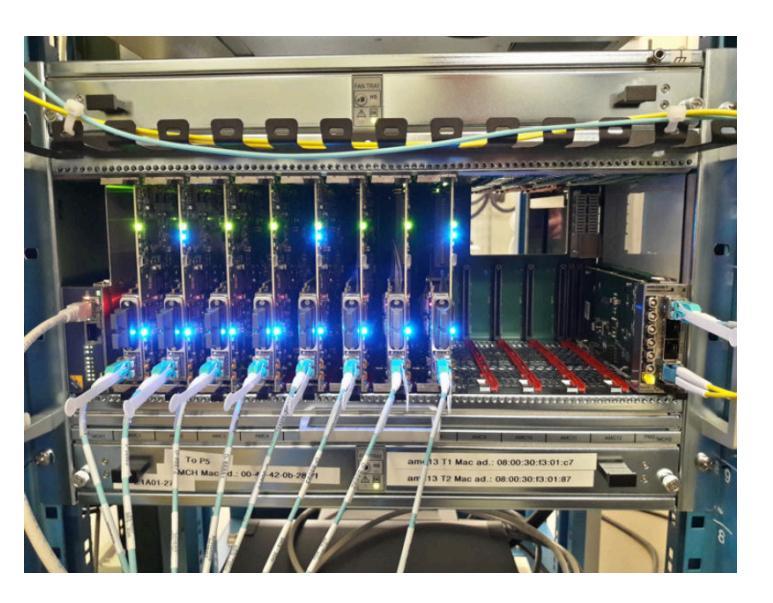
workbench setup

- FED itself can emulate hits
- full pixel system (108 FEDs) in global run with 3 emulated hits per ROC (~PU=105)
- no problems

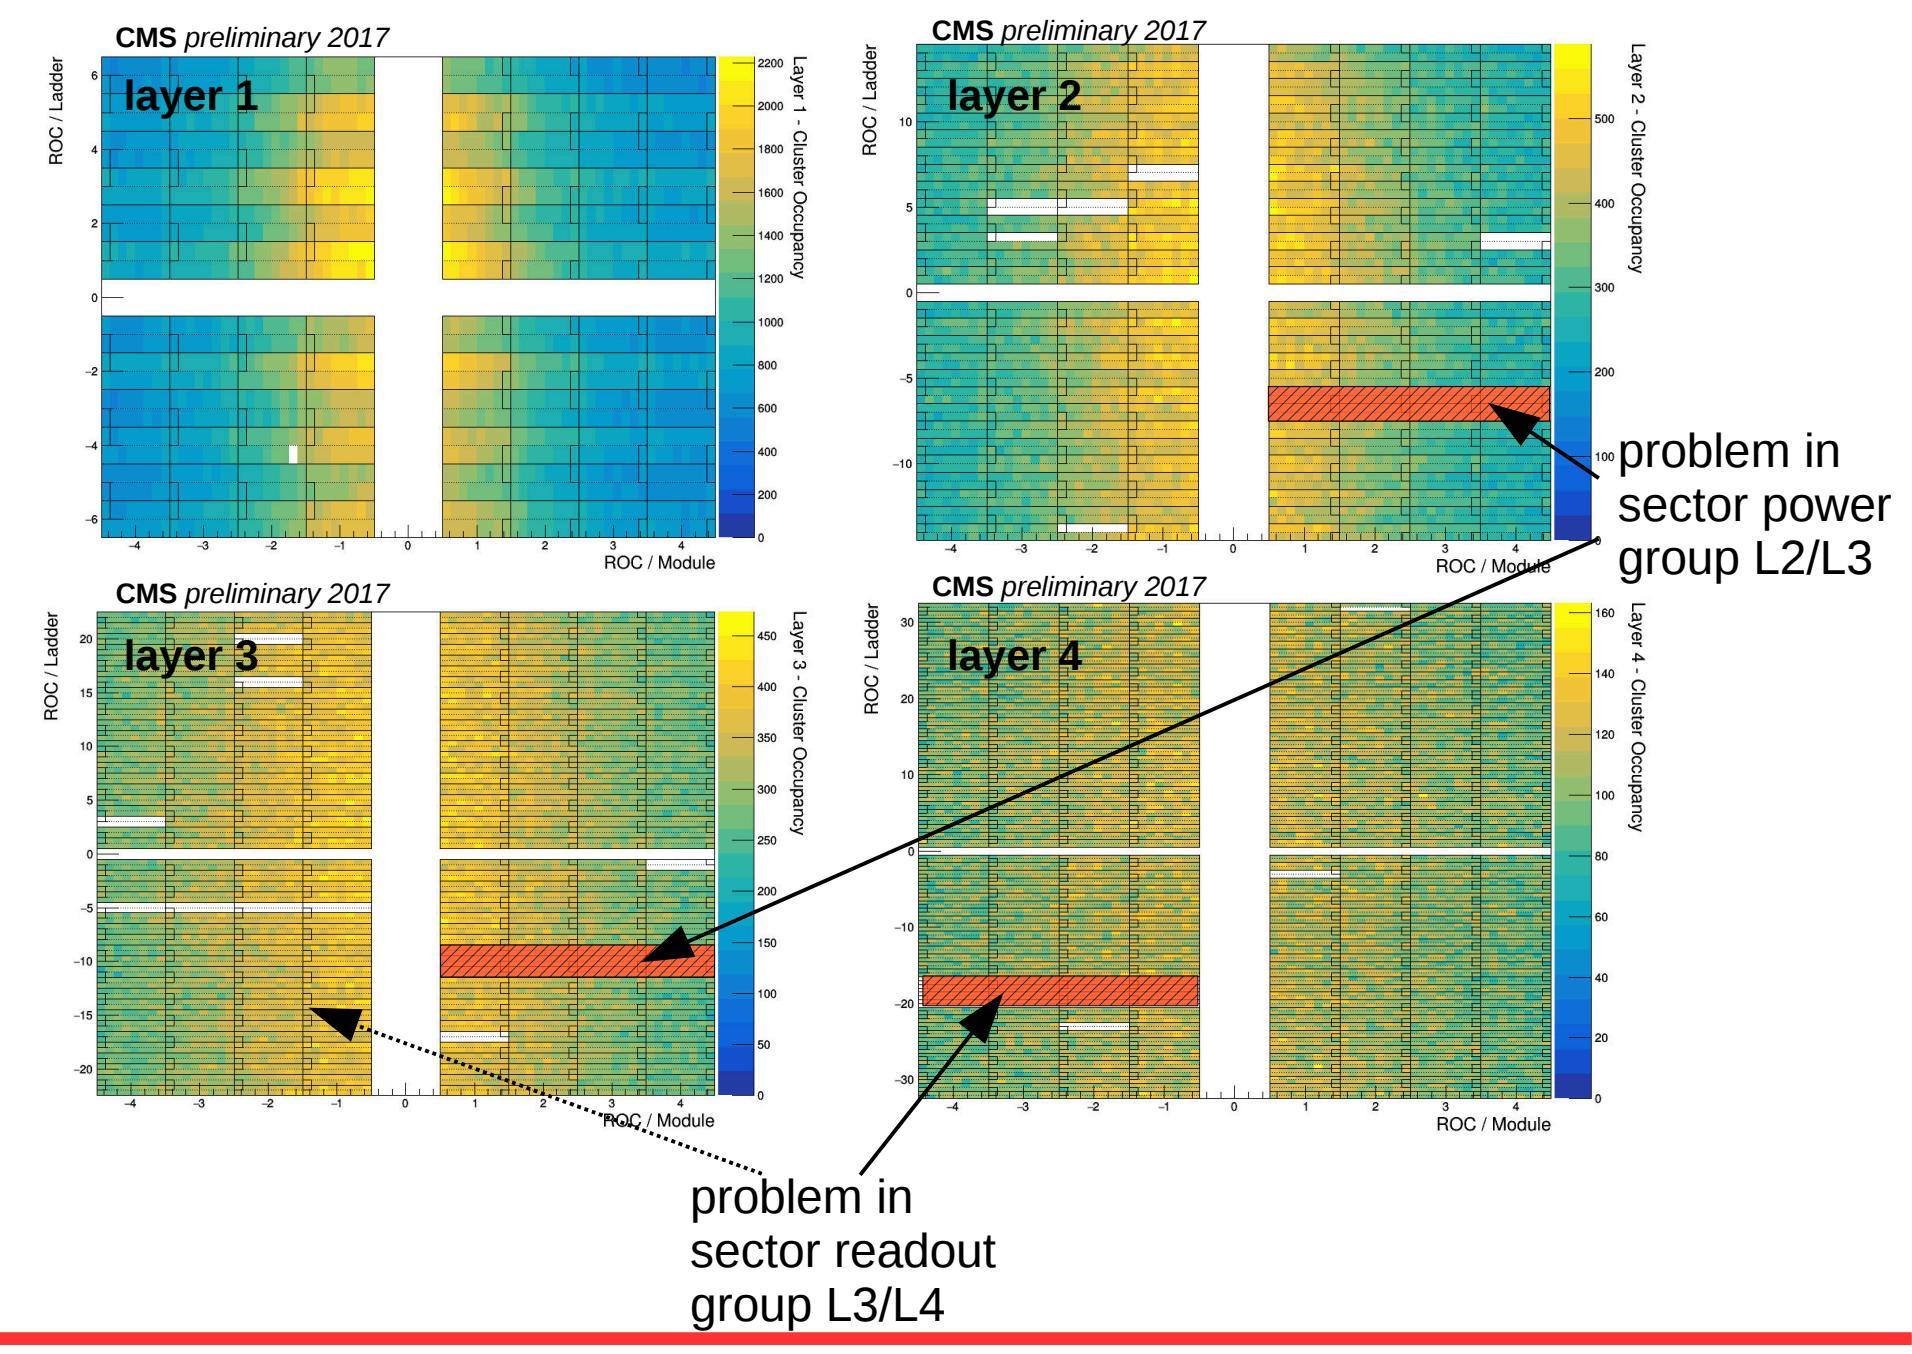
Detector Status – BPix Occupancy Map

BPix&FPix 95.1% active channels

most problems affect groups of modules:

- power groups
- readout groups

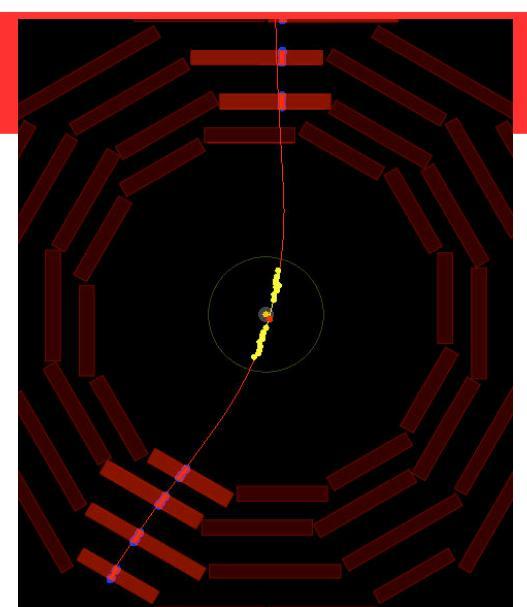
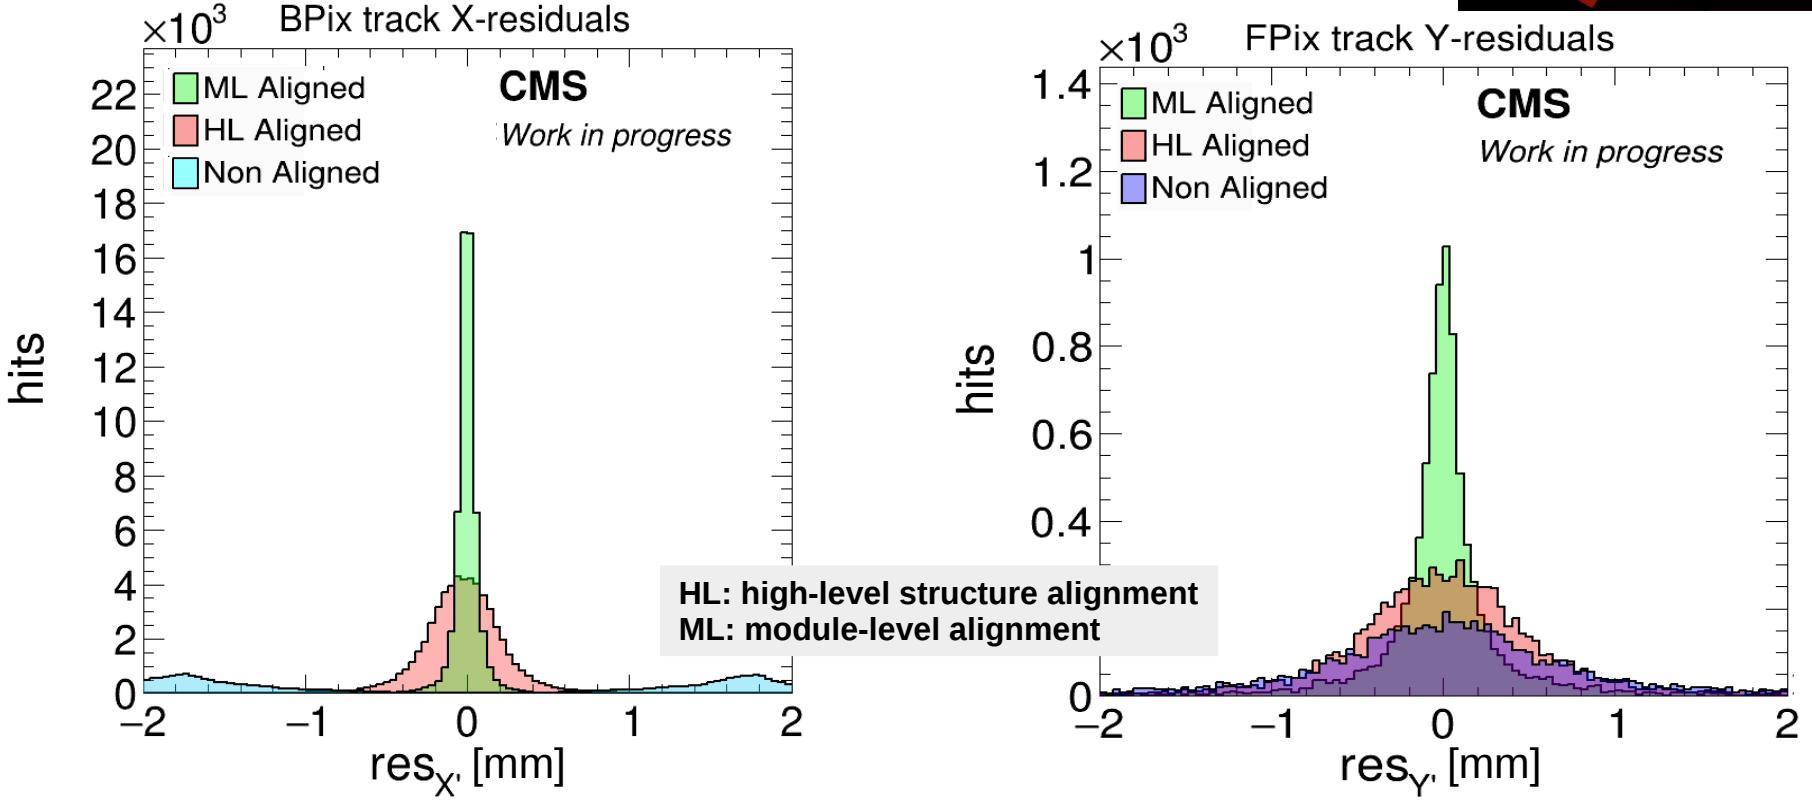
Cosmic runs provided valuable input for spatial and timing alignment:

- **low occupancy** helps to prevent ambiguities
- determine correct bunch crossing to read out wrt L1 trigger from hit-on-track efficiency
- determine **position** of BPix and FPix from track fit

very good starting conditions for final alignment with collisions
