- **Status of TPC R&D**

High granularity readout: Production of TPC module

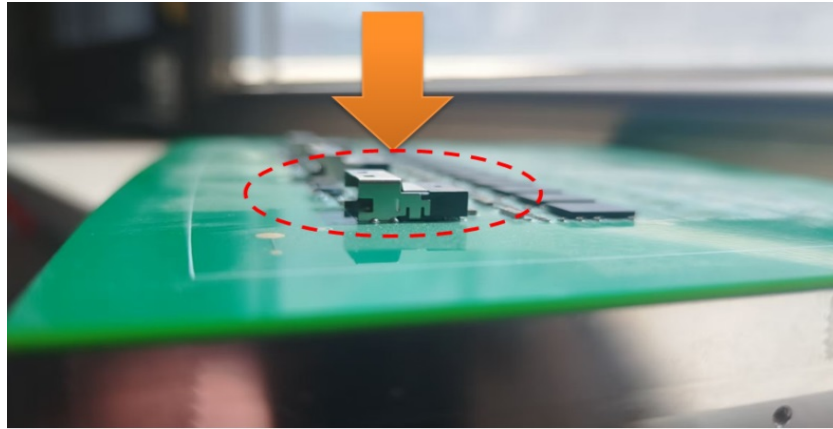
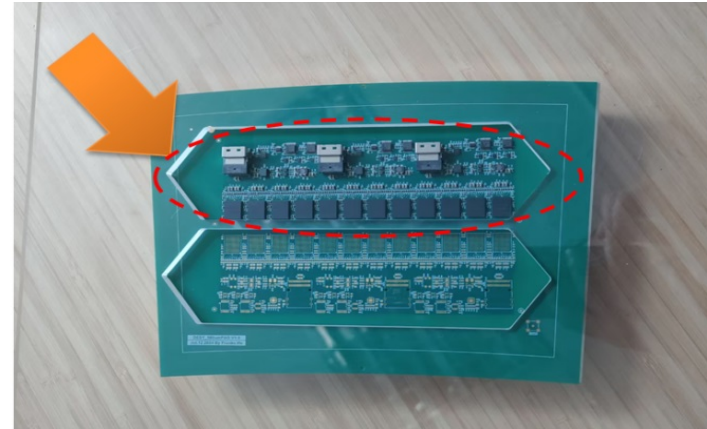
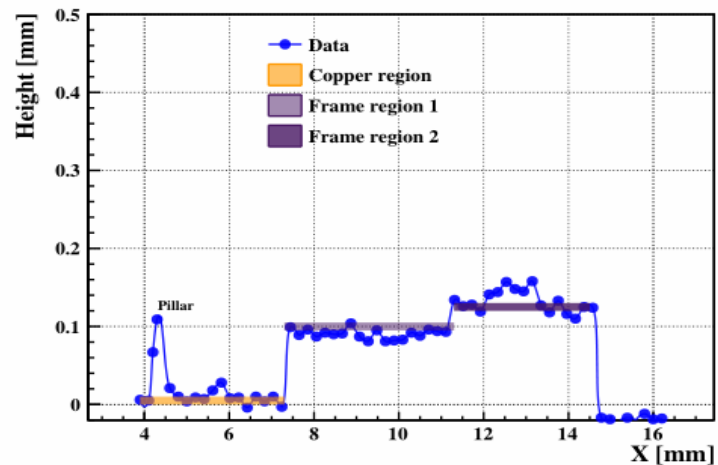
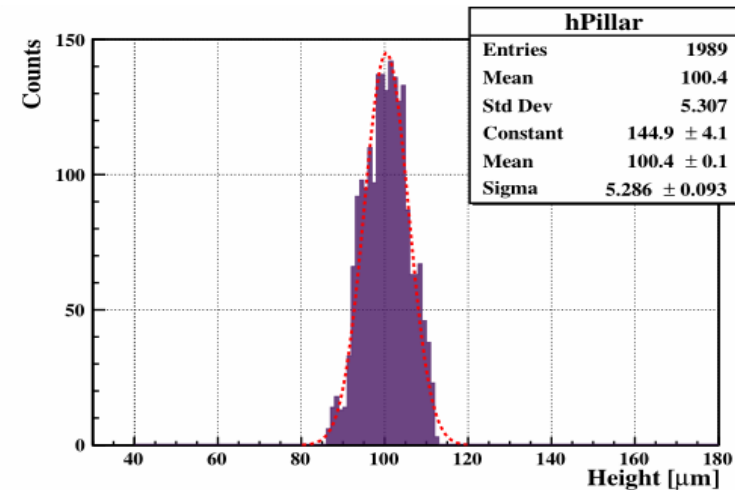
- **Key issues to address #1**

- Development of the pillar is constrained by the **height** of the transmission interface
- After three rounds of process optimization, this issue **has been resolved** using flat-plate pressing

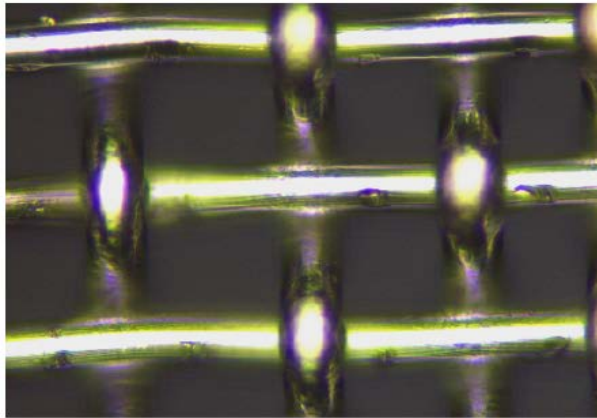
(a) 未辊压的不锈钢网

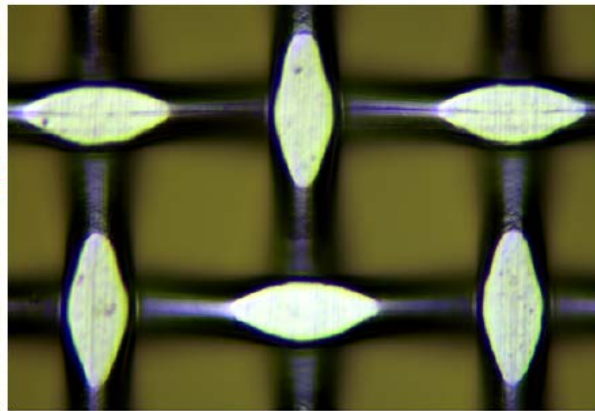
(b) 辊压后的不锈钢网

- Stainless steel wire mesh stretching and rolling are optimization
- **Improved detector gain**, resolution and overall performance

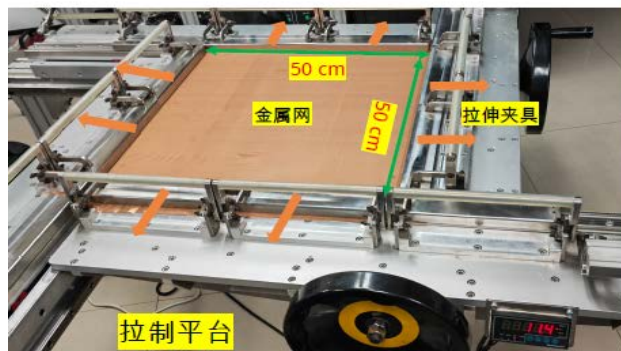
(c) 不锈钢网拉伸平台

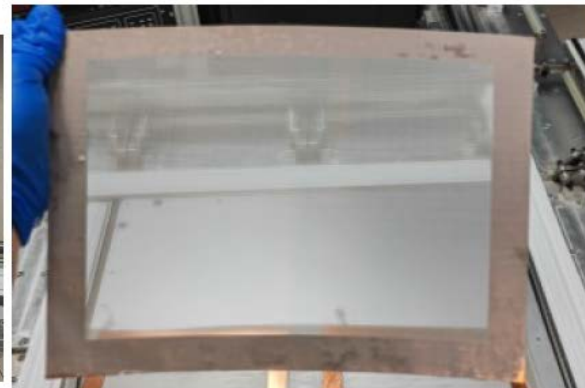
(d) 拉伸后的钢网

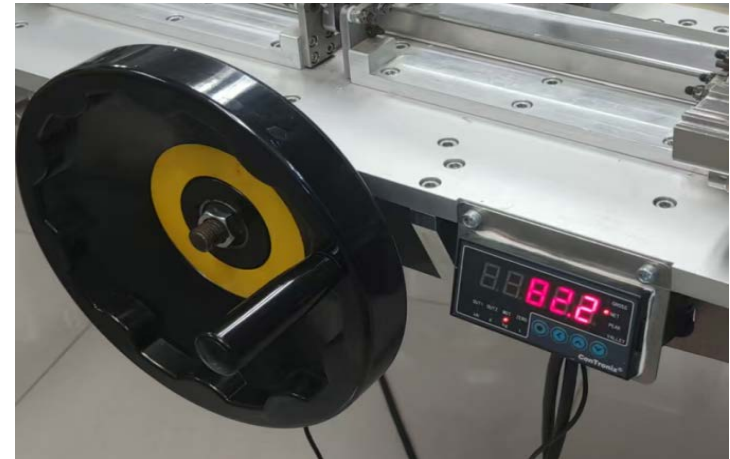
High granularity readout: Micromegas detector tests

- Detector optimization completed
- Test chamber fabrication completed
- Readout system & preliminary electronics prepared with Tsinghua
- Detector installation & gas tests in progress

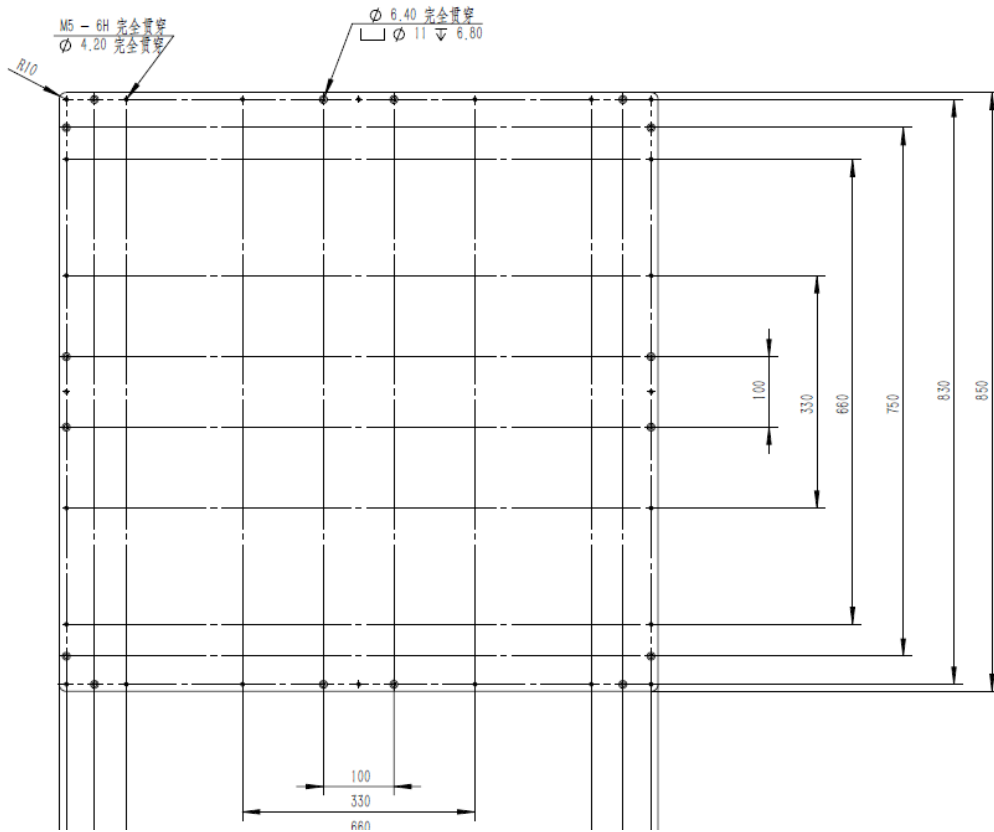
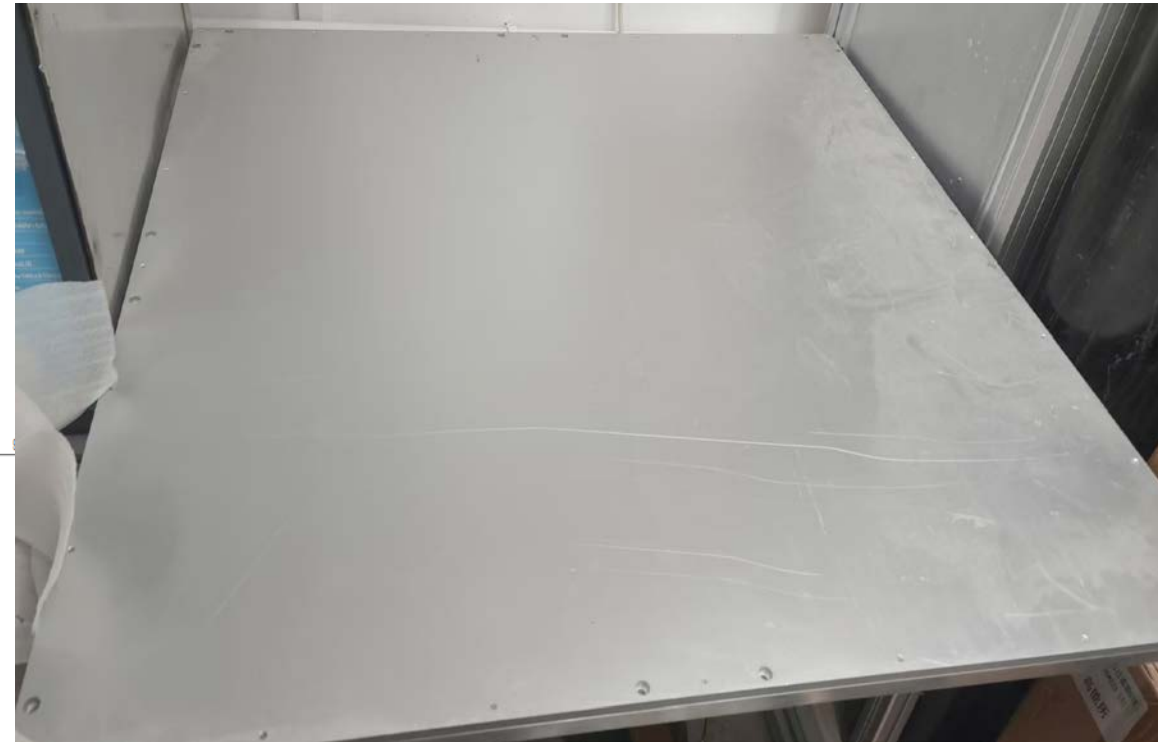
- Impartments of mesh production:
 - Stainless steel pressure bars & Al alloy flat plates: improved fabrication in progress
